# Meyers, El Dorado County, California Road Safety Audit

## Conducted February 8-9, 2016

Prepared By: FHWA Resource Center and in Cooperation with Tahoe Regional Planning Agency

FINAL REPORT April 2016

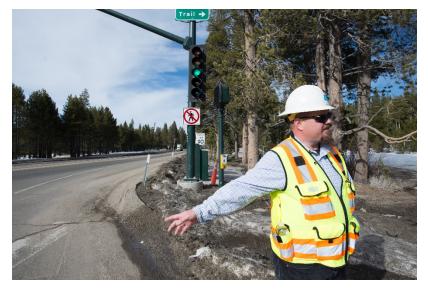
Figure 2: Pioneer Trail Crosswalk (Photo Source: Beryl)

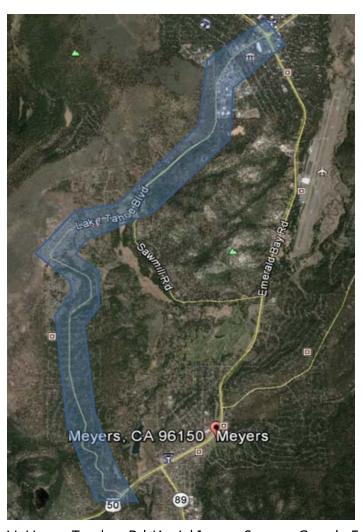
Figure 13: N. Upper Truckee Rd (Aerial Image Source: Google Earth)

N. Upper Truckee Rd is a local neighborhood road that connects to Lake Tahoe Blvd and is a parallel route to US 50 into South Lake Tahoe, as shown in Figure 13. There are approximately 2,000 residential properties along N. Upper Truckee Rd which generates a high volume of local traffic daily. The 2014 AADT for N. Upper Truckee Rd was approximately 5,750 vehicles per day<sup>17</sup>. During peak periods this route has become a "bypass" for long traffic delays on US 50 through Meyers to leave Tahoe. Anecdotally, it is also thought to be used as a bypass of chain control during inclement weather events. It is also speculated that smart map technologies are showing this as an optional route, which results in higher than normal traffic volumes for this facility. During peak periods the traffic on this roadway likely exceeds its capacity as noted anecdotally by CHP, and local residents.

N. Upper Truckee Rd also accommodates a Class II bike lane. In both the 2010 El Dorado County traffic study and the 2016 TRPA/TMPO *Active Transportation Plan* the intersection with US 50 is designated as a top priority intersection for improvements. This intersection intersects US 50 on approximately a 6% grade, with a wide cross section. Drivers on US 50 tend to have high speeds (>40mph) on the downgrade and the N. Upper Truckee intersection may have limited sight distance during some seasons (i.e. trees, snow banks). No turn lanes are provided on N Upper Truckee Rd.

- Consider installation of speed feedback signs and lighting on the downgrade of EB US 50 and an intersection ahead warning sign possibly with the supplemental street name sign. See Figure 14 for examples.
- Consider intersection design improvements for safety and operations (i.e. turn lanes, checking sight distance/triangles seasonally)
- Consider static signage to discourage bypassing chain control or designation as a local road, "no through traffic/local traffic only"
- Enhancements to rural/ local road ITS using both permanent and temporary Changeable Message Signs (CMS) to disperse travel demand. Messaging can include time to reach SR 89/US 50 intersection, or promote changing travel plans due to current delays.

• Extension of the shared-use path known as the **Meyers Bikeway** should be constructed to reach North Upper Truckee along US 50 with consideration for separated or buffered bike lane along N. Upper Truckee. Please TRPA/TMPO's *Complete Street Resource Guide*<sup>18</sup> for design recommendations.

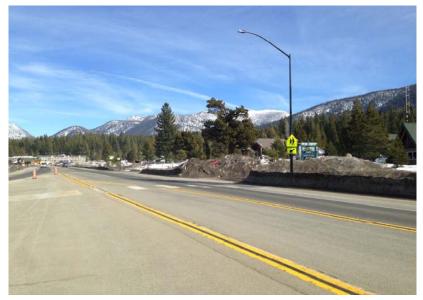
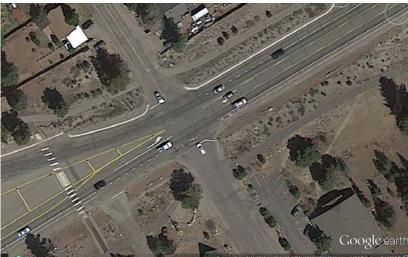
Figure 22: Apache Ave Intersection and Midblock School Pedestrian Crossing (Photo Source: Isebrands; Aerial Image Source: Google Earth)

This design is not consistent with best practices for a pedestrian/school crossing on a high speed (40mph) roadway. The community was vocal about not wanting to move the crosswalk; however, the crosswalk was relocated as part of 1A732 Water Quality project. (It also installed the most current stripping for bike lanes.)

Caltrans determined the mid-block crossing near the CA Ag Inspection Station is an easier place to cross, due to the wide gap in travel lanes created

by the CA Ag Inspection Station widening, than the Apache Ave intersection where more vehicle conflicts exist. The crosswalk at the intersection was removed for potential safety reasons prior to the installation of the crosswalk at the CA Ag Inspection Station. Rear end collisions had occurred while pedestrians were trying to cross. The connections and pathways to/from this crosswalk are currently not maintained in the winter so pedestrians must walk in US 50 between the crosswalk and Apache Ave<sup>27</sup>.

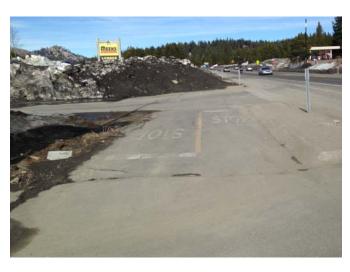
Figure 24: Class I Pathway near Meeks Lumber (Photo Source: Isebrands)

In this 1,500ft stretch of the study area, there are 11 access points (driveways) with almost all of those being within 700ft of the Santa Fe St/Apache Ave intersection. This includes one lane in each direction on US 50, a two-way-left-hand-turn-lane (TWLTL) and a Class I and II bikeway. Between the golf course parking lot and just west of Pioneer Trail the right of way through Meyers is its narrowest.

Additionally, the pathway is not currently maintained in the winter and is impassable, as shown in Figure 24; however in 2017 it is anticipated to be maintained by El Dorado County through Measure R/S funding.

- Re-design<sup>28</sup> driveways to allow the Class I pathway to be contiguous through the driveways, reducing effect that the driveway looks and operates like an intersection, as shown in Figure 25.
- Consider a pedestrian crossing study (i.e. origins and destinations of pedestrian movements) in this area to establish the best location for a marked high visibility pedestrian crossing.
- Provide a high visibility pedestrian crossing once optimal and safest location is determined
  - o A RRFB or PHB may also be considered to supplement the crossing on this high speed roadway if warranted.

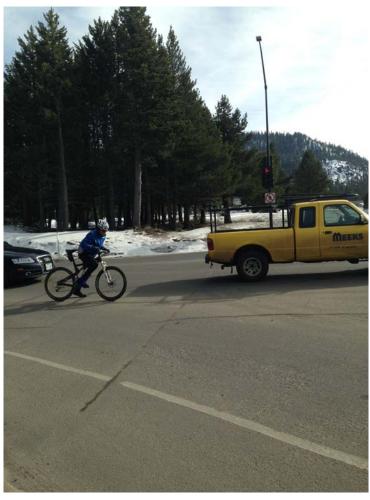
Figure 26: Pioneer Trail Intersection (Source: Isebrands)

The Pioneer Trail intersection is the northern gateway to Meyers from South Lake Tahoe. It is the only signalized intersection in the study area. Drivers are required to reduce their 55 mph speed to a 40 mph headed into Meyers in this area. The AADT of Pioneer Trail is approximately 6,335 vehicles per day. According to CHP this is the highest crash location within the study area. This intersection is a choke point during the peak periods. Right turning vehicles from NB US 50 to Pioneer Trail are given priority for intersection efficiency (right green arrow). This right turn tends to be a fast movement. During the winter months this area can be icy (cross slope, drainage issues and lack of sun/freeze-thaw) and contributes to crashes A number of the crashes occur when vehicles on EB US 50 turn right onto EB Pioneer Trail at an unsafe speed and then slide into the WB side of Pioneer Trail. Intersection and stopping sight distance/triangles at the intersection may be affected by trees, poles, signal cabinet and signs.

Pedestrian and bicycle facilities are disjointed and lack connectivity at this intersection. Pedestrians are only allowed to cross US 50 in the crosswalk on the north side of the intersection and that crossing does not connect to another pedestrian facility. All other pedestrian movements are prohibited. The Class I bicycle facility parallel to US 50 does not connect to the Class II facility or the Class I pathway east of US 50.
