Pleasant Valley Road (SR 49)/Patterson Drive Intersection Signalization Project

Draft Delineation of Waters of the U.S., Including Wetlands

Diamond Springs, El Dorado County, California

**February 2009
(revised April 2009)**

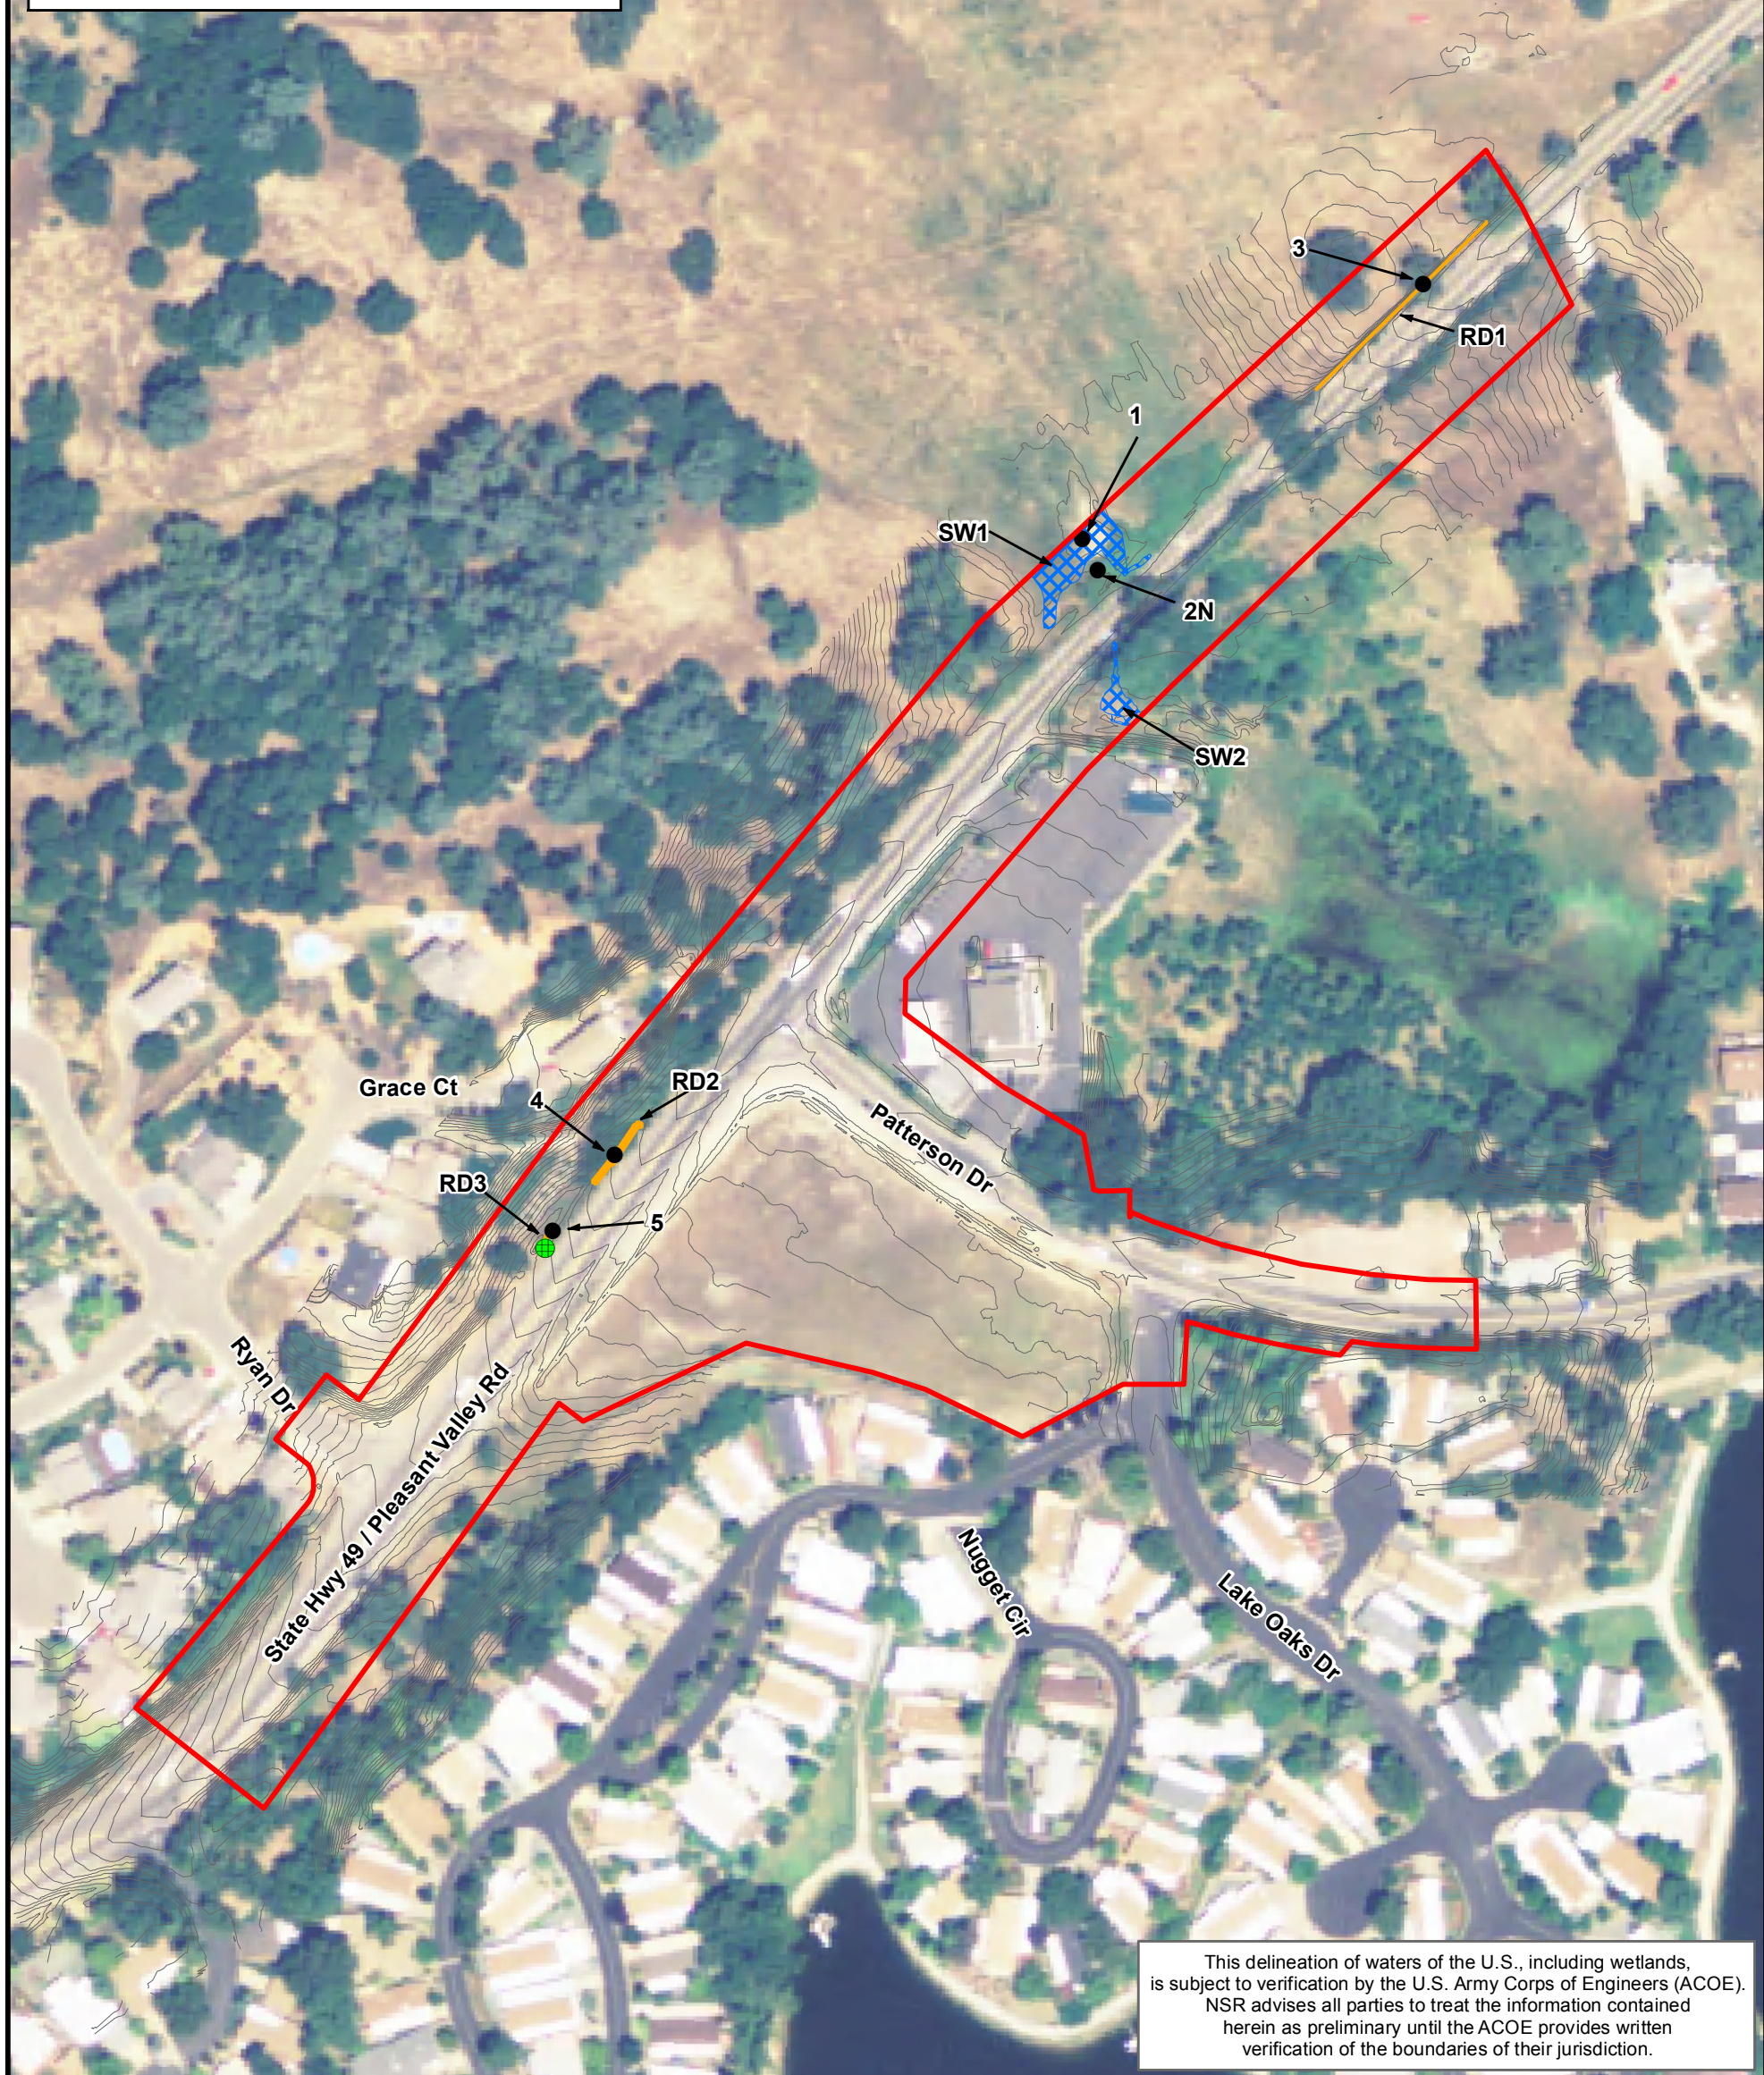
Figure 4
Waters of the U.S., Including Wetlands
 June 30, 2008
Pleasant Valley Road (SR 49)/Patterson Drive
Intersection Signalization Project

A delineation map depicting the size and location of each delineated feature within the study area is presented as Figure 4. One waters of the U.S. type was delineated within the study area – seasonal wetland. Two seasonal wetlands occupy a total of 0.094 acre of the study area.

- Study Area (8.993 Acres)
- Data Point
- Culvert
- Contour (1 ft. Intervals)
- Roadside Ditch (0.014 Acre)
- Waters of the U.S.
Seasonal Wetland (0.094 Acre)

Waters of the United States		
Label	Waters Type	Acreage
SW1	Seasonal Wetland	0.074
SW2	Seasonal Wetland	0.020
TOTAL		0.094

Non-Jurisdictional Features			
Label	Waters Type	Acreage	Length (ft)
RD1	Roadside Ditch	0.005	209
RD2	Roadside Ditch	0.008	68
RD3	Roadside Ditch	0.001	12
TOTAL		0.014	289

One feature type, not subject to federal jurisdiction, was also delineated within the study area – roadside ditch. Three roadside ditches occupy a total of 0.014 acre (289 linear feet) of the study area.

Two seasonal wetlands (SW1 and SW2) totaling 0.094 acre were delineated within the study area. These features are located on either side of Highway 49 just east of the Tower Mart parking lot and are connected by a culvert that passes under the highway. SW1 and SW2 are characterized as localized, topographic depressions that pond water during the winter months and seasonally support a growth of obligate and facultative wetland plants. At the time of the delineation these features were dry, however signs of recent inundation were apparent in the form of surface soil cracks and horse track imprints, formed in wet soil, still held their shape.

Three non-vegetated ditches are located on the northern edge of Pleasant Valley Road (RD1, RD2, and RD3 on Figure 3). These features are characterized as excavated, roadside ditches that contain little to no vegetation. RD1 is approximately 1-2 feet wide, 1-2 feet deep, and is approximately 0.005 acre (209 linear feet) in size. RD2 is a wide, shallow ditch that is approximately 4-5 feet wide, no more than 2 feet deep, and is approximately 0.008 acre (68 linear feet) in size. RD3 is a very short, concrete-lined, 2-3 feet wide, 2 feet deep, and is approximately 0.001 acre (12 linear feet) in size. It appears that RD2 may overflow and drain to RD3 during high rain events, however there is no defined swale or ditch that clearly connects these two features. RD3 drains to a culvert under Pleasant Valley Road. Given that these ditches were constructed in uplands to drain upland areas, these ditches do not qualify as waters of the U.S. Representative photograph of these ditches are presented in Attachment B, Photographs 3 through 5.

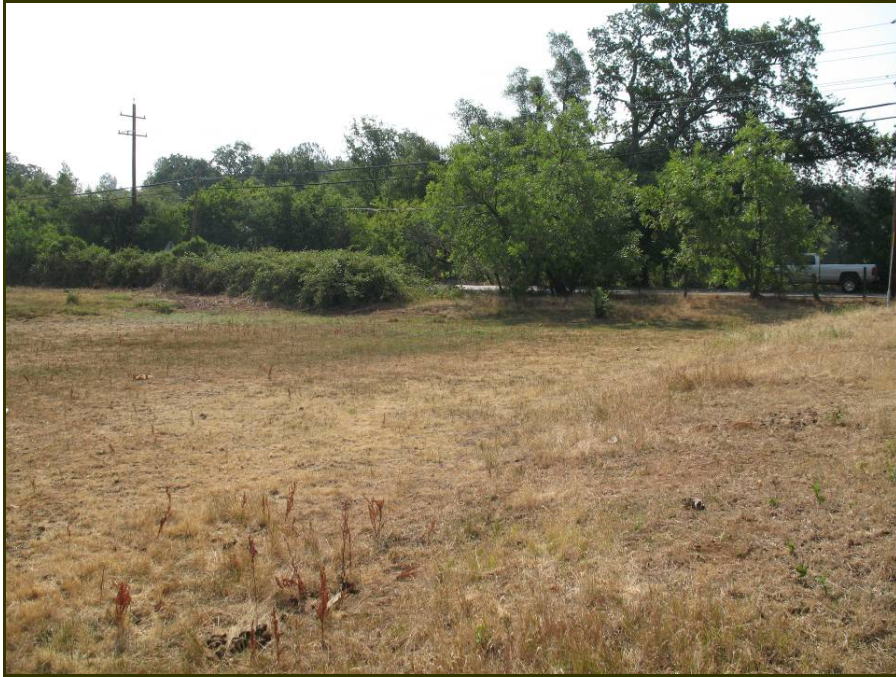
Photograph 1. Photograph showing seasonal wetland (SW1) located on the north side of Pleasant Valley Road. Photograph taken from the edge of the study area looking east across SW1.

When water is present these seasonal wetlands drain south through a swale-like feature to a ponded area behind the Tower Mart property. From this ponded area, the drainage flows south to Patterson Lake. Patterson Lake eventually drains to the North Fork of the Cosumnes River about 5 miles south of the Project Area through a series of smaller creeks. Because these wetlands are hydrologically connected to Patterson Lake and eventually the North Fork of the Cosumnes River they qualify as waters of the U.S. Representative photographs of the seasonal wetlands are presented in Attachment B, Photographs 1 and 2.

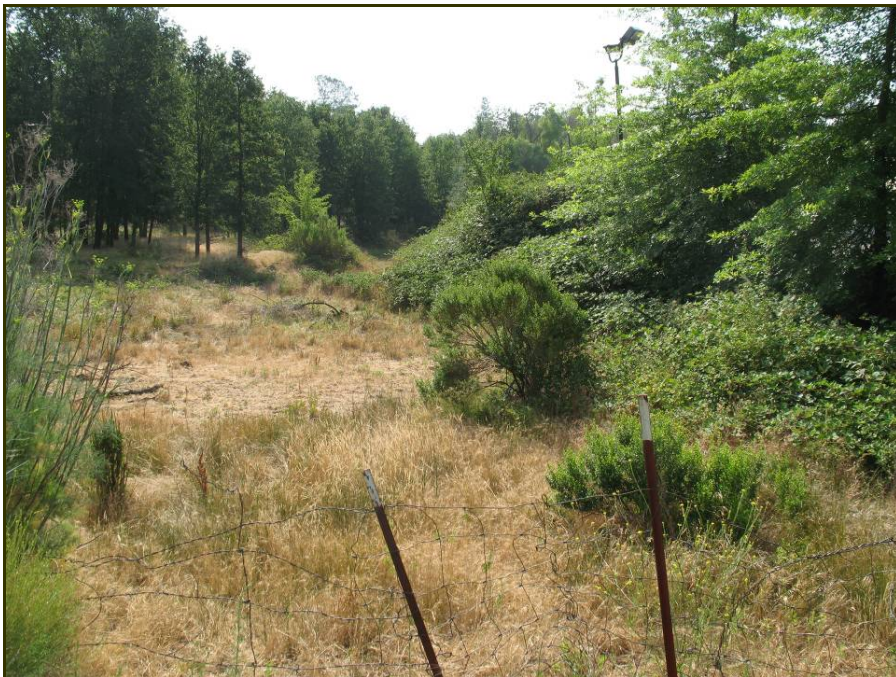
Photograph 2. Photograph showing seasonal wetland (SW2) located on the south side of Pleasant Valley Road. Photograph taken from the edge of Pleasant Valley Road looking east. The light post in the background is located at the northeastern corner of the Tower Mart parking lot.

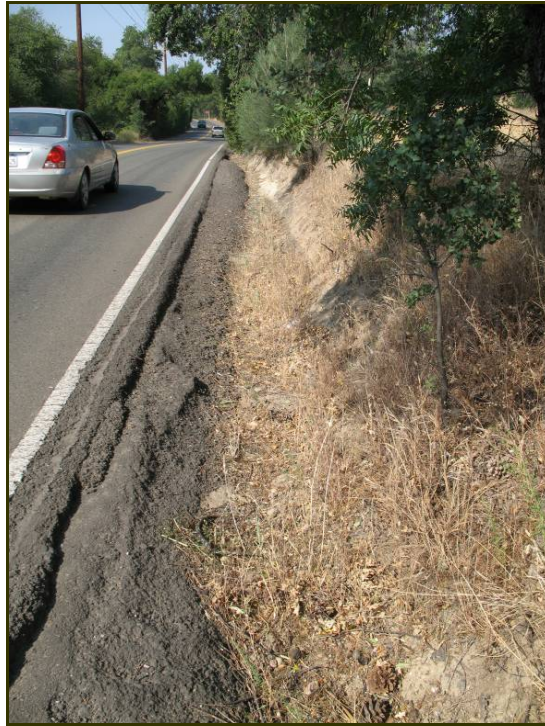
Photograph 3. Photograph of roadside ditch (RD1) located on the north side of Pleasant Valley Road near the northern end of the study area. Photograph taken from the eastern end of the ditch looking southwest along Pleasant Valley Road.

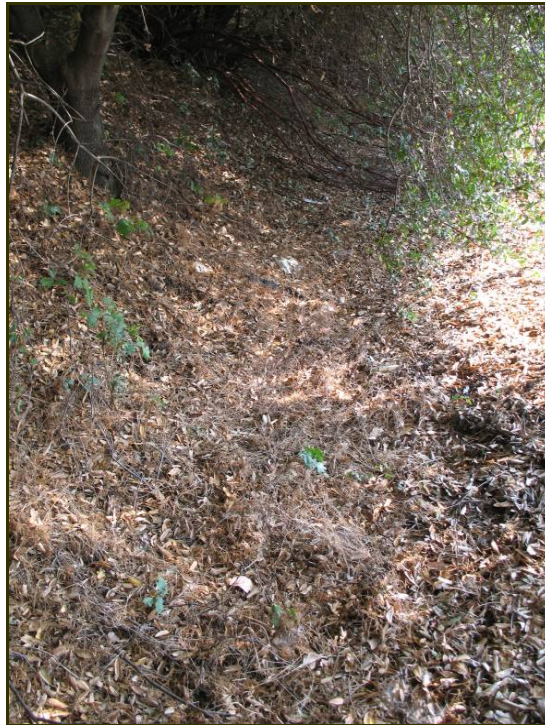
Photograph 4. Photograph of roadside ditch (RD2) located in the north side of Pleasant Valley Road between Ryan Drive and Patterson Drive. Photograph taken from middle of RD2 looking the northeast.

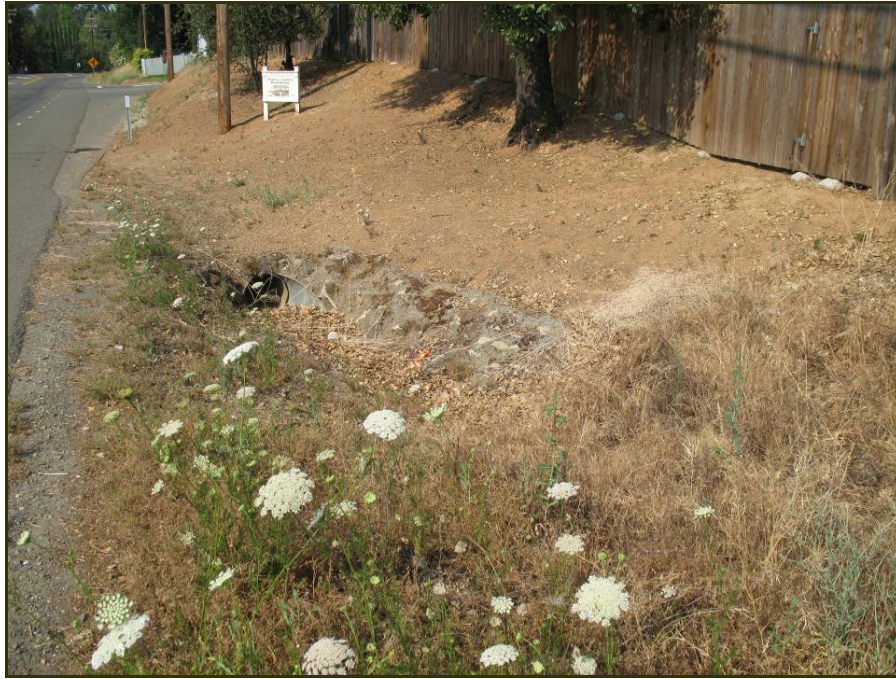
Photograph 5. Photograph of roadside ditch (RD3) and culvert located on the north side of Pleasant Valley Road near Ryan Drive. Photograph taken just east of the feature looking southwest along Pleasant Valley Road.
