## **Appendix E: Delineation of Jurisdictional Waters and Wetlands**

Subject: **Notice of Revisions to the Diamond Springs Parkway Project Study Area Delineation Map (USACE ID 200900188)**

**Delineation of Jurisdictional Waters and Wetlands  
Diamond Springs Parkway Project  
Missouri Flat Area of Unincorporated  
El Dorado County, California**

*Placerville, California, USGS 7.5-minute Topographic Quadrangle Map  
Sections 24 and 25, Township 10N, Range 10E  
Sections 19 and 30, Township 30N, Range 11E*

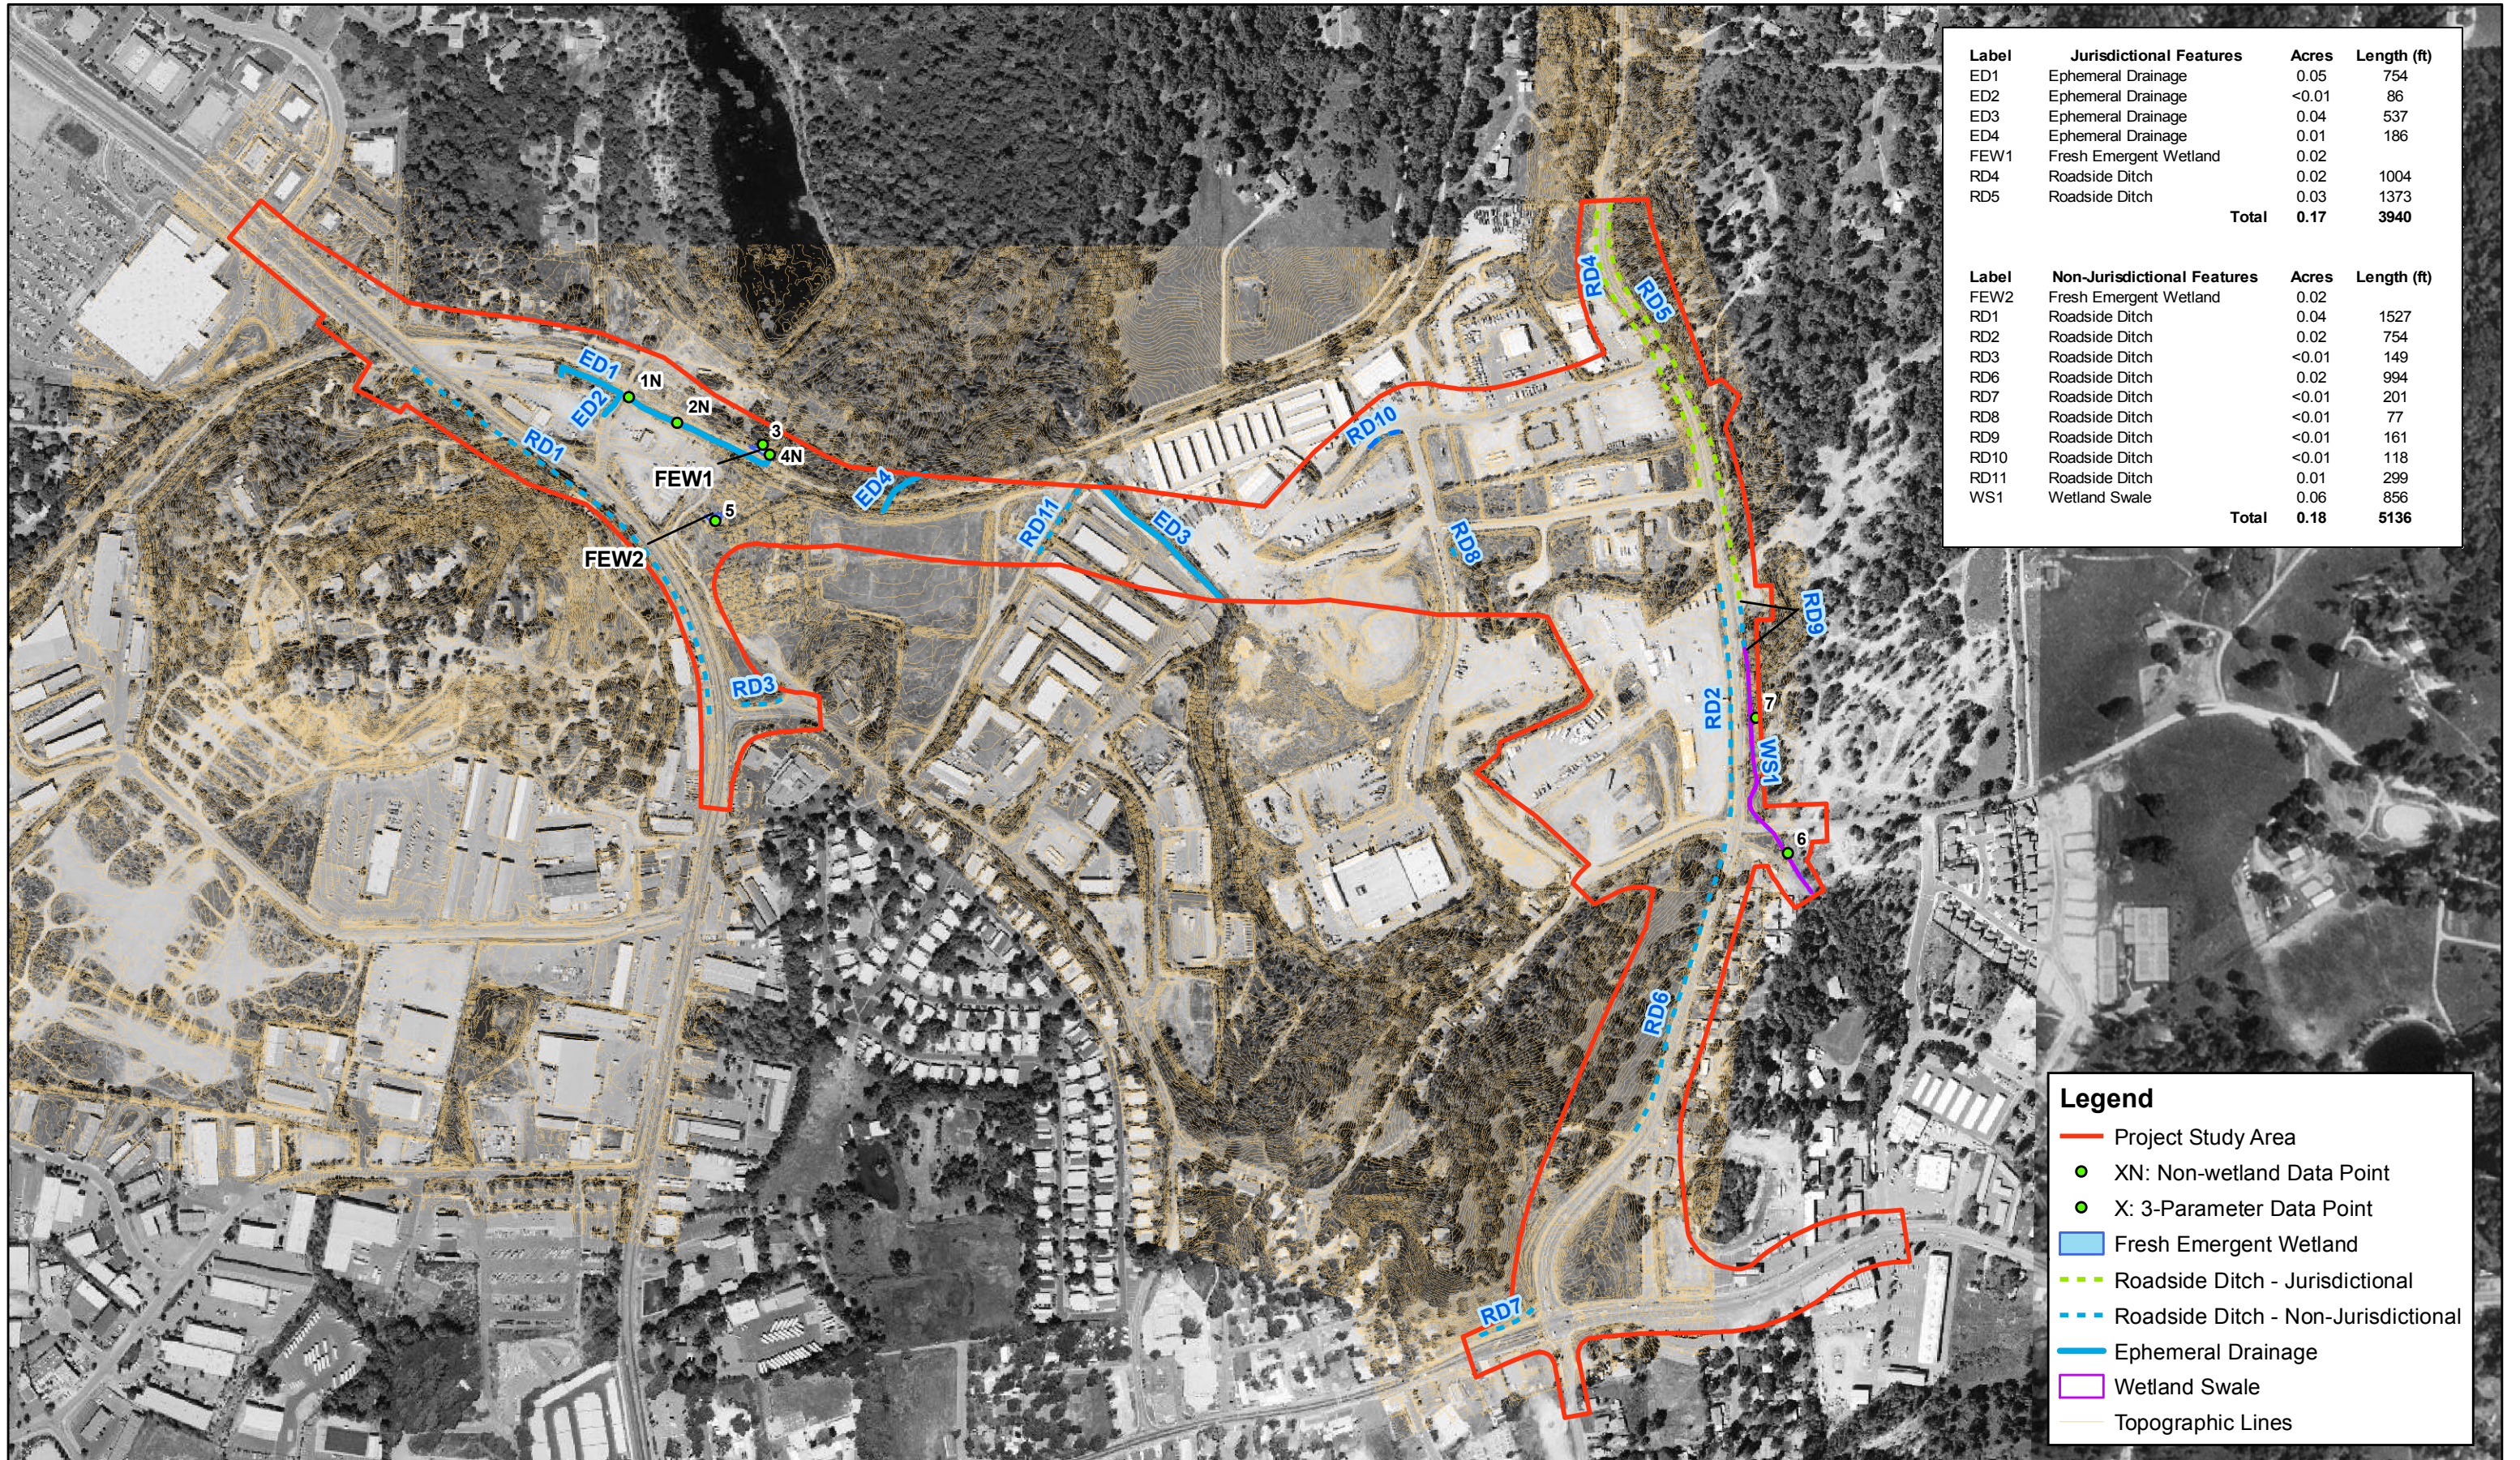
## Appendix C Delineation of Jurisdictional Waters and Wetlands

Label	Jurisdictional Features	Acres	Length (ft)
ED1	Ephemeral Drainage	0.05	754
ED2	Ephemeral Drainage	<0.01	86
ED3	Ephemeral Drainage	0.04	537
ED4	Ephemeral Drainage	0.01	186
FEW1	Fresh Emergent Wetland	0.02	
RD4	Roadside Ditch	0.02	1004
RD5	Roadside Ditch	0.03	1373
	<b>Total</b>	<b>0.17</b>	<b>3940</b>

Label	Non-Jurisdictional Features	Acres	Length (ft)
FEW2	Fresh Emergent Wetland	0.02	
RD1	Roadside Ditch	0.04	1527
RD2	Roadside Ditch	0.02	754
RD3	Roadside Ditch	<0.01	149
RD6	Roadside Ditch	0.02	994
RD7	Roadside Ditch	<0.01	201
RD8	Roadside Ditch	<0.01	77
RD9	Roadside Ditch	<0.01	161
RD10	Roadside Ditch	<0.01	118
RD11	Roadside Ditch	0.01	299
WS1	Wetland Swale	0.06	856
	<b>Total</b>	<b>0.18</b>	<b>5136</b>

The delineation of waters of the U.S. identified seven (7) features that are U.S. Army Corps of Engineers (USACE) jurisdictional. These include four (4) ephemeral drainages, two (2) roadside ditches, and one (1) fresh emergent wetland. These features exhibit a “significant nexus” to Weber Creek, a Traditionally Navigable Water (TNW). As such, these features are subject to regulation by the USACE. Total acreage of USACE jurisdictional features is 0.17 acre (3,940 linear feet), of which 0.02 acre consist of wetlands.

The study area contains 11 features not considered federally jurisdictional. These include nine (9) roadside ditches that do not enter, intersect, or otherwise capture flows from any TNW, Relatively Permanent Water (RPW), or seasonal wetland; therefore, these features do not contain any federally jurisdictional waters. In addition, the study area contains one isolated wetland swale and one fresh emergent wetland that are isolated and, therefore, considered federally non-jurisdictional. Total acreage of non-federally jurisdictional features is 0.18 acre (5,136 linear feet).

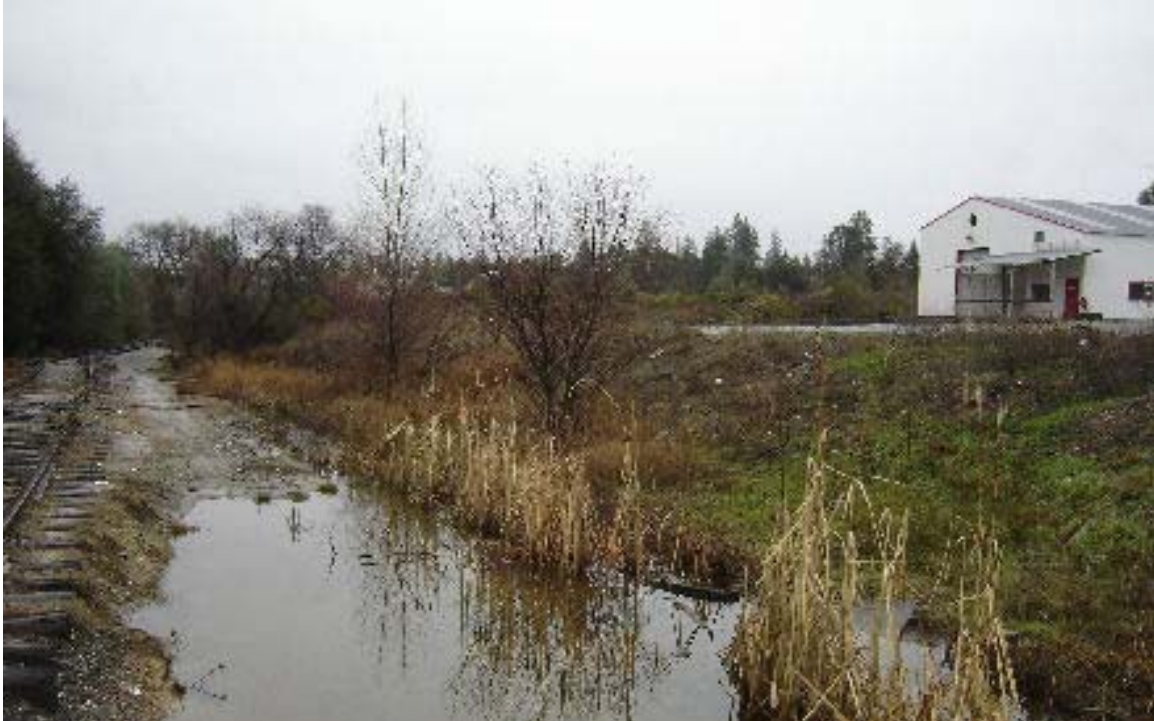
The study area contains three plant communities: mixed willow series, mixed oak series, and California annual grassland series. Mixed willow series is associated with Ephemeral Drainage 1 (ED1, Appendix C), which runs southeast to northwest through the central portion of the study area. Overstory species include Fremont cottonwood (*Populus fremontii*, FACW), valley oak (*Quercus lobata*, FAC), arroyo willow (*Salix lasiolepis*, FACW), and black willow (*S. gooddingii*; OBL). Shrub species observed include coyotebrush (*Baccharis pilularis*, NI), Himalayan blackberry (*Rubus discolor*, FACW), giant reed (*Arundo donax* FACW), coffeeberry (*Rhamnus californica*, NI), snowberry (*Symphoricarpos mollis*, NI), and poison oak (*Toxicodendron diversilobum*, NI). Other species include rush (*Juncus* sp.), St. John's wort (*Hypericum perforatum*, NI), tall annual willowherb (*Epilobium brachycarpum*, UPL), and sheep sorrel (*Rumex acetosella*, FAC).

**Photograph 1:** View of Ephemeral Drainage 1 (ED1), looking east from Old Depot Road. Photograph taken January 8, 2008.

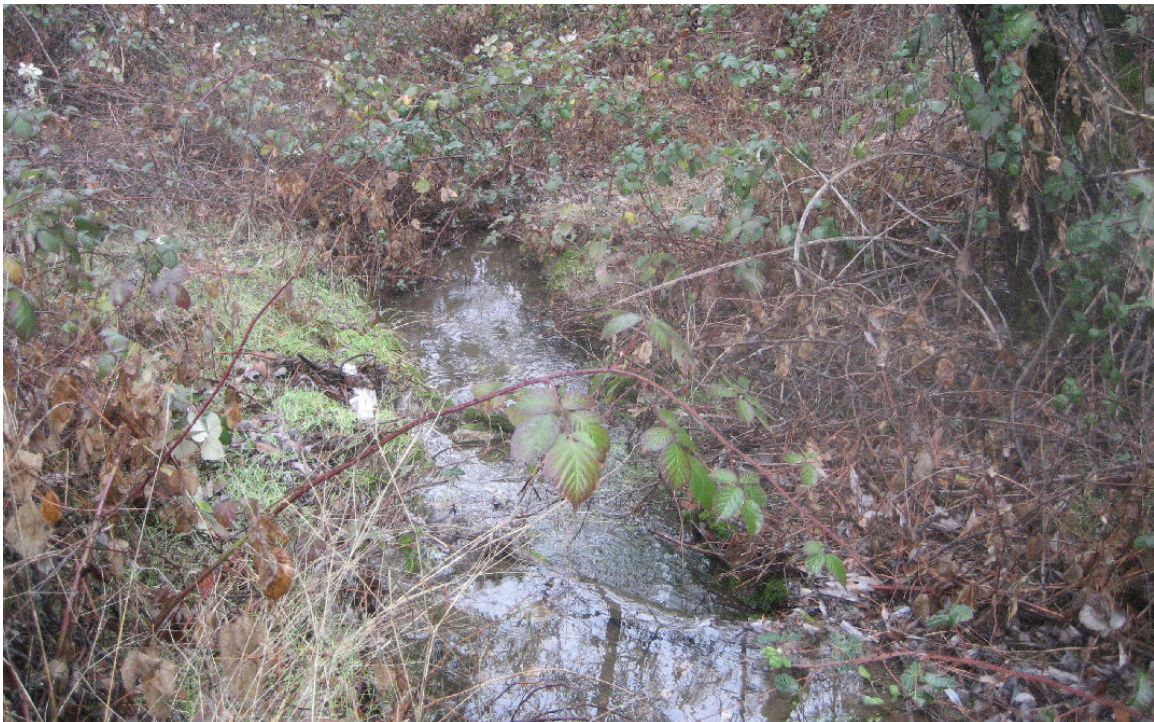
Where ED3 originates south of the study area it is a deeply incised, broad, silt-lined basin with very steep, well-vegetated banks. In addition to the presence of water, OHWM indicators include shelving, litter, debris, watermarks, and aerial adventitious roots on tree trunks. ED3 is disturbed; it is lined with relatively barren post-industrial land and industrial and commercial development. During the field visits trash was observed throughout the length of ED3, including discarded oil containers, household refuse, and 50-gallon drums.

During the last several months of 2007, additional water entered ED3 as the result of a leaking underground water main servicing Gold Key Storage, which borders the study area on the northwest. Water exiting the broken water main traveled approximately 500 feet and entered ED3 beneath tree roots. According to Rick Siegel, Maintenance Supervisor at Gold Key Storage, the leak was discovered and repaired in December 2007 (Siegel, pers comm. 2008).

**Photograph 2:** View of Ephemeral Drainage 3 (ED3), looking south near the southern end of the feature. Photograph taken January 8, 2008.

The study area is bisected by one major drainage feature (Ephemeral Drainage [ED] 3). This feature is considered an RPW; during the December 11-13, 2007 site visit there were areas of ponding, but the majority of the channel was dry. Flow was first observed on January 10, 2008, four days after a major storm event.

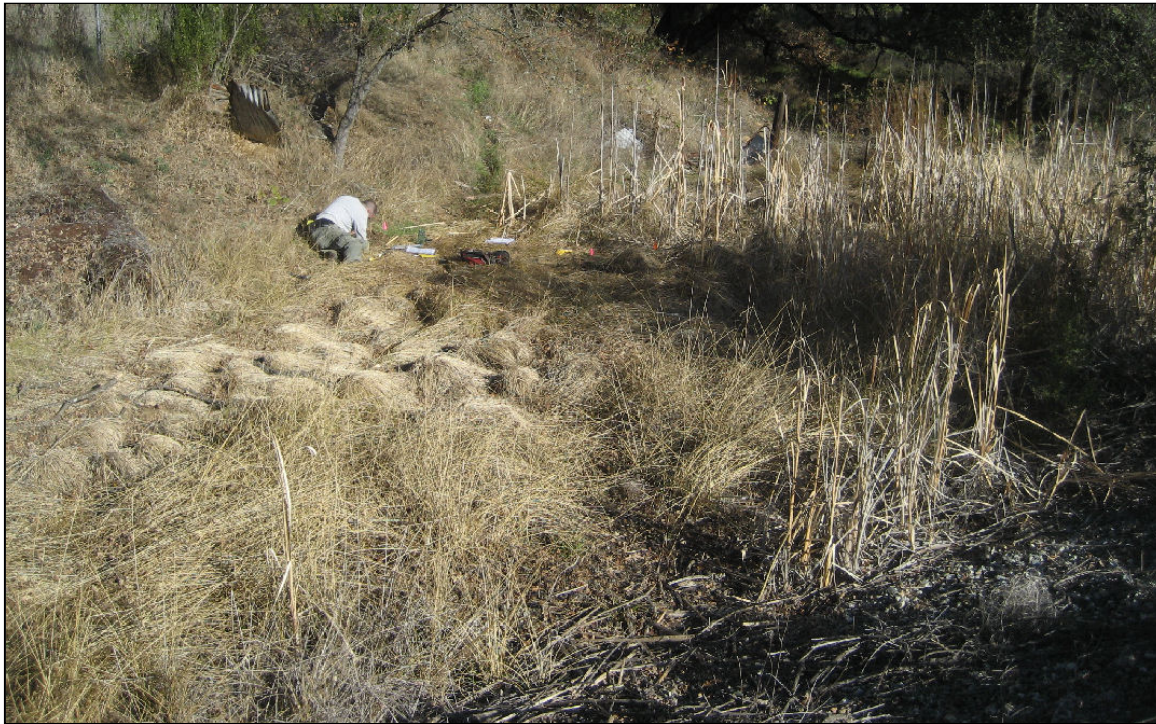
Fresh Emergent Wetland 1 (FEW1) is located in the northwestern portion of the study area at the terminus of ED1 (Photograph 3, Appendix D). It is a low-lying feature at the northern base of the railroad tracks. It receives flows directly from ED1 as well as surface flows from adjacent uplands to the north and west. FEW1 was ponded during the field delineation conducted in January. Dominant plants in this feature include narrow-leaf cattail, nutsedge (*Cyperus eragrostis*), and Baltic rush (*Juncus balticus*).

**Photograph 3:** View of Fresh Emergent Wetland 1 (FEW1) looking northeast from the southwestern edge of the feature. Photograph taken December 7, 2007.

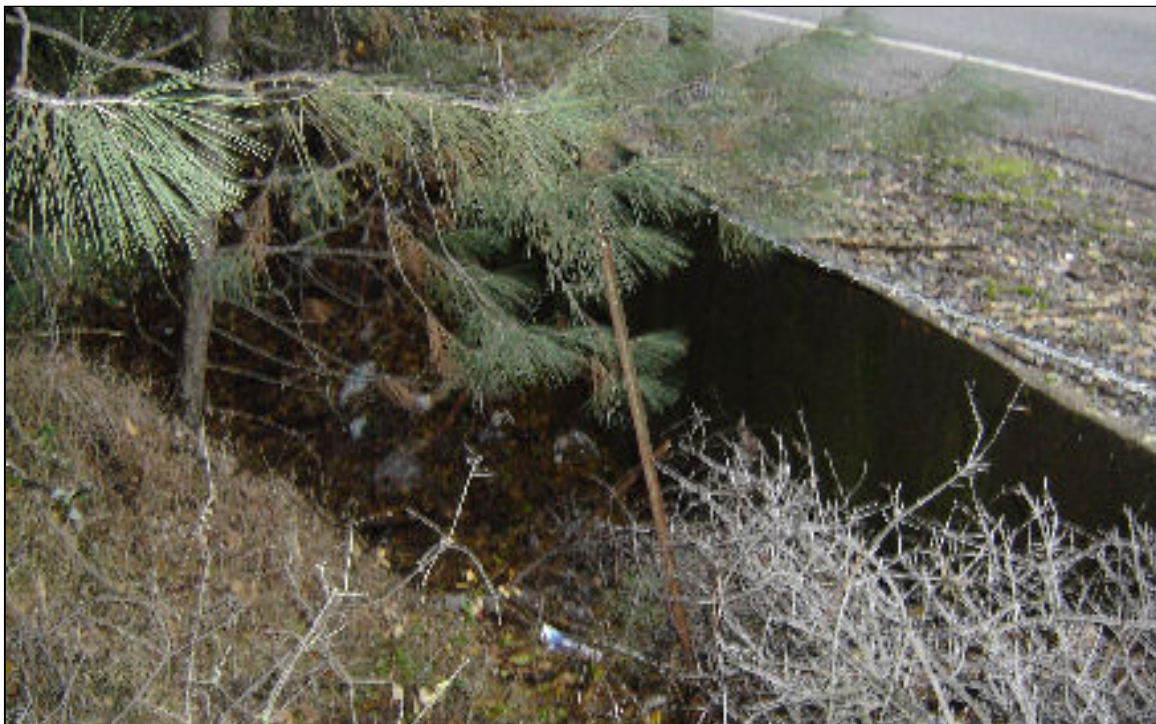
**Photograph 4:** View of Roadside Ditch 8 (RD8) west-southwest. Photograph taken January 8, 2008.

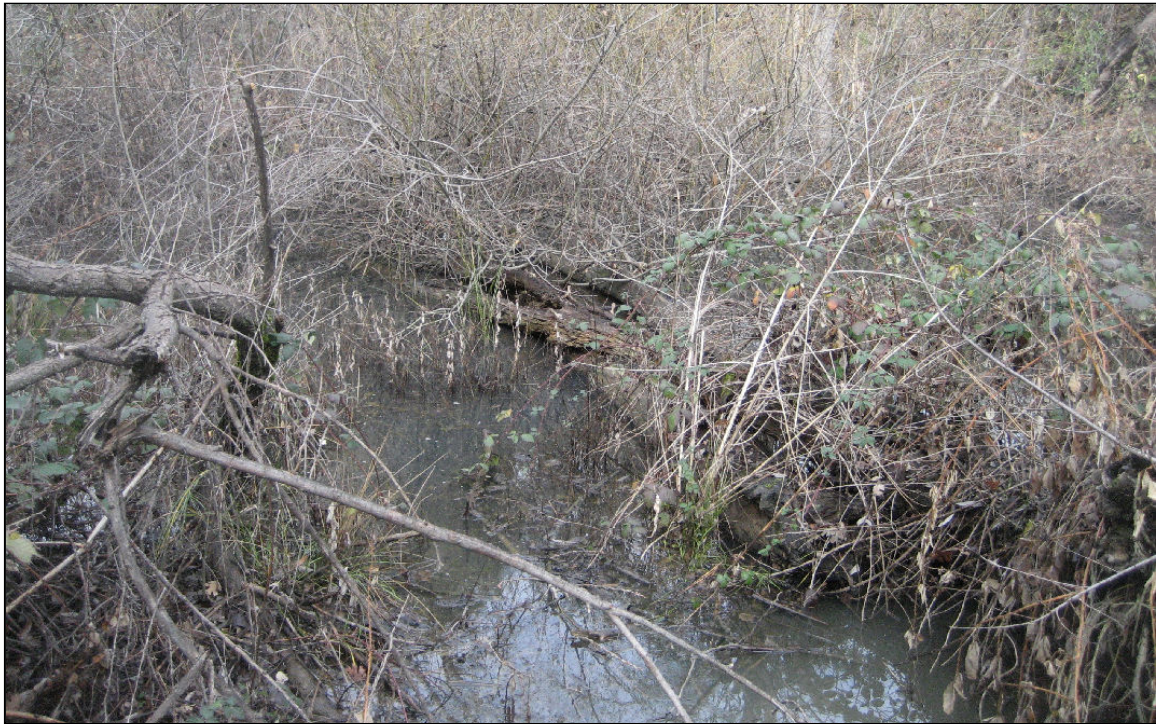
**Photograph 5:** View of outlet of Ephemeral Drainage 4 (ED4). Shows culvert beneath dirt road that discharges water into wooded area in the northern portion of the Project Site. Photograph taken January 8, 2008.

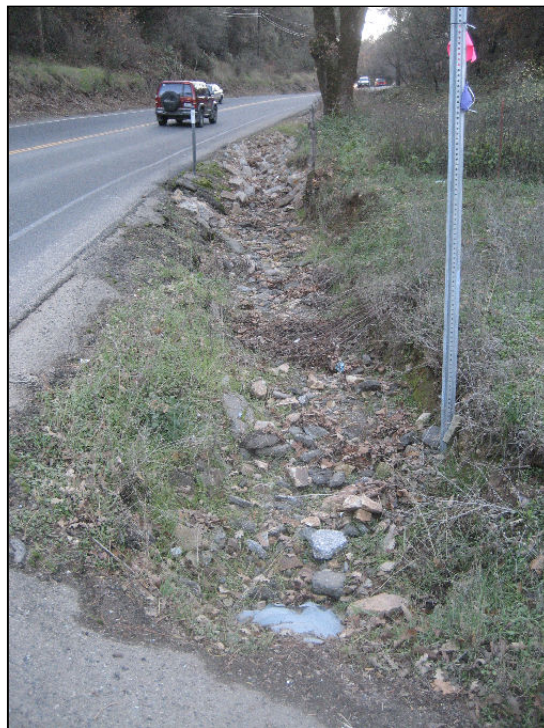
**Photograph 6.** View of Roadside Ditch 4 (RD4), looking south from the northern edge of the feature. Photograph taken December 7, 2008.

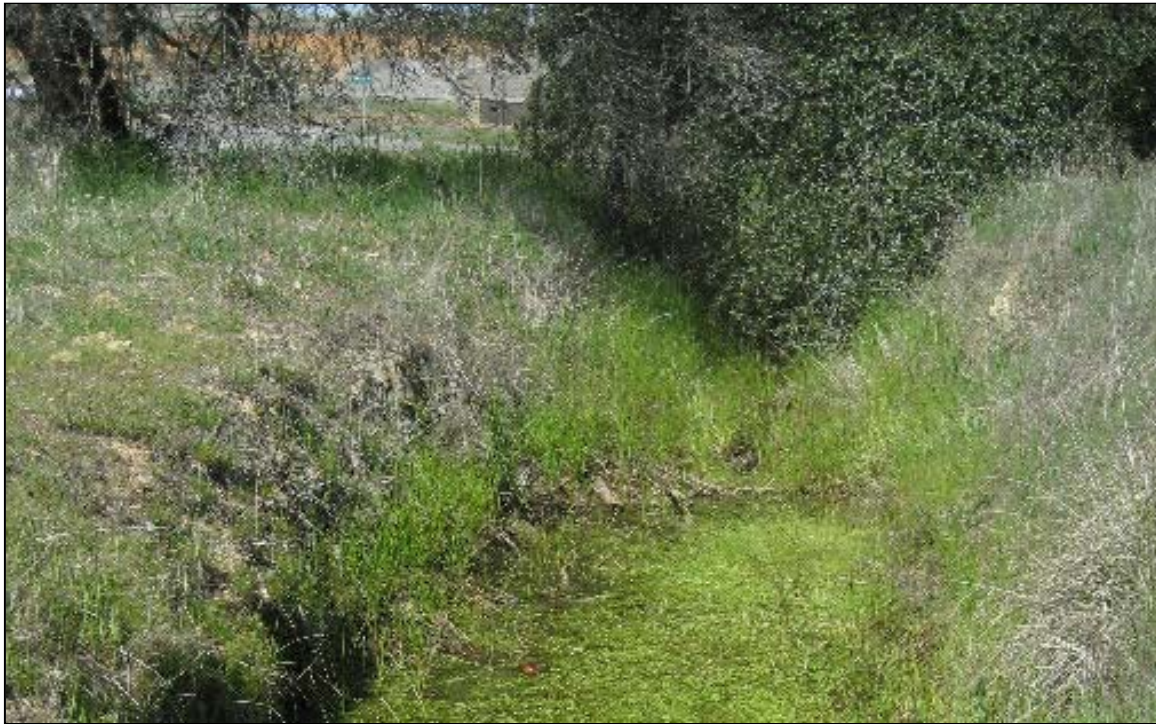
**Photograph 7:** View of Fresh Wetland Swale 1 (WS1), looking southeast from the portion of the feature south of Black Rice Road. Photograph taken March 28, 2008.

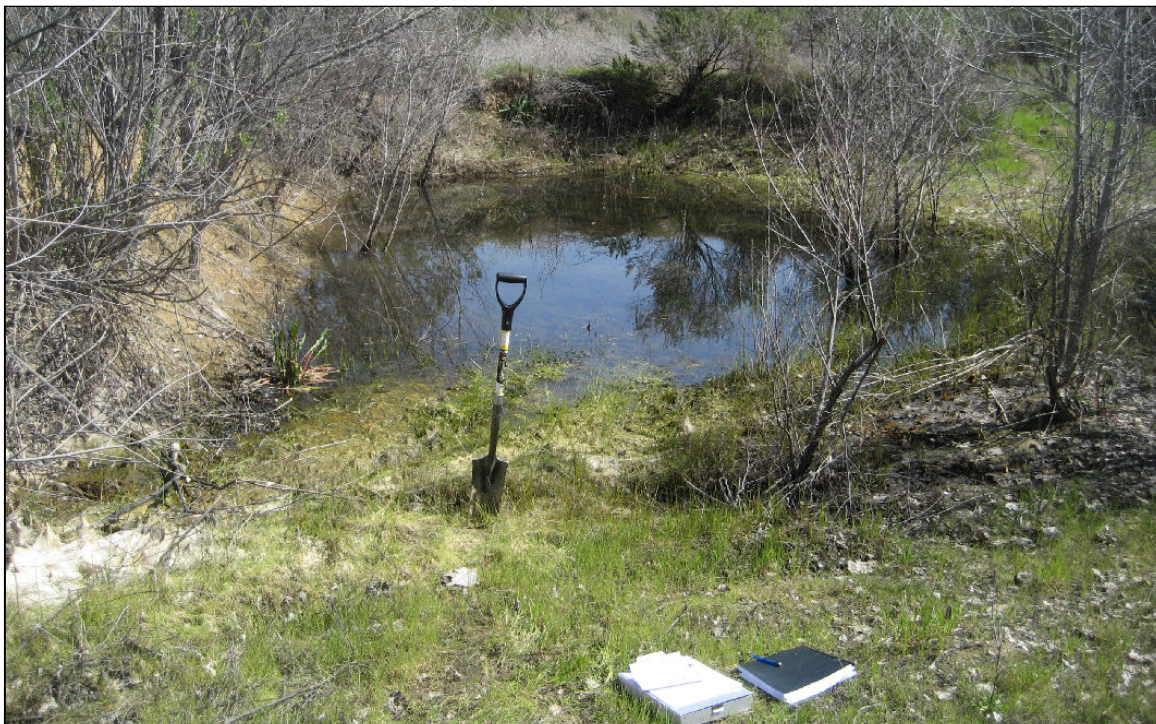
**Photograph 8:** View of Fresh Emergent Wetland 2 (FEW2) looking north. Photograph taken March 23, 2008.
