**INITIAL SITE ASSESSMENT**  
**Silva Valley Pkwy/SR50 Interchange**  
**03-ED-50, KP 3.1 (PM 1.7)**  
**El Dorado Hills, California**

**April 2007**

**Prepared by:**  
**BLACKBURN CONSULTING**  
**BCI File Number 556.1**

**Subject: Initial Site Assessment  
Silva Valley Pkwy/SR50 Interchange  
03-ED-50, KP 3.1 (PM 1.7)  
El Dorado Hills, California**

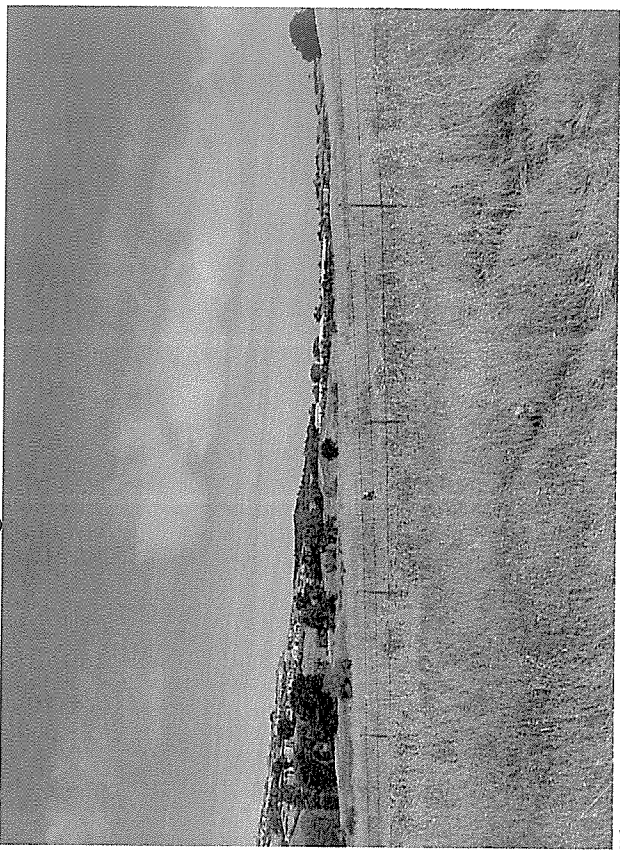
Photo 16: Lot 1- EDH-52; looking north from Tong Road.

Current interchange improvement plans require complete acquisition of this parcel. The parcel existing features include old foundations, pilasters, and concrete debris piles. The majority of the site is undeveloped barren land (Photos 15, 16, and 40 through 43).

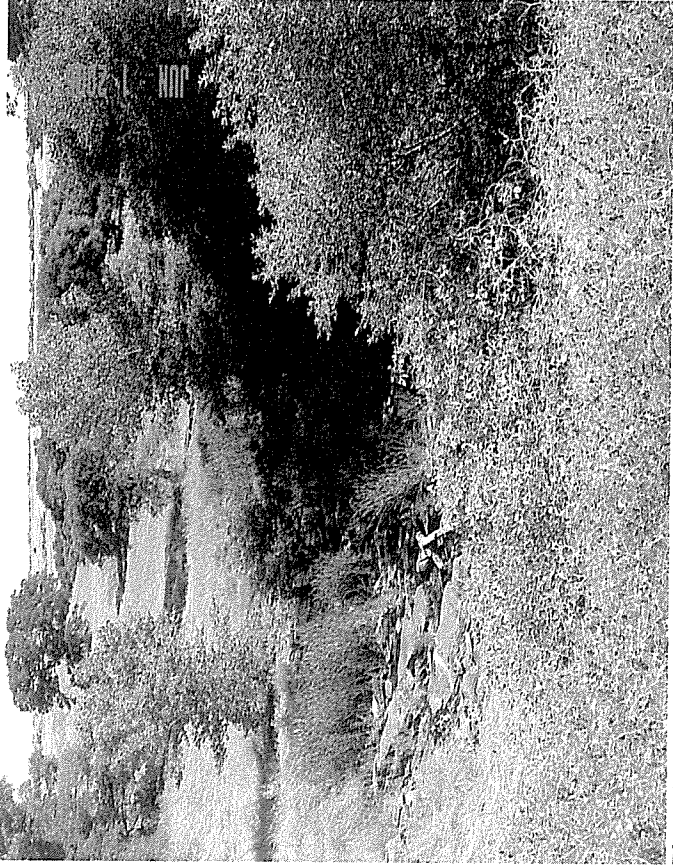
Photo 17: Carson Creek, located between Lots 3 & 4. The creek flows south beneath the Tong Road embankment and then beneath SR50.

Currently owned by the County. Proposed plans show an on- and off-ramp through the western part of the site. This parcel is currently undeveloped (Photo 17).

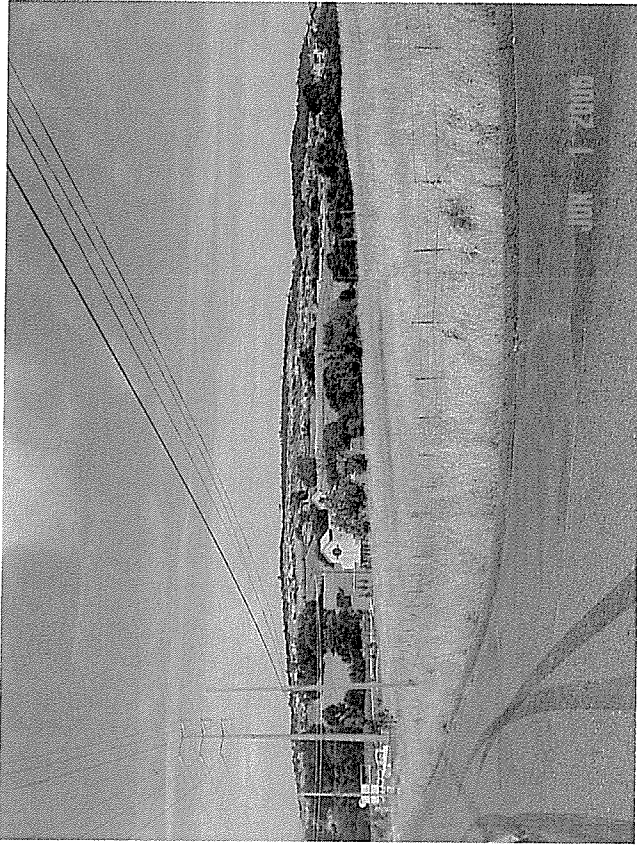
Photo 21: Lot 6, Lot 5 (bare lot with signs) and Lot 4 (Presbyterian Church) – looking from foreground to background, respectively; WNW from Tong Road.

Proposed for partial site acquisition. Impact may be right-of-way acquisition along the south property boundary with Tong Road. This parcel is developed by a large church structure and parking area (Photo 21).

Proposed for partial site acquisition. Impact may be right-of-way acquisition along the south property boundary. This parcel is undeveloped, with remnants of previous structures visible on the ground surface (Photo 21).

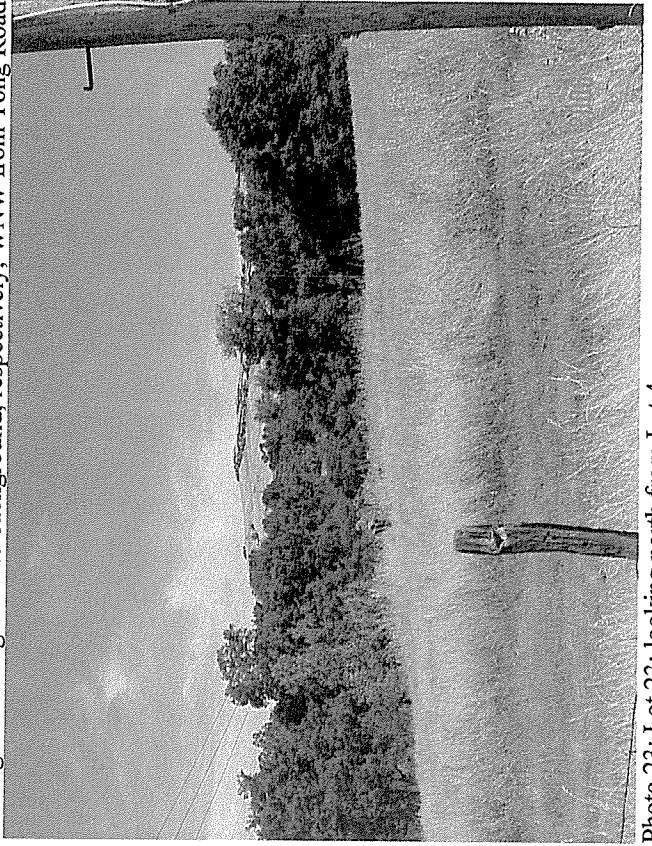
Photo 23: Lot 23; looking north from Lot 4.

Proposed for partial site acquisition. Potential impacts are located near the west and south property lines, for the proposed Country Club Drive roadway improvements. The proposed road is located along the northern boundary of Parcels 3, 4, 5, and 6. This parcel is currently improved by a dirt road, but is otherwise barren (Photos 22 and 23), with some trees and imported gravel and soil stockpiles along the north boundary.

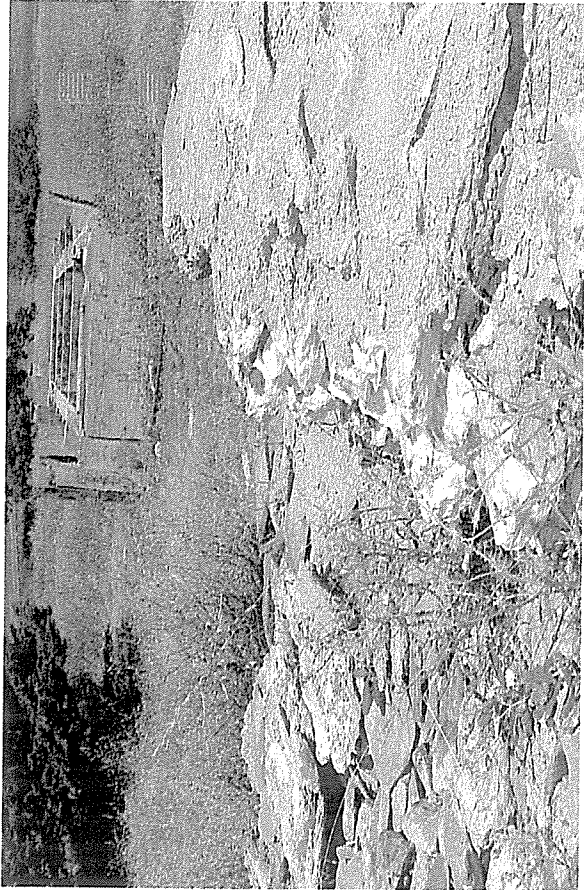
Photo 41: Lot 1; Remnant foundation structure(s); looking north. Concrete "basins" in background.

Issues associated with a former farm residence include leach fields/septic tanks and buried heating oil tanks. The remnant concrete structures need to be assessed for LCP and ACM, prior to demolition and preparation of construction documents. An assessment for the presence of these materials may materially affect the purchase of the parcel. We recommend that the construction documents include specifications making the contractor aware of the possible presence of LCP and ACM during grading operations, and his responsibility to respond accordingly.

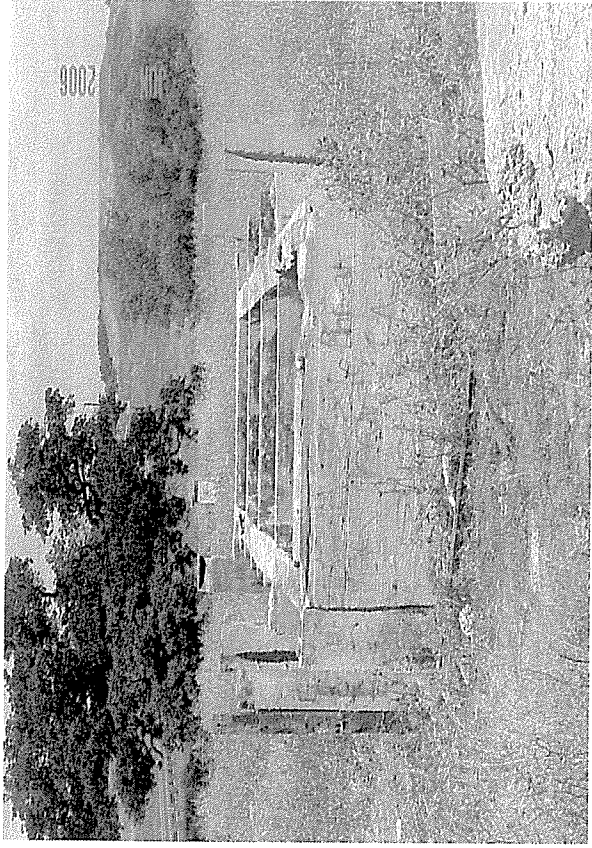
Photo 42: Lot 1; close-up of the "basin" structure. Looking north. Silva Valley Parkway can be seen on the left.

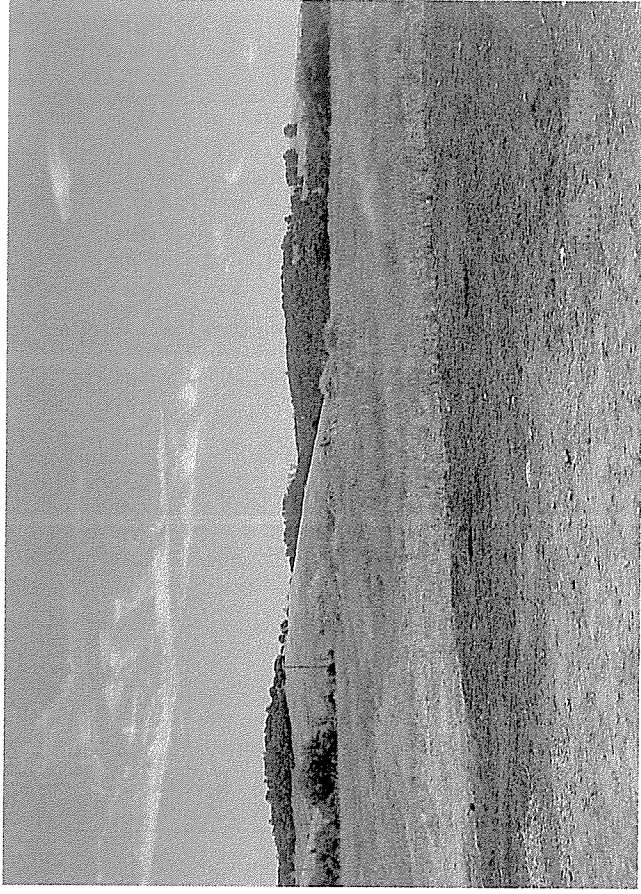
Photo 44: Lot 23 – Serrano Associates LLC; looking southeast from the corner of Russi Ranch Dr. and Village Green Dr. Soil stockpiles in background.

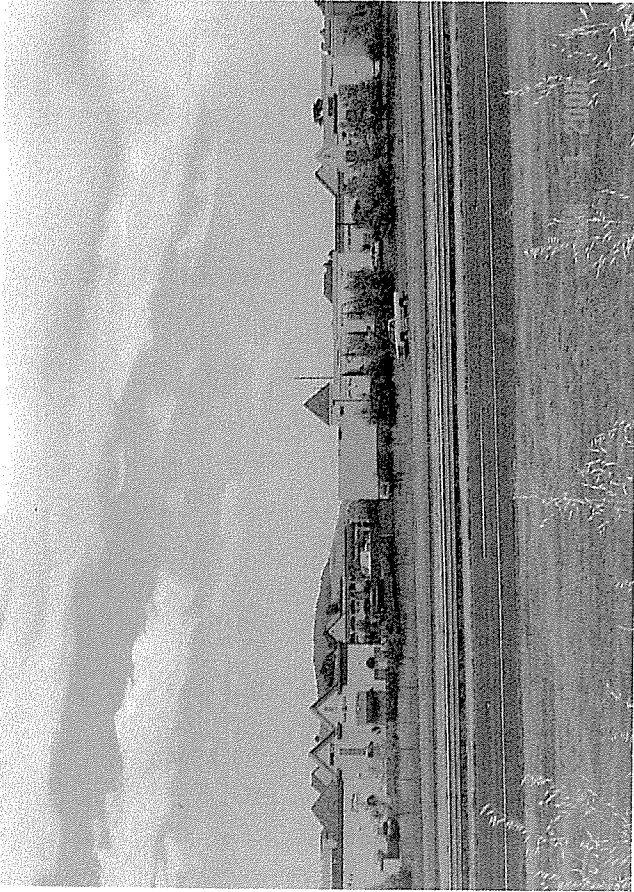
Photo 57: Lot 27 and 31 – Town Center East LP & Syers Properties LLC; looking south across SR50 from near Lot 22.

PARCEL 27, “TOWN CENTER EAST LP”, APN 107-130-3610  
Proposed for partial site acquisition. Impact is located along the north property line, adjacent to the SR50 eastbound on-ramp from the El Dorado Hills Blvd/Latrobe Road interchange. The parcel is developed as a shopping are and associated paved parking (Photos 56 and 57).

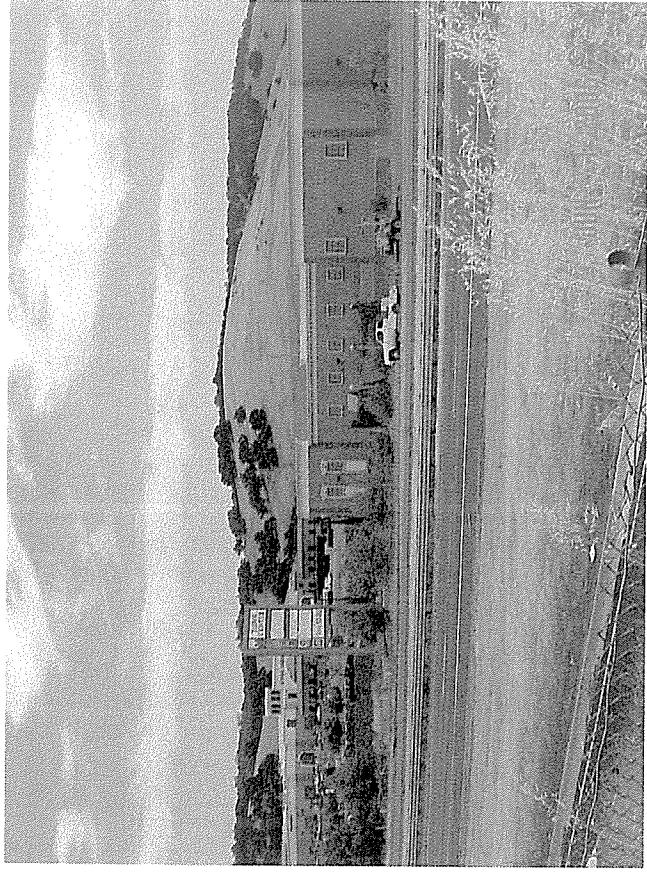
Photo 58: Lot 28 – EDH Town Center East Owners Association; looking southeast across SR50.

PARCEL 28, “EDH TOWN CNTR EAST OWNERS ASSOC“, APN 107-130-4310  
Proposed for partial site acquisition along the north property line with the SR50 eastbound on-ramp. This parcel is an undeveloped marshy area next to the “Town Center” (Photo 58).

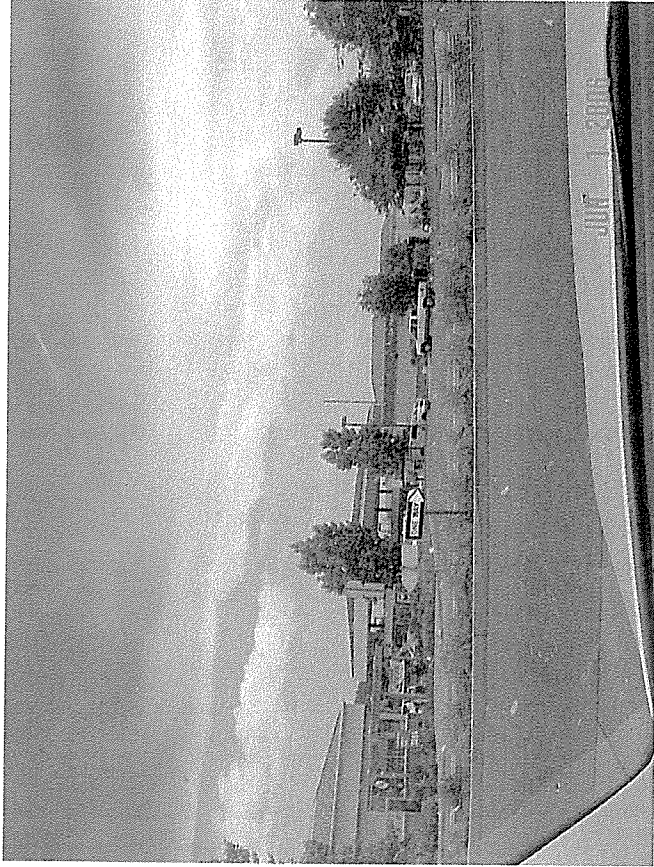
Photo 61: "Chevron" service station looking south across entrance road to the shopping center. The gas station is located south and adjacent to Lot 31.

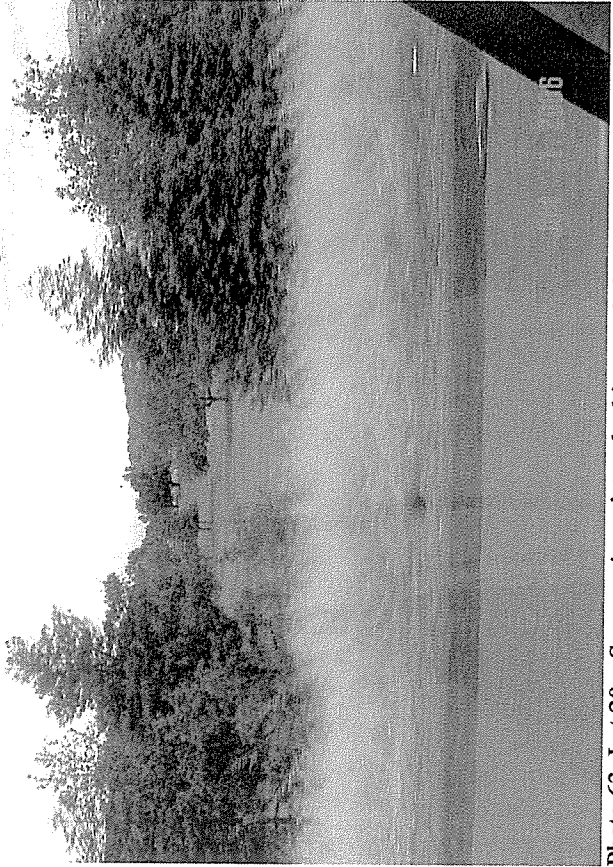
Photo 63: Lot 20 – Serrano Associates; looking north from SR50 at the golf course.

Proposed for partial site acquisition. Impacts are located along the south property line with SR50. This parcel is currently developed by a country club and golf course (Photo 63).

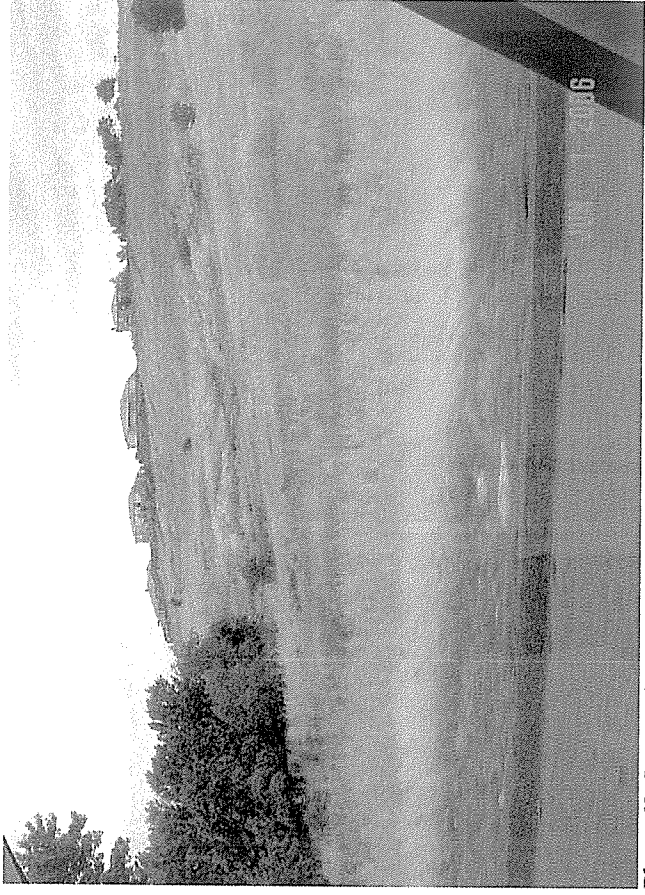
Proposed for partial site acquisition. Impacts are located along the south property line with SR50 and along the east property boundary with Silva Valley Parkway. This hilly parcel is currently undeveloped (Photos 62, 64, and 65). We note the presence of a former residence, exemplified by old foundations.

Photo 62: Lot 21; looking northwest from SR50. Old building foundations are located to the west (left) of view shown in the photograph.

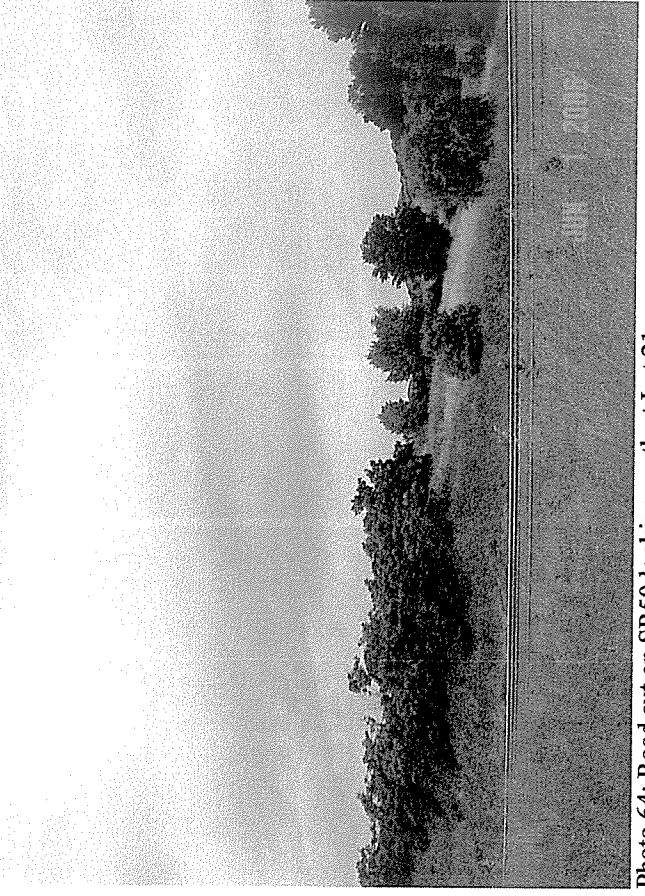
Occurrences of naturally occurring asbestos (NOA) are typically associated with local faulting and ultramafic rocks. We observed prominent shear zones along the western road-cut of El Dorado Hills Boulevard and along SR50 road cuts east and west of the El Dorado Hills Boulevard/SR50 interchange. The shear zones are related to faulting and/or compressional stresses from the west spur of the Bear Mountains Fault Zone. The fault trace, bearing approximately north-south, is located 500 feet east of the El Dorado Hills Interchange. Rocks associated with the faulting may contain talc-sericite schist or talc-chlorite schist.

Photo 64: Road cut on SR50 looking north at Lot 21.

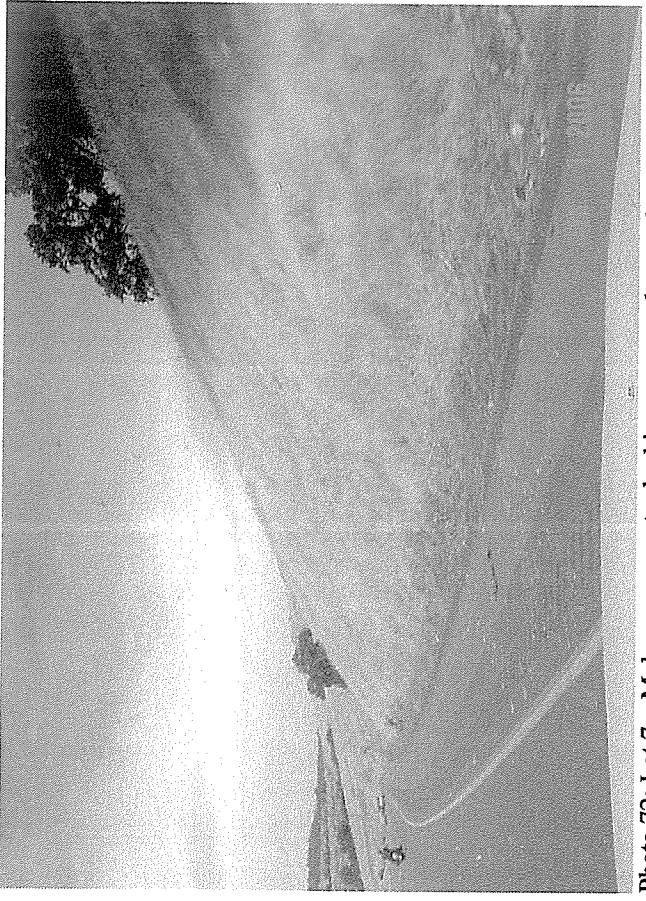
Photo 72: Lot 7 - Mohanna property; looking west-northwest along SR50. Lot 7 is on the north (right) shoulder.

Plans appear to indicate partial site acquisition. Impacts may be along the south property boundary, where SR50 borders the parcel. This parcel is currently undeveloped along the freeway, but improved by a residence on the north side (Photos 69 and 72), away from the freeway.
