Rubicon Trail Site Assessment

February 5, 2013

Photo Monitoring:

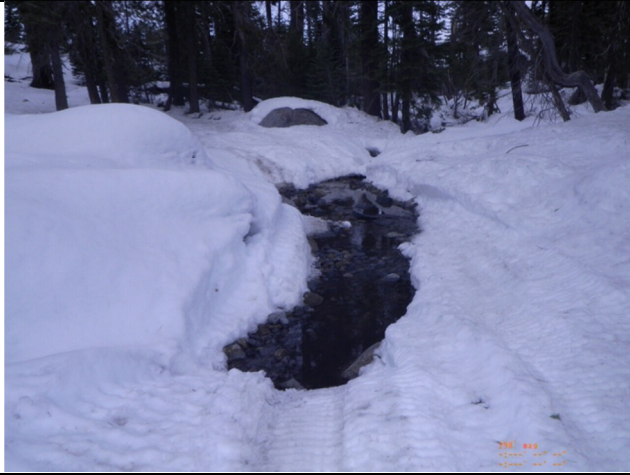
Gate Keeper
 LL Station 146+77.03
 Water Depth: 0.3'

The Rock Outlet Protection (ROP) was exposed through the snow, with run off moving across the ROP. The water was clear with no signs of sediment moving in the water with the flow appearing to be moving towards the snow covered BMP.

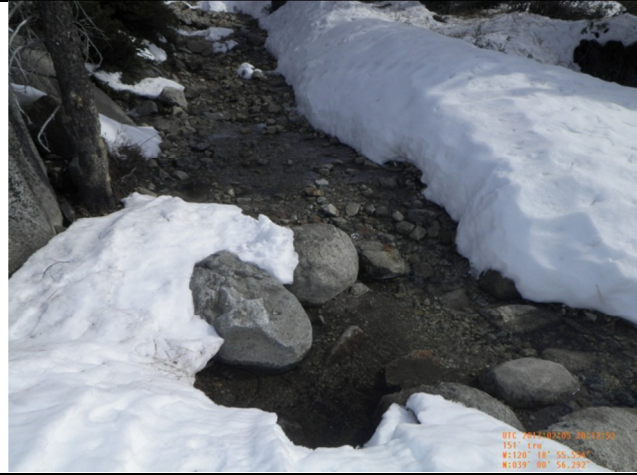
Post Pile
 RT Station 75+00
 Water Depth: 0.1'

The Rock Ditch Crossing (RDX) was under the snow and could not be observed. Run off was seen flowing down the trail with no signs of sediment in the water.

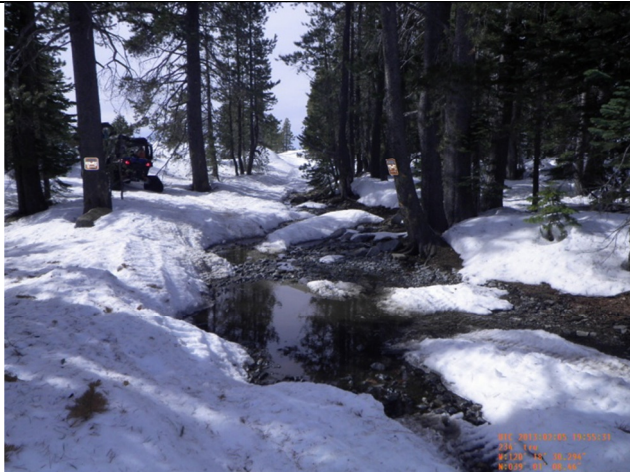
Ellis Creek Intertie
 RT Station 99+86.95
 Water Depth: 0.2'

The Rock Lined Channel (RLC) was exposed through the snow, with run off moving in the RLC. The run off was clear with no signs of sediment moving in the water. The water was moving towards the Rock Energy Dissipater (RED) which was still covered with snow.

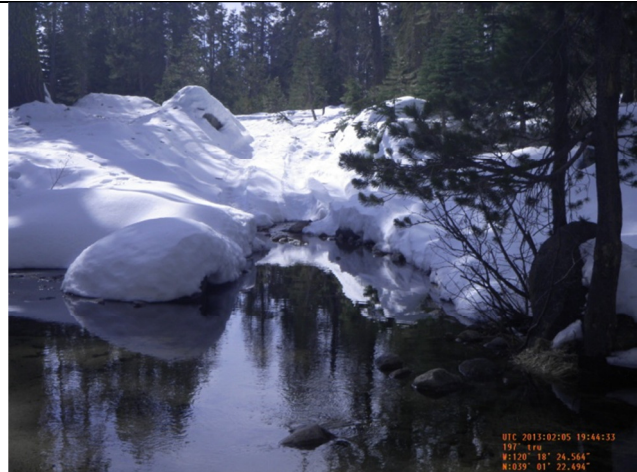
Ellis Creek
 RT Station 115+00
 Water Depth: 0.8'

There was run off that was moving from the trail and into Ellis Creek. The water that was going into the creek was clear with no signs of sediment evident.

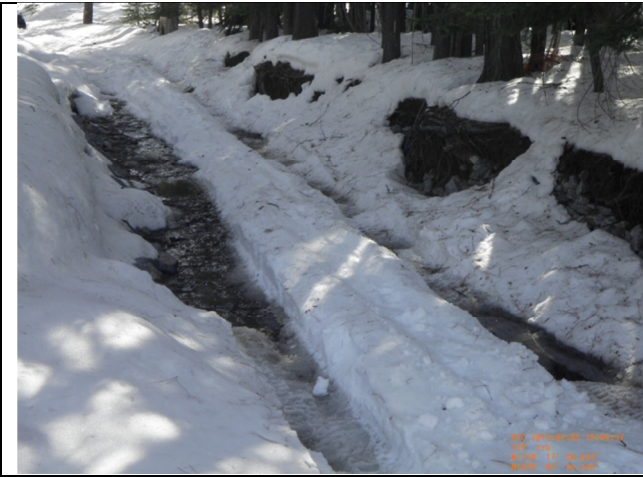
Walker Hill
RT Station 170+80
Water Depth: 0.2'

The Rock Slope Protection (RSP) was exposed in spots through the snow. There was run off that was flowing down the trail in spots. The water was clear and did not have noticeable signs of sediment.

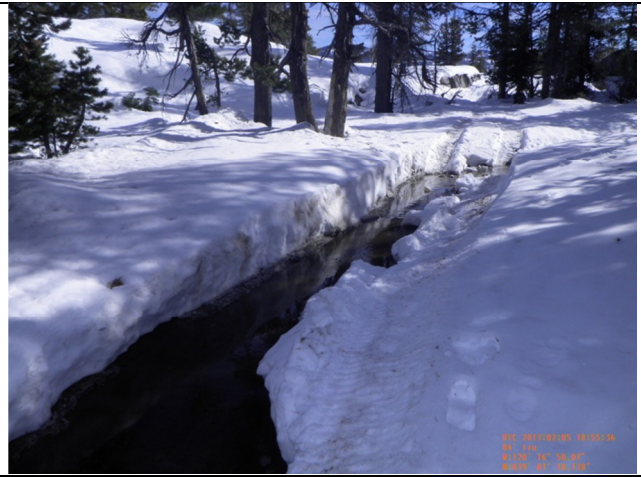
Soup Bowl
RT Station 198+40.84
Water Depth: 0.4'

The Rock Ditch Crossing (RDX) was exposed through the snow with run off moving through it. The water that was moving through the RDX was clear and did not appear to have signs of sediment.

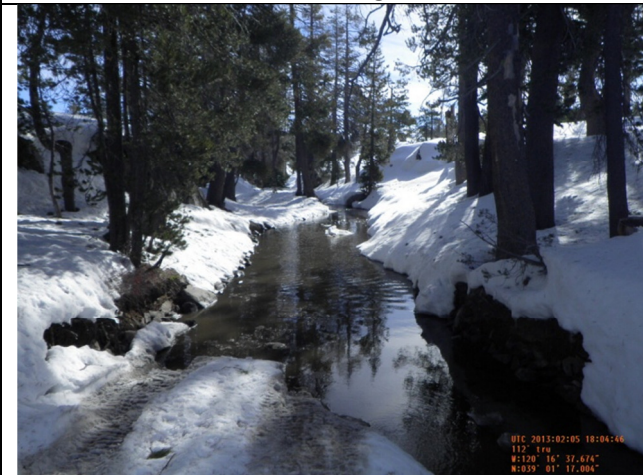
Winter Camp
RT Station 209+58.39
Water Depth: 0.6'

The Rock Fill (RF) was exposed through the snow. There was run off moving over the RF. The water was clear and did not have noticeable signs of sediment.

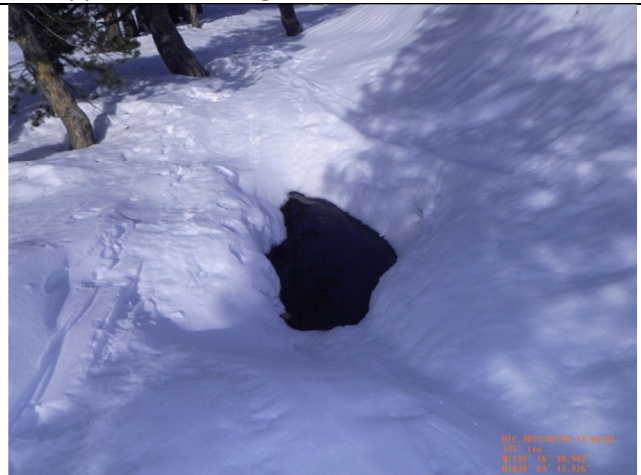
Little Sluice
RT Station 213+50.32
Water Depth: 0.3'

The Rock Fill (RF) was exposed in one spot through the snow. There was run off that was flowing over the RF. The water was clear and did not have any noticeable signs of sediment.
