# Rubicon Trail Site Assessment

## February 21, 2013

**County Assessment:** As of this site visit for the conditions observed, the County has determined that the goals of the Saturated Soil Water Quality Protection Plan (SSWQPP) are being met. Observed water levels were low enough to not pose a risk of washing contaminants from the under carriage of vehicles.

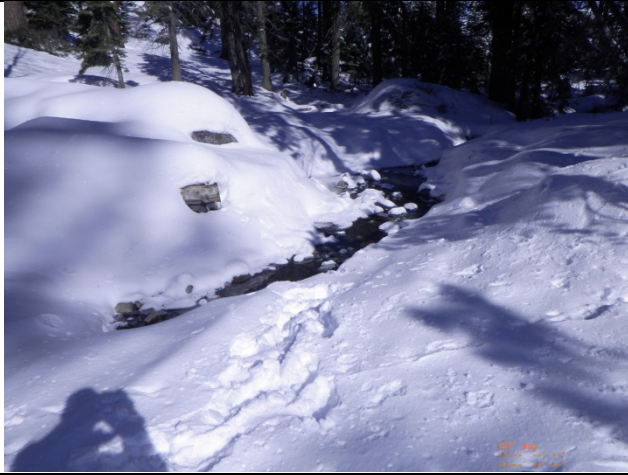
Gate Keeper  
 LL Station 146+77.03  
 Water Depth: 0.5'

The Rock Outlet Protection (ROP) was exposed through the snow, with run off moving across the ROP. The snow level was higher since the last visit so the ROP was exposed less. The water was clear with no signs of sediment moving in the water with the flow appearing to be moving towards the snow covered BMP.

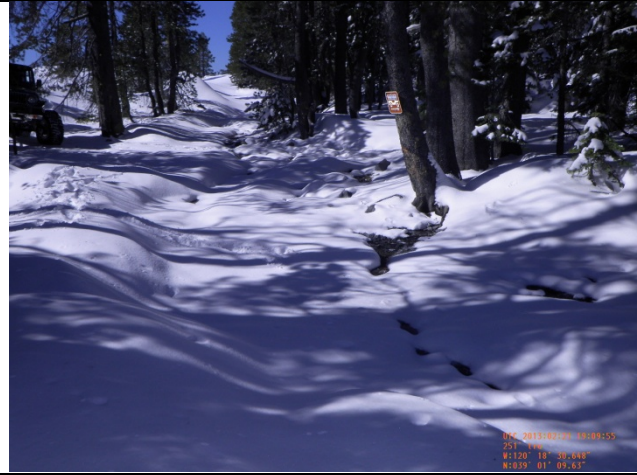
Ellis Creek Intertie  
 RT Station 99+86.95  
 Water Depth: 0.2'

The Rock Lined Channel (RLC) was exposed minimally through the snow, with run off moving in the RLC. The run off was clear with no signs of sediment moving in the water. The water was moving towards the Rock Energy Dissipater (RED) which was still covered with snow.

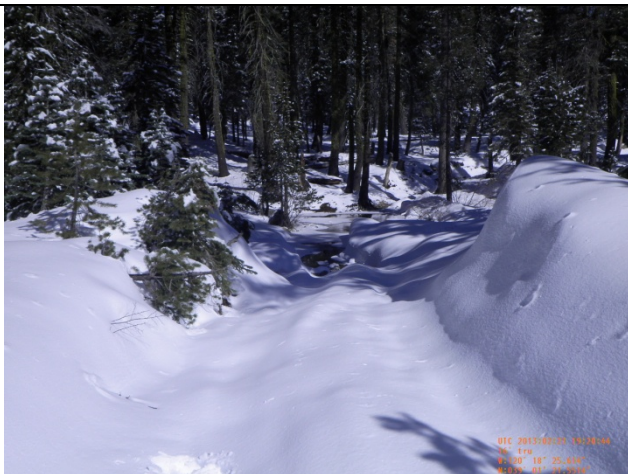
Ellis Creek  
 RT Station 115+00  
 Water Depth: 0.6'

Trail covered in snow, except where the Trail crosses Ellis Creek. Runoff from edge of Trail was noted moving from Trail into Ellis Creek. The water that was going into the creek was clear with no signs of sediment evident. Note that water depth measurement was for Ellis Creek flow.

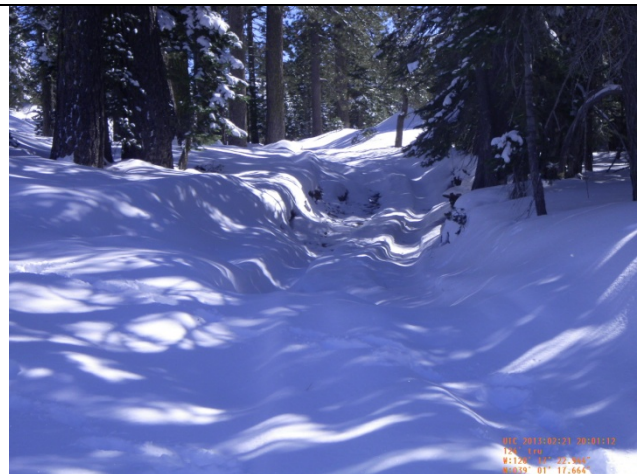
Walker Hill  
 RT Station 170+80  
 Water Depth: 0.2'

The Rock Slope Protection (RSP) was exposed minimally in spots through the snow. There was no run off that was visible at this site.
