# Rubicon Trail Site Assessment

## February 26, 2013

**County Assessment:** As of this site visit for the conditions observed, the County has determined that the goals of the Saturated Soil Water Quality Protection Plan (SSWQPP) are being met. Observed water levels were low enough to not pose a risk of washing contaminants from the under carriage of vehicles.

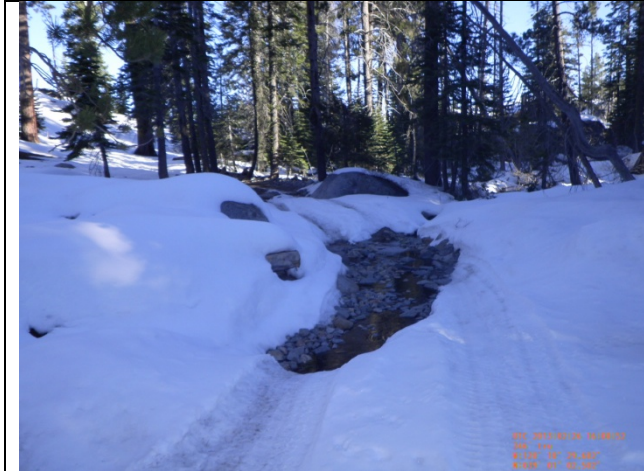
**Gate Keeper**  
LL Station 146+77.03  
Water Depth: 0.4'

The Rock Outlet Protection (ROP) was exposed through the snow, with run off moving across the ROP. The water was clear with no signs of sediment moving in the water with the flow appearing to be moving towards the snow covered BMP.

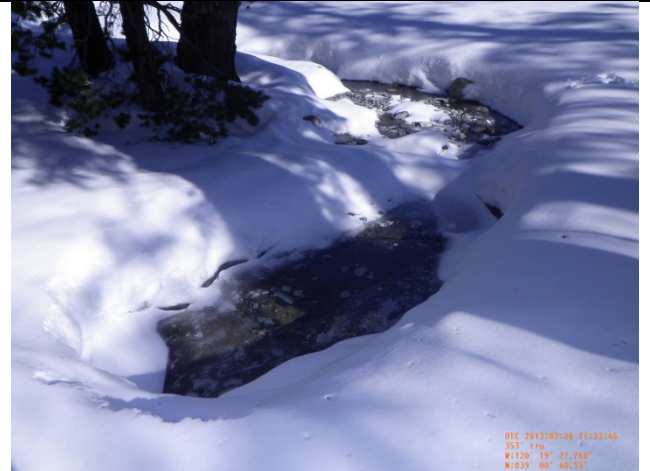
**Wentworth Springs Camp Ground**  
RT Station 33+65.67  
Water Depth: 0.2'

The Rock Ditch Crossing (RDX) was exposed through the snow, with run off moving across the RDX. The water was clear with now signs of sediment moving in the water.

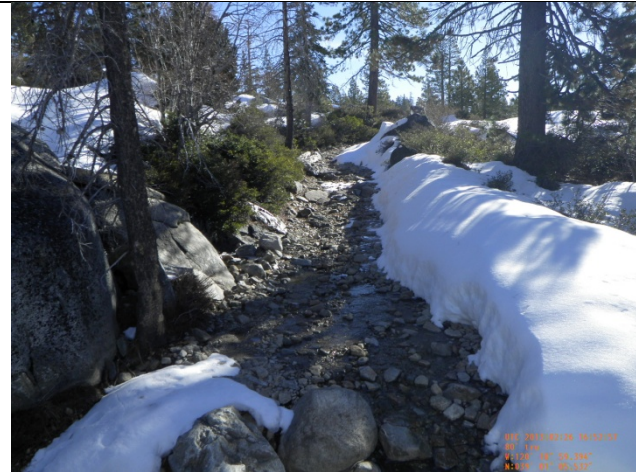
**Post Pile**  
RT Station 75+00  
Water Depth: 0.3'

The Rock Ditch Crossing (RDX) was under the snow and could not be observed. Run off was seen flowing down the trail with no signs of sediment in the water.

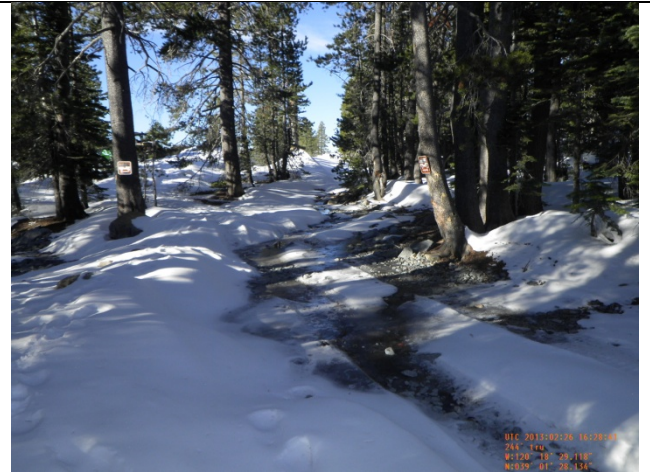
**Ellis Creek Intertie**  
RT Station 99+86.95  
Water Depth: 0.2'

The Rock Lined Channel (RLC) was exposed minimally through the snow, with run off moving in the RLC. The run off was clear with no signs of sediment moving in the water. The water was moving towards the Rock Energy Dissipater (RED) which was still covered with snow.

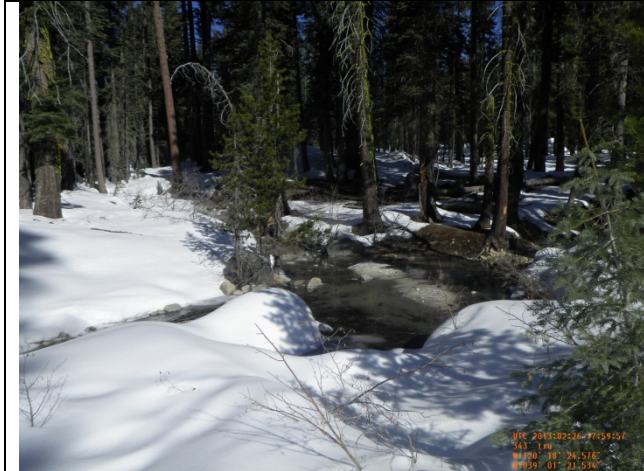
**Ellis Creek**  
RT Station 115+00  
Water Depth: 0.6'

There was run off that was moving from the trail and into Ellis Creek. The water that was going into the creek was clear with no signs of sediment evident.

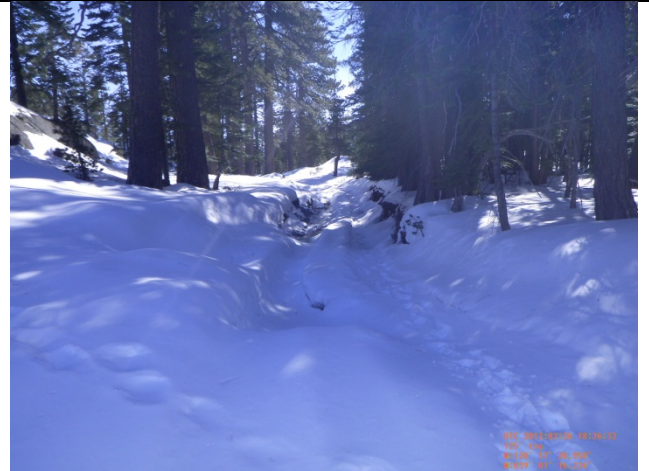
**Walker Hill**  
RT Station 170+80  
Water Depth: 0.1'

The Rock Slope Protection (RSP) was exposed in spots through the snow. There was minimal run off that was flowing down the trail in spots. The water was clear and did not have noticeable signs of sediment.

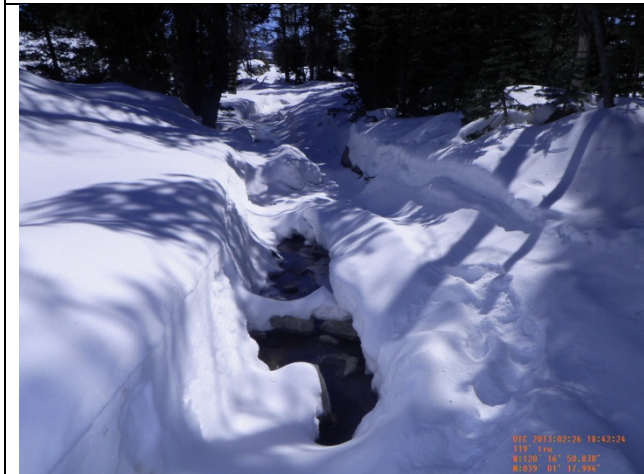
**Soup Bowl**  
RT Station 198+40.84  
Water Depth: 0.3'

The Rock Ditch Crossing (RDX) was exposed through the snow with run off moving through it. The water that was moving through the RDX was clear and did not appear to have signs of sediment.

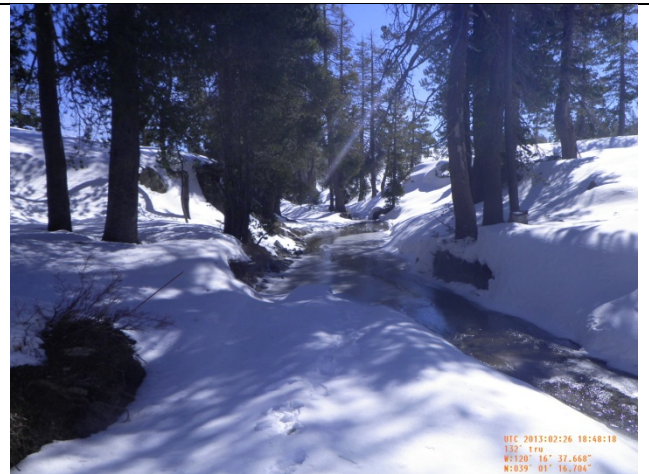
**Winter Camp**  
RT Station 209+58.39  
Water Depth: 0.3'

The Rock Fill (RF) was exposed through the snow. There was run off moving over the RF. The water was clear and did not have noticeable signs of sediment.

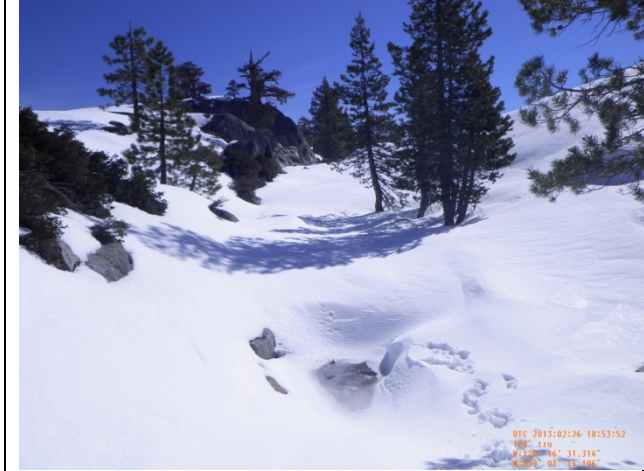
Little Sluice  
RT 213+50.32  
Water Depth: 0.2'

The Rock Fill (RF) was minimally exposed in one spot through the snow. There was run off that was flowing over the RF. The water was clear and did not have any noticeable signs of sediment.
