**County Assessment:** As of this site visit for the conditions observed, the County has determined that the goals of the Saturated Soil Water Quality Protection Plan (SSWQPP) are being met. Observed water levels were low enough to not pose a risk of washing contaminants from the under carriage of vehicles.

#### **Photo Monitoring:**

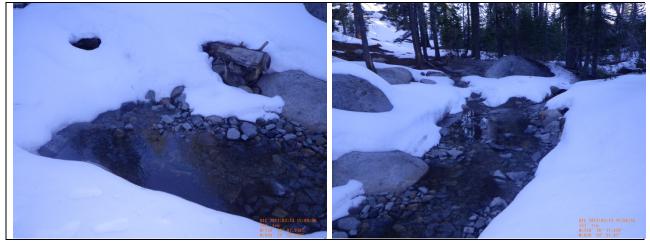
Gate Keeper

LL Station 146+77.03

Water Depth: 0.5'

The Rock Outlet Protection (ROP) was exposed through the snow, with run off moving across the ROP.

The water appeared to be moving towards the snow covered BMP.

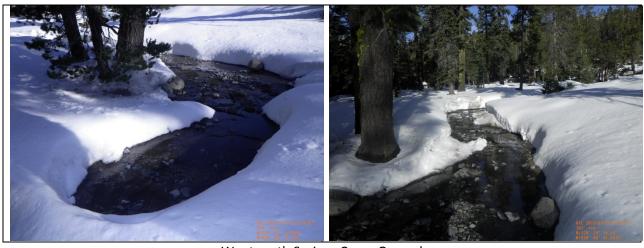
Wentworth Springs Camp Ground

RT Station 33+65.67

Water Depth: 0.2'

The Rock Ditch Crossing (RDX) was exposed through the snow, with run off moving across the RDX.

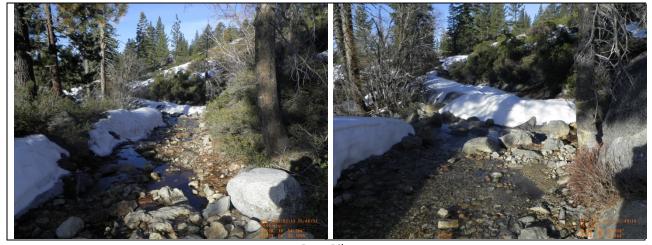
Post Pile

RT Station 75+00

Water Depth: 0.5'

The Rock Ditch Crossing (RDX) was under the snow and could not be observed. Run off was seen flowing down the trail.

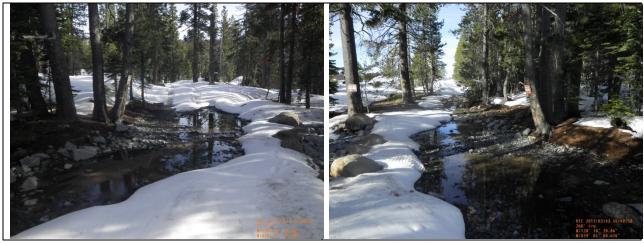
Ellis Creek Intertie

RT Station 99+86.95

Water Depth: 0.2'

The Rock Lined Channel (RLC) was exposed through the snow, with run off moving in the RLC. The water was moving towards the Rock Energy Dissipater (RED) which was partially covered with snow.

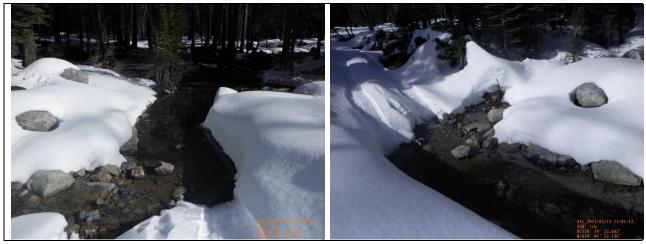
Ellis Creek

RT Station 115+00

Water Depth: 0.7'

There was run off that was moving from the trail and into Ellis Creek.

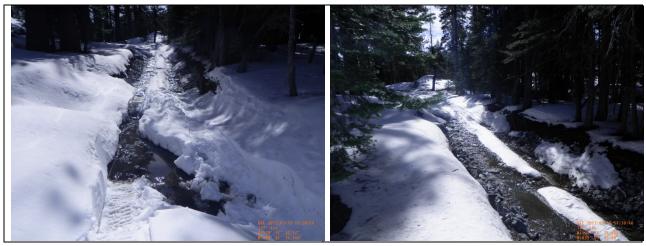
Walker Hill

RT Station 170+80

Water Depth: 0.2'

The Rock Slope Protection (RSP) was exposed in spots through the snow. There was run off that was flowing down the Trail.

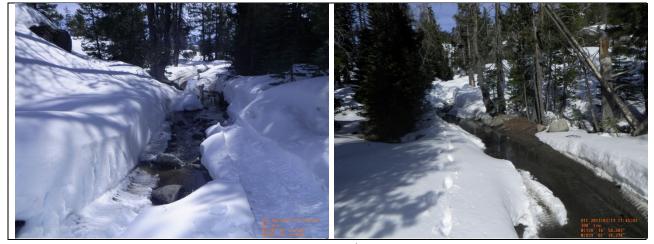
Soup Bowl

RT Station 198+40.84

Water Depth: 0.5'

The Rock Ditch Crossing (RDX) was exposed through the snow with run off moving through it.

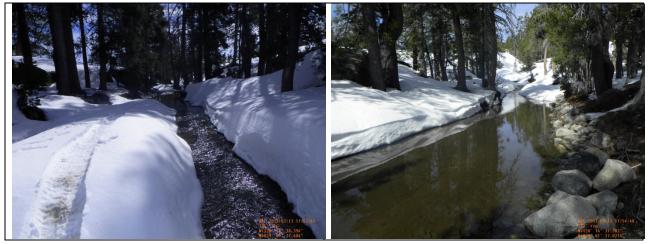
Winter Camp

RT Station 209+58.39

Water Depth: 0.9'

The Rock Fill (RF) was exposed through the snow. There was run off moving over the RF.

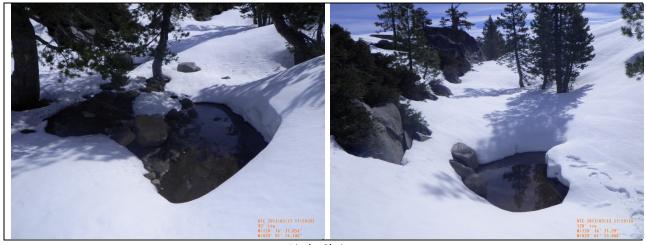
Little Sluice

RT 213+50.32

Water Depth: 0.3'

The Rock Fill (RF) was exposed in two spot through the snow. There was run off that was flowing over the RF.
