# Rubicon Trail Site Assessment

## February 24, 2014

**Rubicon Trail  
El Dorado County Site Assessment  
February 24, 2014**

## Photo Monitoring:

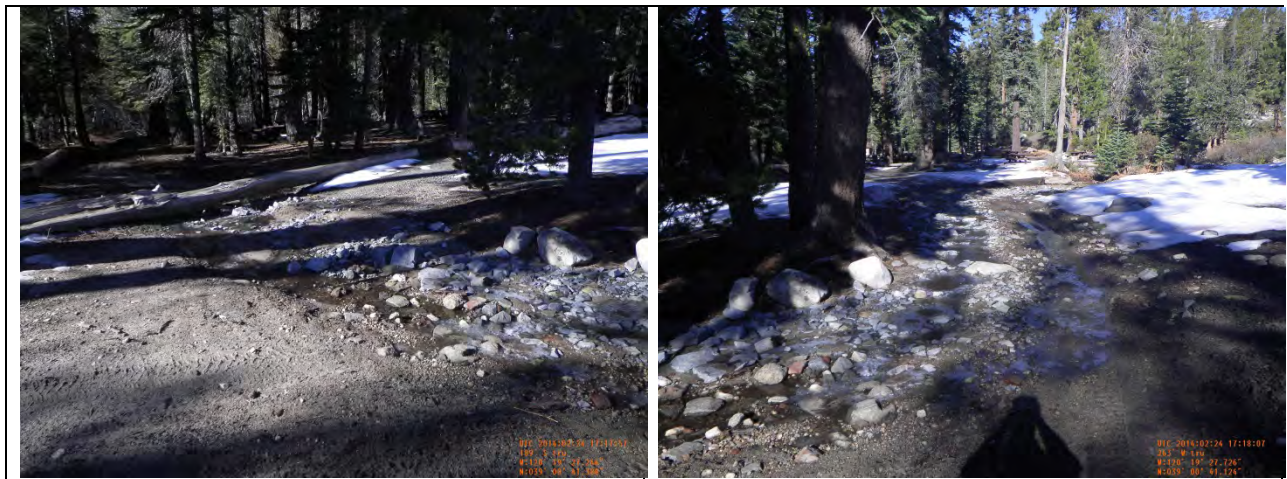
Wentworth Springs Campground  
RT Station 33+65.67

Water Depths: 0.1', 0.2', 0.2'  
(Average: 0.17')

Notes: The Rock Ditch Crossing (RDX) was exposed with snow melt run-off flowing across the RDX.

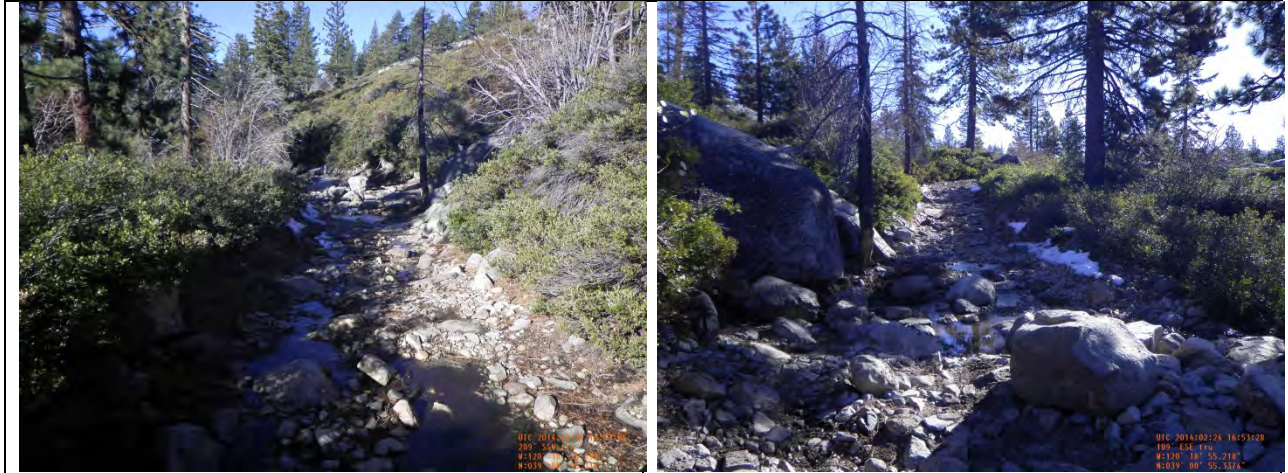
Post Pile  
RT Station 75+00

Water Depths: 0.3', 0.3', 0.4'  
(Average: 0.33')

Notes: The Rock Ditch Crossing (RDX) was observed and was functioning as designed. Snow melt run-off was observed flowing down the hardened surface of the Trail.

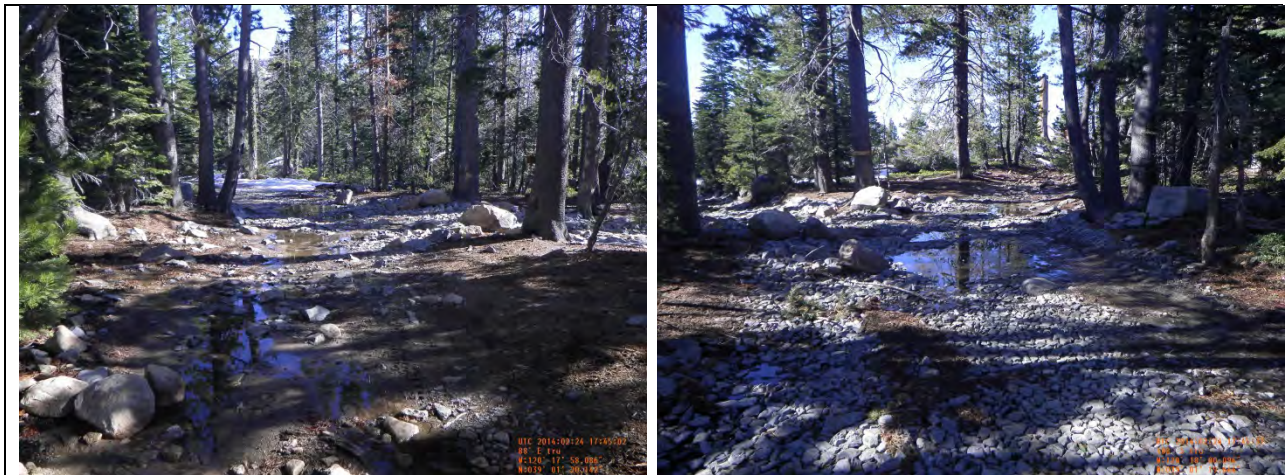
Ellis Creek Intertie  
RT Station 99+86.95

Water Depths: 0.1', 0.2', 0.2'  
(Average: 0.17')

Notes: The Rock Lined Channel (RLC) was exposed with snow melt run-off flowing in the RLC. The water was properly draining towards the Rock Energy Dissipator (RED) which was not covered with snow and functioning as designed.

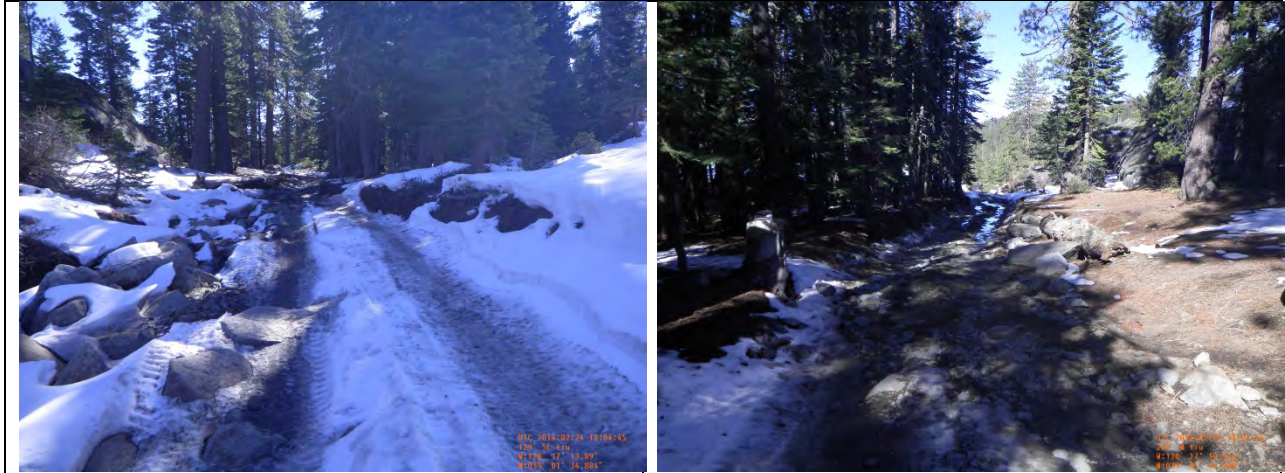
Walker Hill  
RT Station 170+80

Water Depths: 0.1', 0.1', 0.2'  
(Average: 0.13')

Notes: The Rock Slope Protection (RSP) was not fully exposed on both sides of the Trail. There was minimal snow melt run-off flowing down the hardened surface of the Trail, which discharges into a Rock Energy Dissipator.

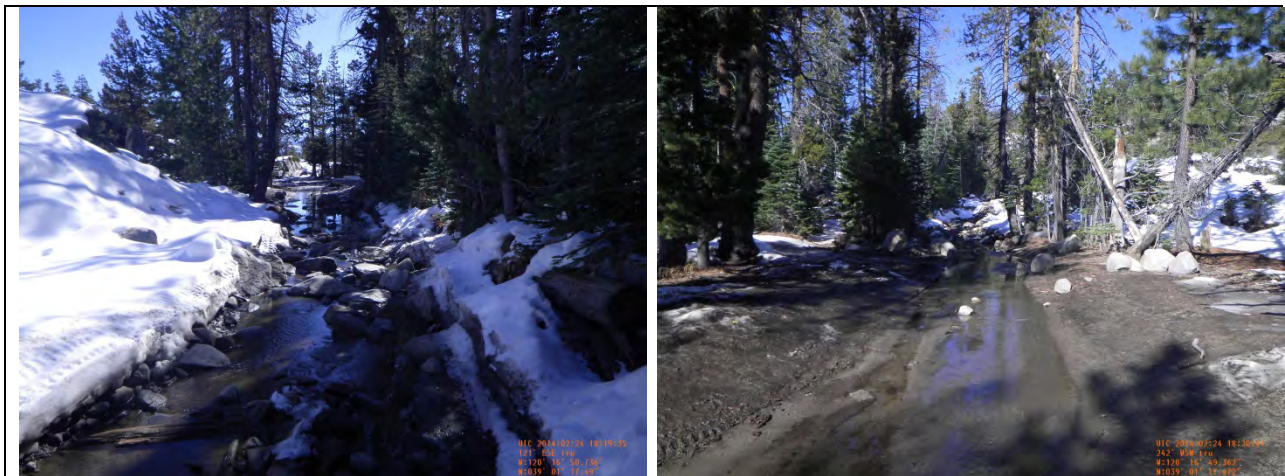
Soup Bowl  
RT Station 198+40.84

Water Depth: 0.2', 0.2', 0.3'  
(Average: 0.23')

Notes: The Rock Ditch Crossing (RDX) was exposed through the snow with snow melt run-off flowing through it.

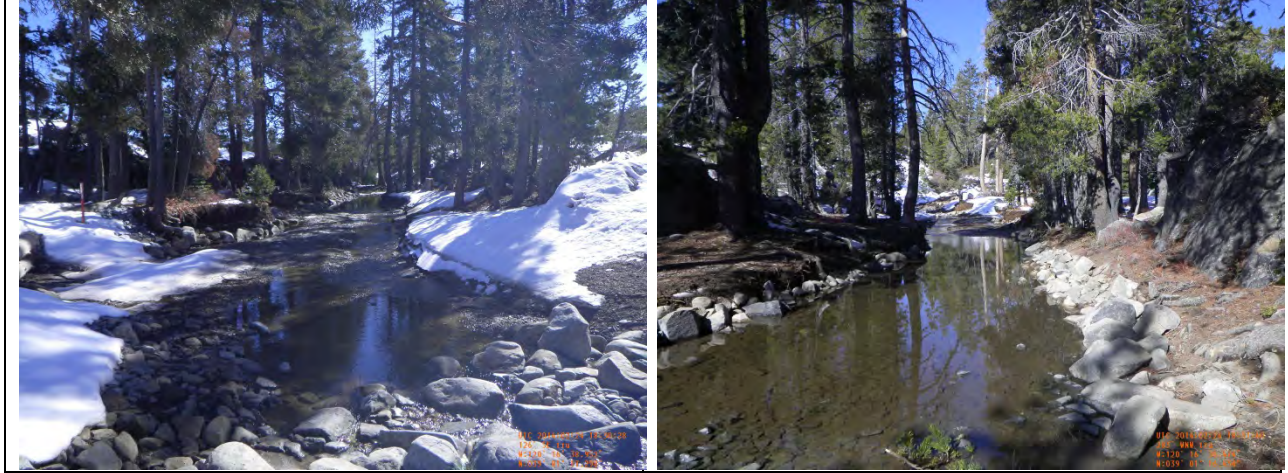
Winter Camp  
RT Station 209+58.39

Water Depth: 0.8', 0.8', 0.9'  
(Average: 0.83')

The Rock Fill (RF) was not fully exposed through the snow. Where visible, the run off was flowing over the RF.

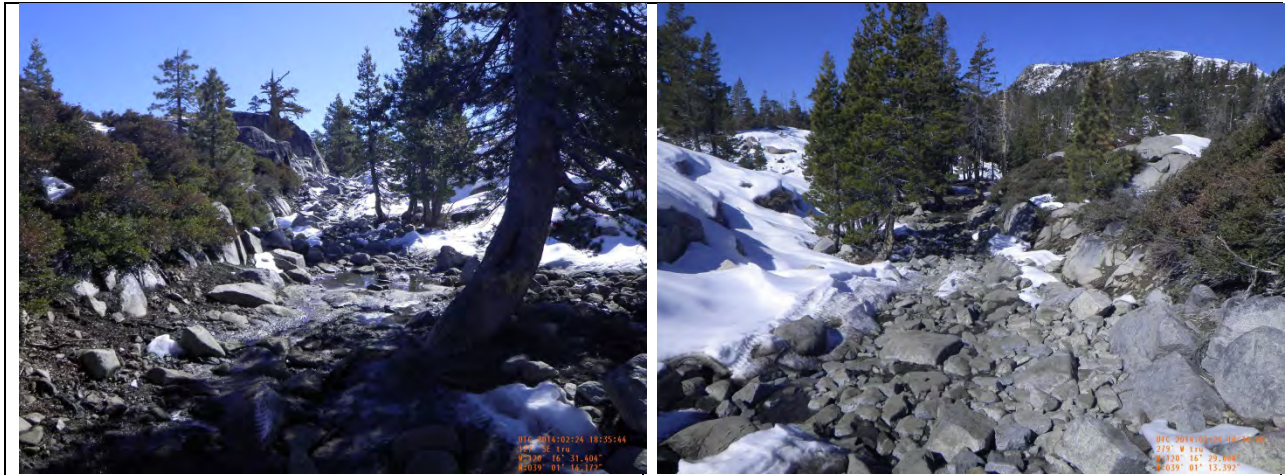
Little Sluice  
RT 213+50.32

Water Depth: 0.2', 0.2', 0.3'  
(Average: 0.23')

The Rock Fill (RF) was mostly exposed through the snow. Where visible, the run off was flowing over the RF.
