Rubicon Trail Site Assessment

March 14, 2014

**Rubicon Trail
El Dorado County Site Assessment
March 14, 2014**

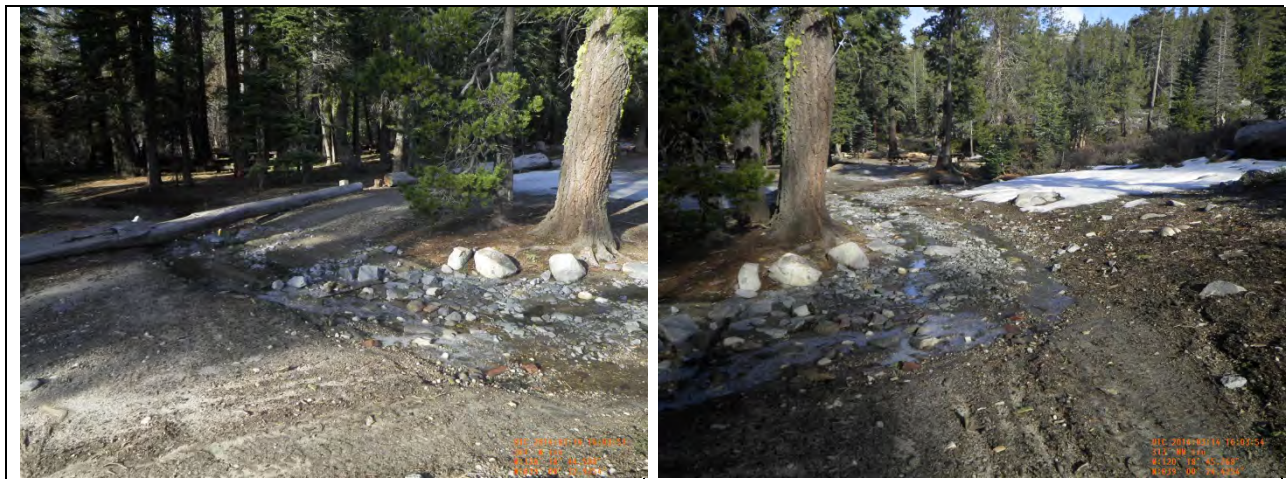
Wentworth Springs Campground
RT Station 33+65.67

Water Depths: 0.1', 0.1', 0.2'
(Average: 0.13')

Notes: The Rock Ditch Crossing (RDX) was exposed with snow melt run-off flowing across the RDX.

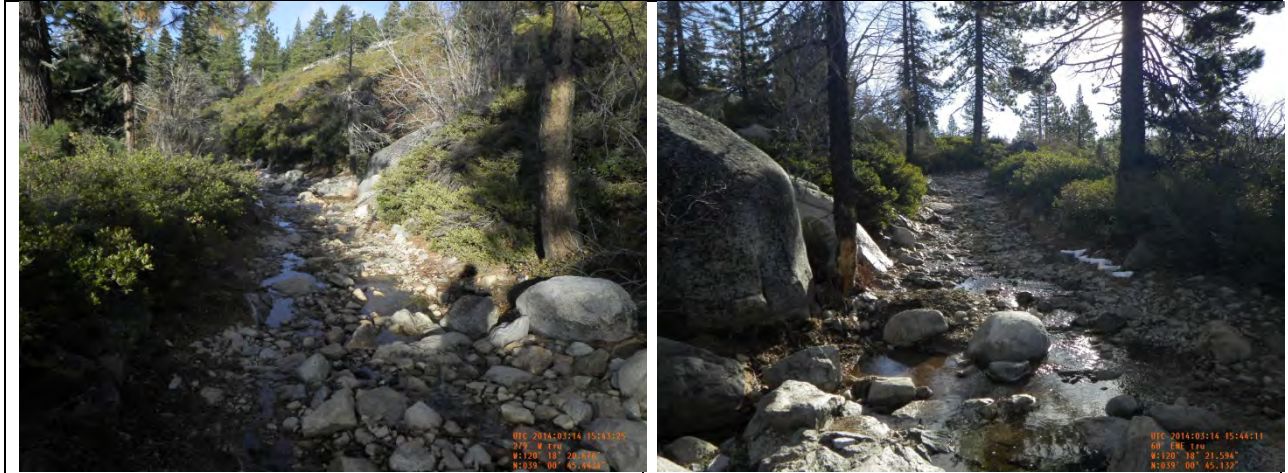
Post Pile
RT Station 75+00

Water Depths: 0.3', 0.3', 0.4'
(Average: 0.33')

Notes: The Rock Ditch Crossing (RDX) was observed and was functioning as designed. Snow melt run-off was observed flowing down the hardened surface of the Trail.

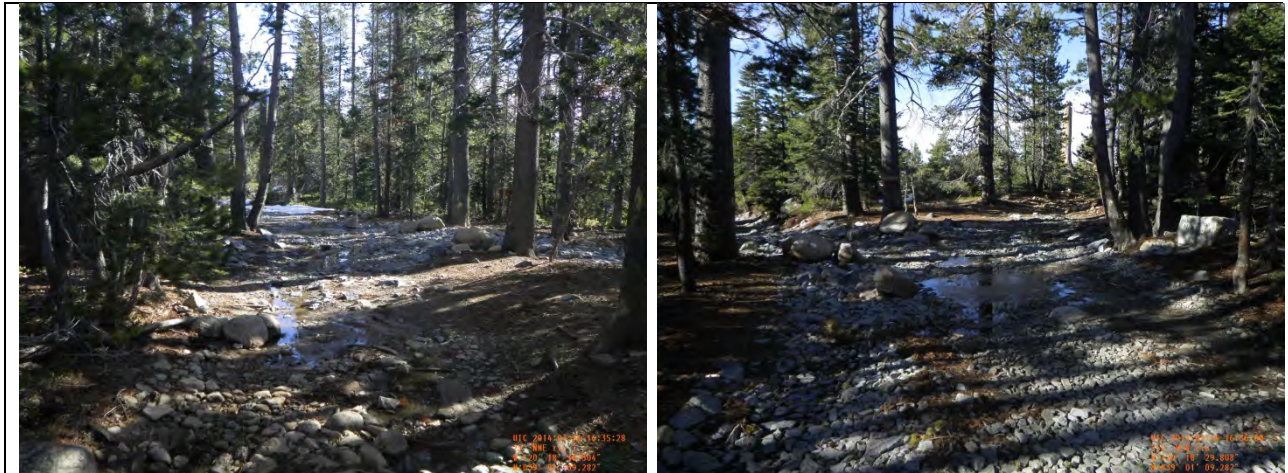
Ellis Creek Intertie
RT Station 99+86.95

Water Depths: 0.1', 0.1', 0.2'
(Average: 0.13')

Notes: The Rock Lined Channel (RLC) was exposed with snow melt run-off flowing in the RLC. The water was properly draining towards the Rock Energy Dissipator (RED) which was not covered with snow and functioning as designed.

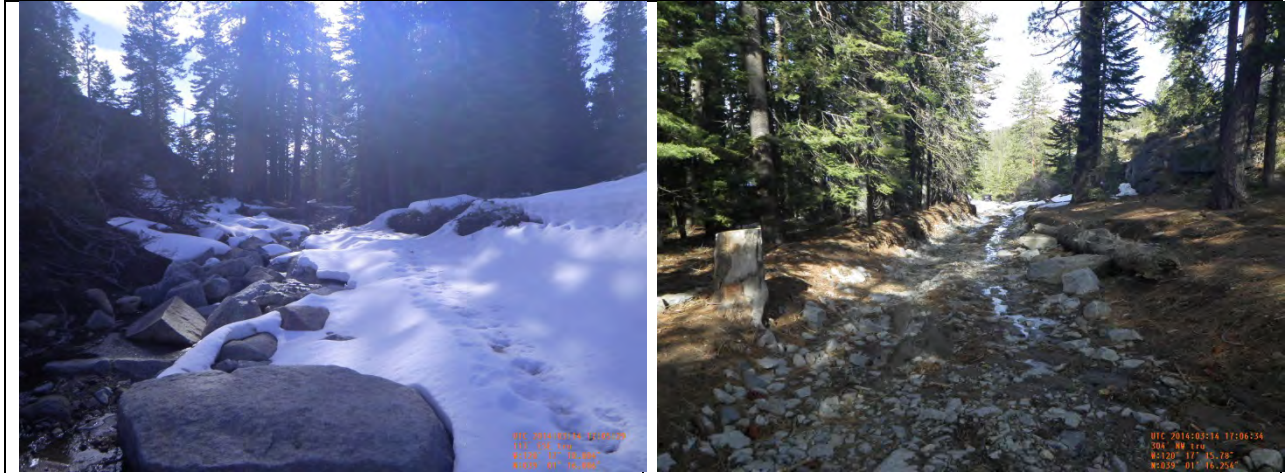
Walker Hill
RT Station 170+80

Water Depths: 0.1', 0.1', 0.3'
(Average: 0.17')

Notes: The Rock Slope Protection (RSP) was not fully exposed on both sides of the Trail. There was minimal snow melt run-off flowing down the hardened surface of the Trail, which discharges into a Rock Energy Dissipator.

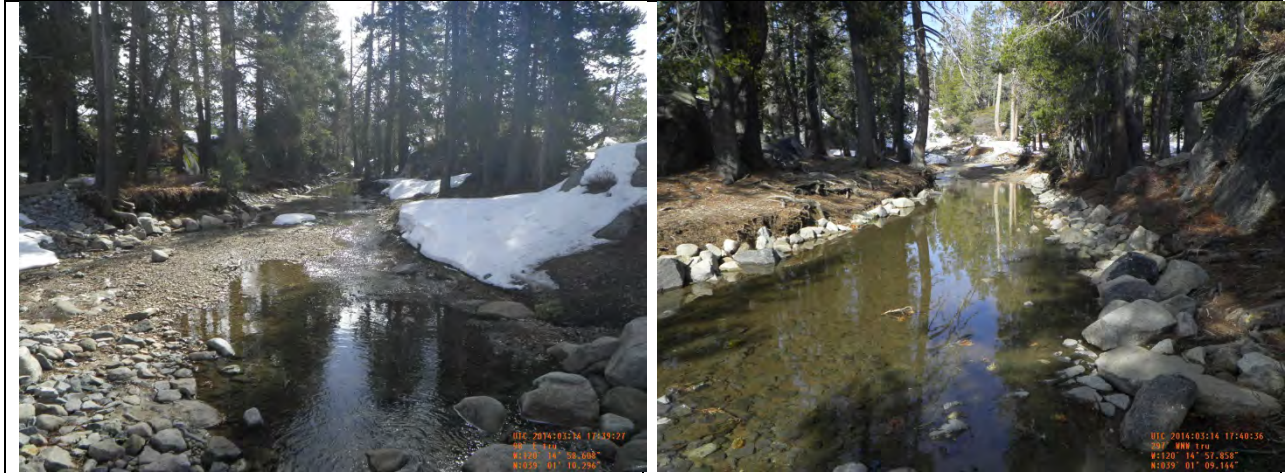
Winter Camp
RT Station 209+58.39

Water Depth: 0.5', 0.8', 0.9'
(Average: 0.73')

The Rock Fill (RF) was almost fully exposed through the snow. Where visible, the run off was flowing over the RF.

County Assessment: As of this site visit for the conditions observed, the County has determined that the goals of the Saturated Soil Water Quality Protection Plan (SSWQPP) are being met. Though the goals are being met, observations at Winter Camp indicate that the three conditions identified in the Monitoring Protocol are also being met which requires a temporary closure of the Trail. The conditions identified at Winter Camp include: saturated soil conditions, water flowing at an amount capable of rinsing contaminants from vehicle components, and water flowing at an amount capable of transporting sediment.

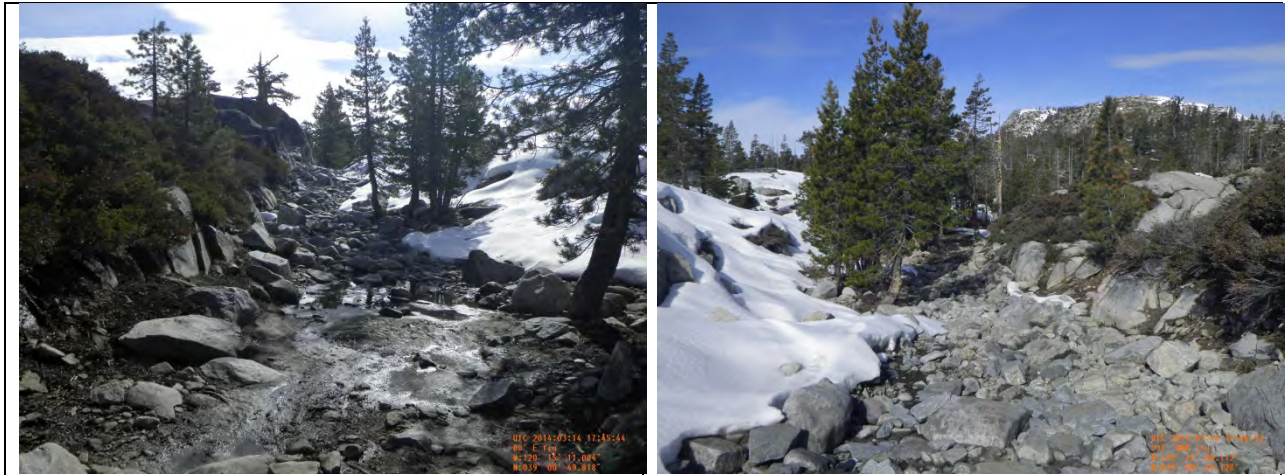
Little Sluice
RT 213+50.32

Water Depth: 0.3', 0.3', 0.3'
(Average: 0.30')

The Rock Fill (RF) was mostly exposed through the snow. Where visible, the run off was flowing over the RF.
