Trail Conditions / Observations: We entered the Rubicon Trail from the Loon Lake entrance. We traveled from Loon Lake to Little Sluice and then to Wentworth Springs Campground. From Wentworth Springs Campground we traveled back to Loon Lake via Gate Keeper. There were no vehicles seen on the Trail over the course of the day. We observed tracks at all sites. Most of the BMP's were not covered with snow along the Trail. The ones that were exposed were functioning as designed.

County Assessment: As of this site visit for the conditions observed, the County has determined that the goals of the Saturated Soil Water Quality Protection Plan (SSWQPP) are being met. Observed water levels were low enough to not pose a risk of washing contaminants from the under carriage of vehicles pursuant to the monitoring protocols.

Rubicon Trail El Dorado County Site Assessment April 18, 2014

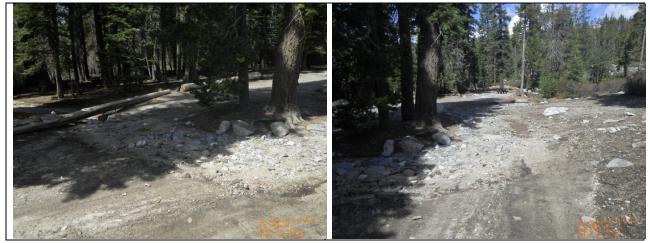
Wentworth Springs Campground RT Station 33+65.67

Water Depths: 0.0', 0.0', 0.0' (Average: 0.00')

Notes: The Rock Ditch Crossing (RDX) was exposed with no snow melt run-off.

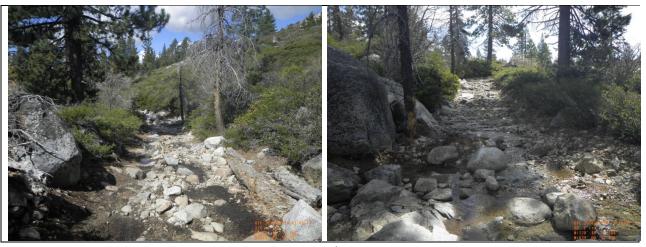
Post Pile RT Station 75+00

Water Depths: 0.2', 0.4', 0.4' (Average: 0.33')

Notes: The Rock Ditch Crossing (RDX) was observed and was functioning as designed. Snow melt run-off was observed flowing down the hardened surface of the Trail.

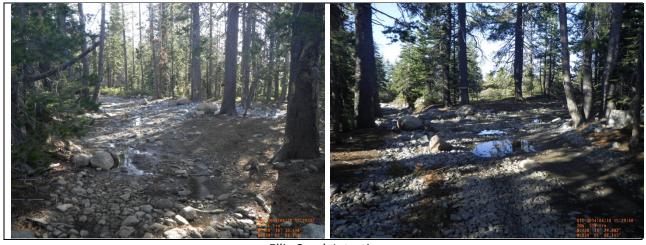
Ellis Creek Intertie RT Station 99+86.95

Water Depths: 0.0', 0.0', 0.0' (Average: 0.00')

Notes: The Rock Lined Channel (RLC) was exposed with no snow melt run-off flowing in the RLC. The Rock Energy Dissipator (RED) was visible and with little to no water flowing through it.

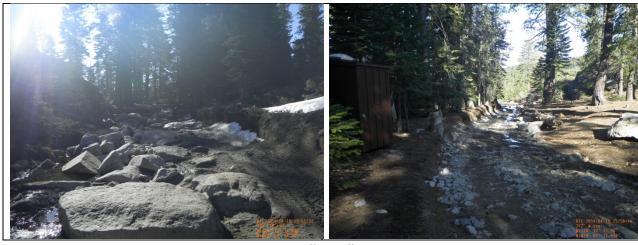
Walker Hill RT Station 170+80

Water Depths: 0.1', 0.1', 0.2' (Average: 0.13')

Notes: The Rock Slope Protection (RSP) was not fully exposed on one side of the Trail. There was snow melt run-off flowing down the hardened surface of the Trail, which discharges into a Rock Energy Dissipator.

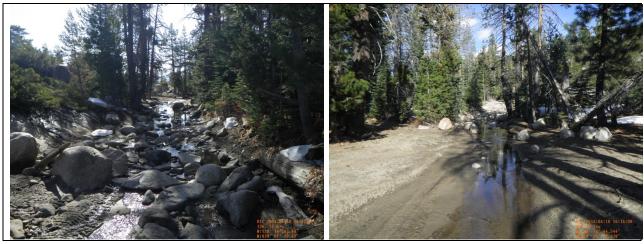
Soup Bowl RT Station 198+40.84

Water Depth: 0.2', 0.3', 0.3' (Average: 0.27')

Notes: The Rock Ditch Crossing (RDX) was exposed with snow melt run-off flowing through it.

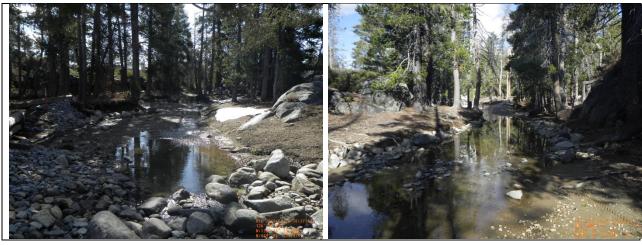
Winter Camp RT Station 209+58.39

Water Depth: 0.4', 0.6', 0.8' (Average: 0.60')

The Rock Fill (RF) was exposed with snow run off flowing over the RF. Although one of the measurements was greater than 8", this appeared to be localized as additional checks of the depths were observed to be less within a 10 foot limit. Per Condition 2 of the Protocol closure of the trail is no longer warranted.

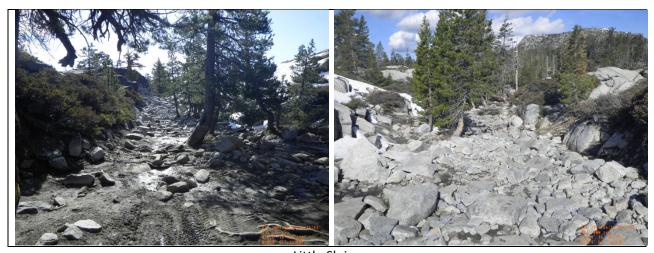
Little Sluice RT 213+50.32

Water Depth: 0.2', 0.2', 0.3' (Average: 0.27')

The Rock Fill (RF) was completely exposed with the run off flowing over the RF.
