Rubicon Trail Site Assessment January 28th, 2015

Photo Monitoring:

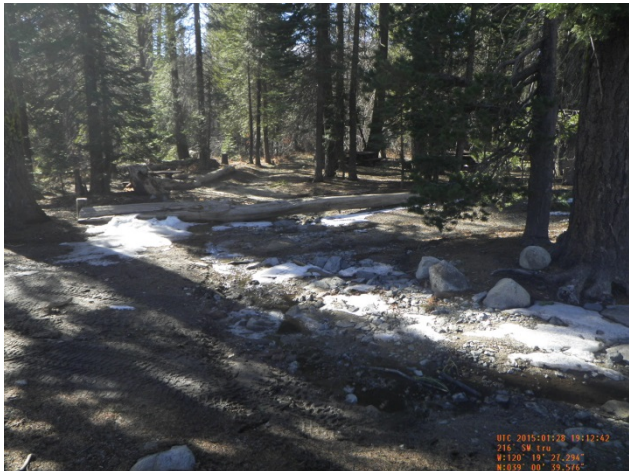
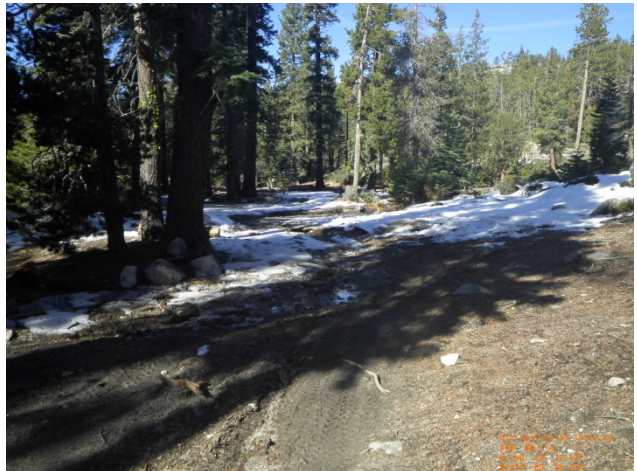
Wentworth Springs Campground
RT Station 33+65

Water Depths: 0.0', 0.0', 0.0'

Notes: The Rock Ditch Crossing (RDX) was exposed with no runoff flowing.

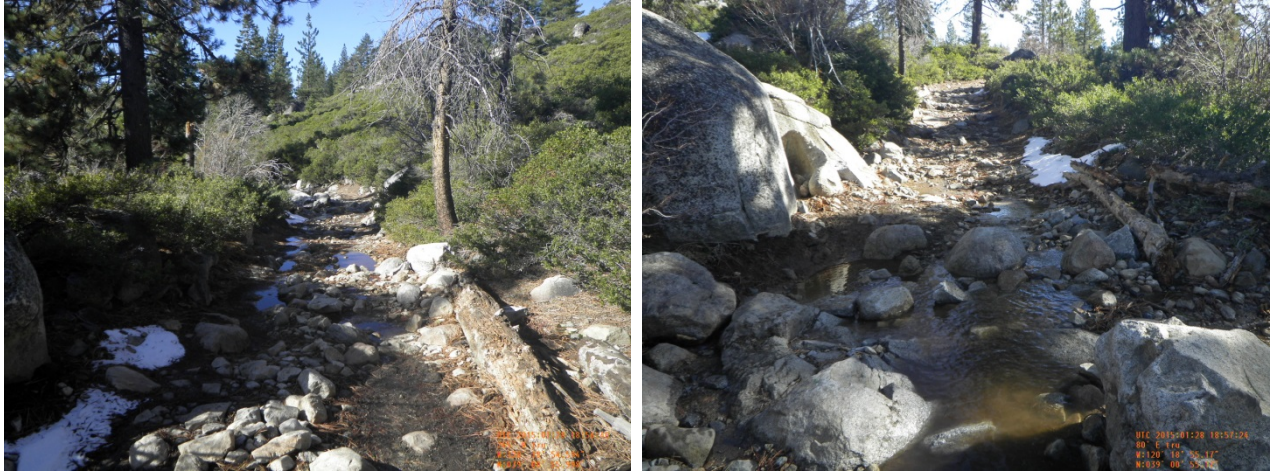
Post Pile
RT Station 75+00

Water Depths: 0.2', 0.4', 0.6'

Notes: The Rock Ditch Crossing (RDX) was observed and was functioning as designed. Runoff was observed flowing down the hardened surface of the Trail.

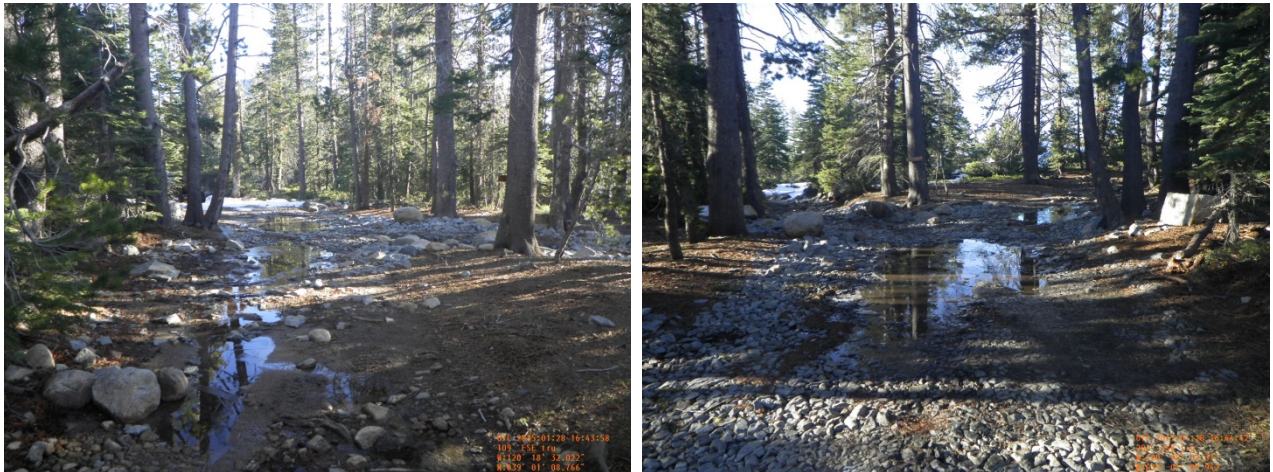
Ellis Creek Intertie
RT Station 99+86

Water Depths: 0.1', 0.2', 0.3'

Notes: The Rock Lined Channel (RLC) was exposed. There was runoff observed in the RLC. The Rock Energy Dissipator (RED) was visible and with water flowing in it.

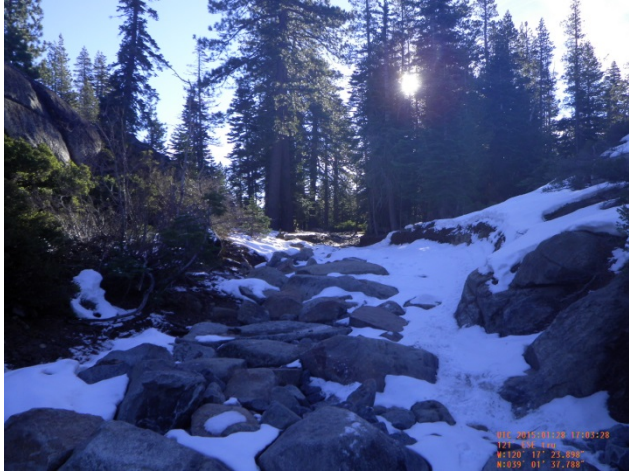
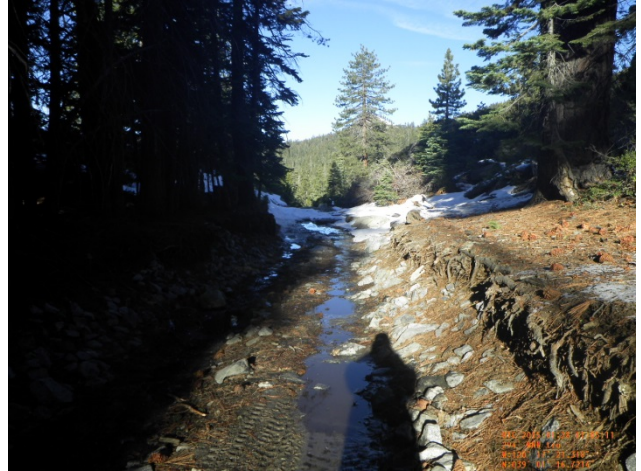
Walker Hill
RT Station 170+80

Water Depths: 0.2', 0.2', 0.3'

Notes: Some of the Rock Slope Protection (RSP) was covered in snow. There was runoff observed flowing down the hardened surface of the Trail.

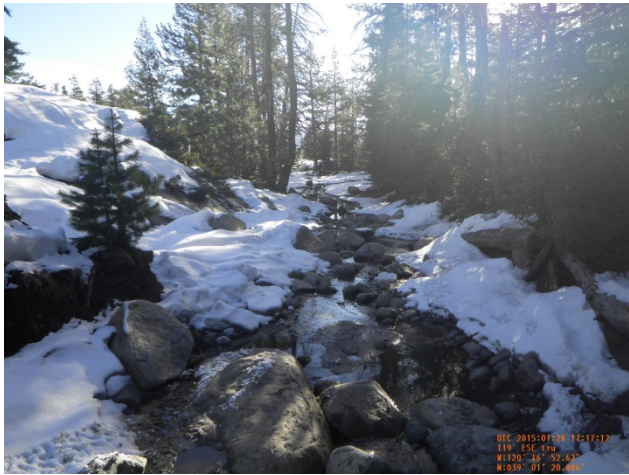
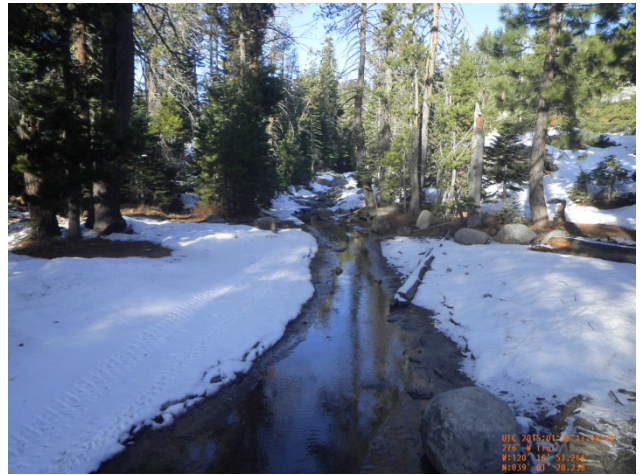
Soup Bowl
RT Station 198+40

Water Depth: 0.2', 0.2', 0.2'

Notes: The Rock Ditch Crossing (RDX) was exposed with runoff flowing through it.

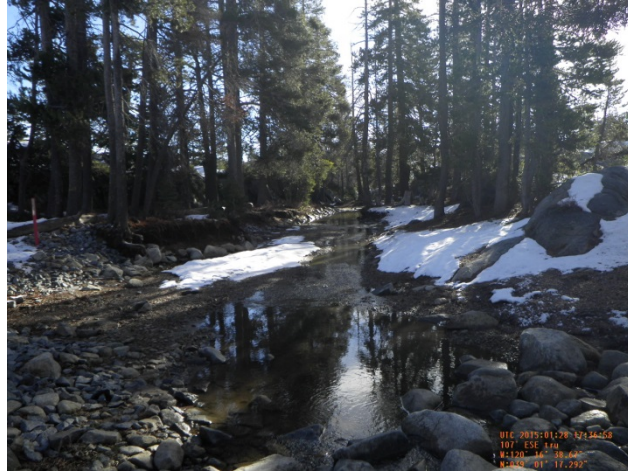
Winter Camp
RT Station 209+58

Water Depth: 0.6', 0.6', (0.7', 0.5', 0.6')

The Rock Fill (RF) was exposed with runoff observed flowing over the RF. There was one measurement that was 0.7'. Two additional measurements were taken within 10 feet (0.5' & 0.6') and the depths were below 0.7' so condition 2 was not met.

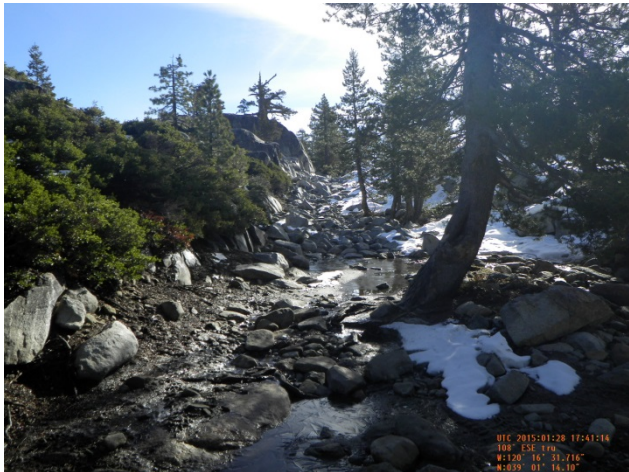
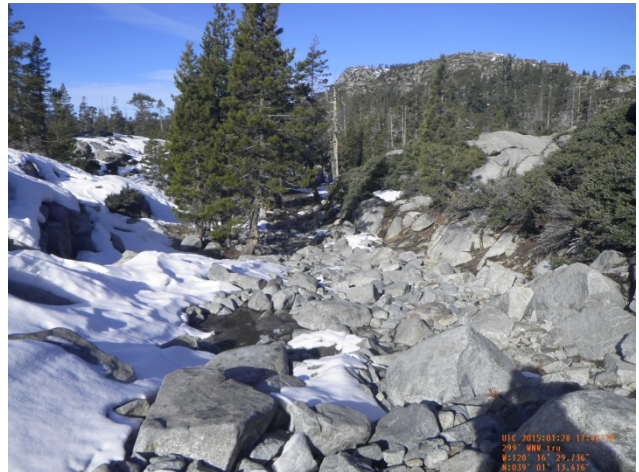
Little Sluice
RT 213+50

Water Depth: 0.3', 0.3', 0.3'

The Rock Fill (RF) was covered with very minimal snow, with the runoff flowing over the RF that was exposed.
