# Rubicon Trail Site Assessment

## March 5<sup>th</sup>, 2015

## Photo Monitoring:

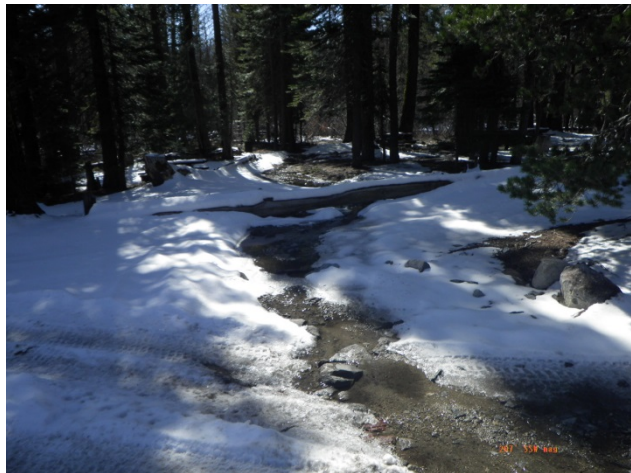
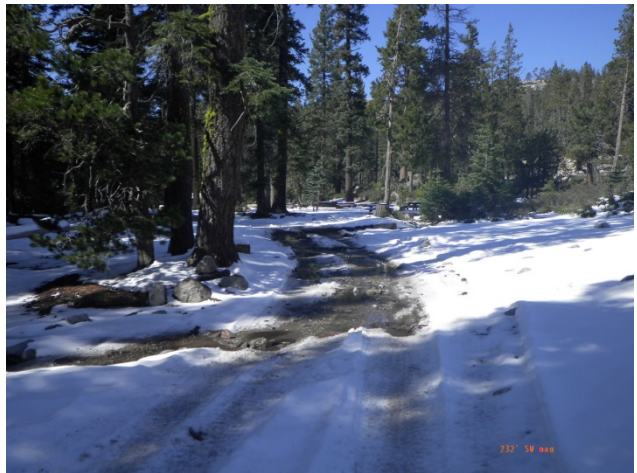
Wentworth Springs Campground  
RT Station 33+65

Water Depths: 0.1', 0.1', 0.1'

Notes: The Rock Ditch Crossing (RDX) was partially exposed with runoff flowing over the harden surface of the Trail.

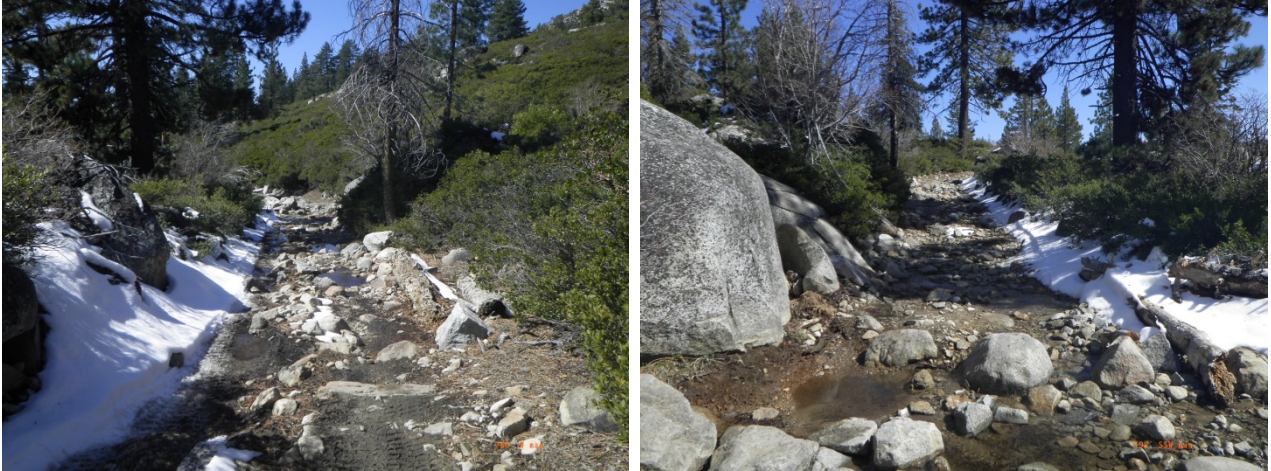
Post Pile  
RT Station 75+00

Water Depths: 0.3', 0.3', 0.3'

Notes: The Rock Ditch Crossing (RDX) was observed and was functioning as designed. Runoff was observed flowing down the hardened surface of the Trail.

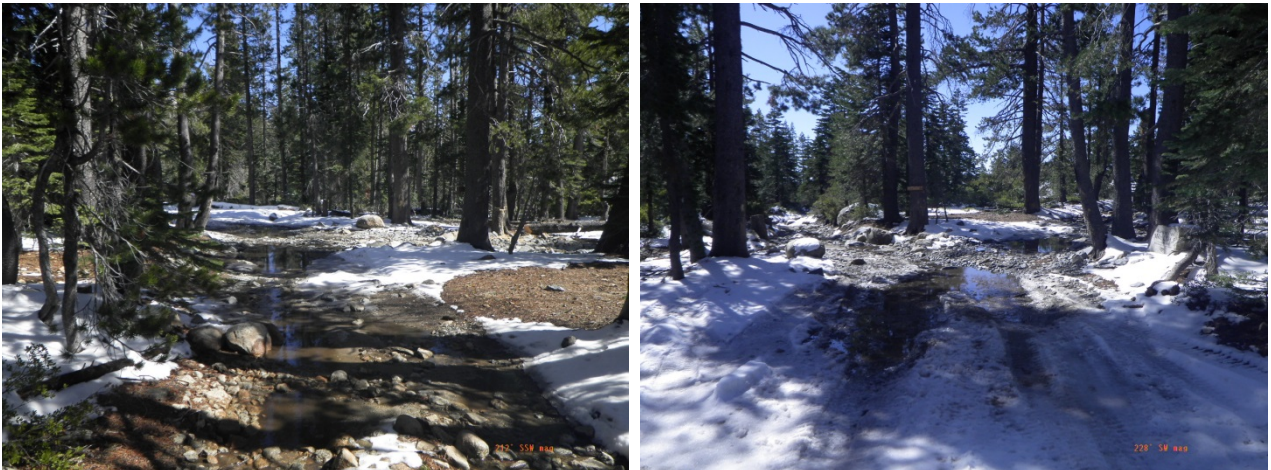
Ellis Creek Intertie  
RT Station 99+86

Water Depths: 0.2', 0.3', 0.4'

Notes: The Rock Lined Channel (RLC) was partially exposed. There was runoff observed in the RLC. The Rock Energy Dissipator (RED) was covered with minimal snow with water flowing in it.

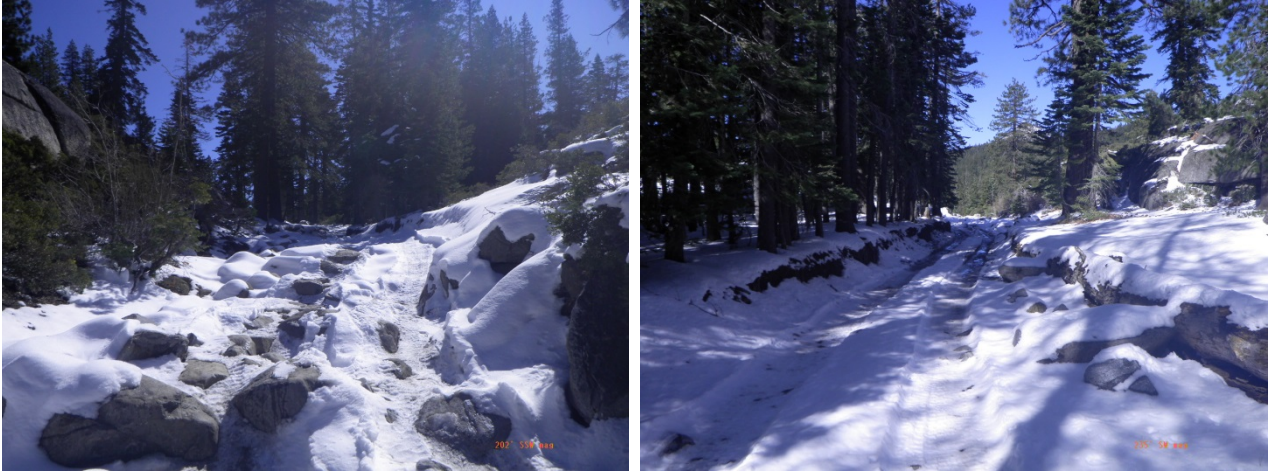
Walker Hill  
RT Station 170+80

Water Depths: 0.1', 0.1', 0.1'

Notes: Most of the Rock Slope Protection (RSP) was covered in snow. Where exposed, runoff was observed flowing down the hardened surface of the Trail.

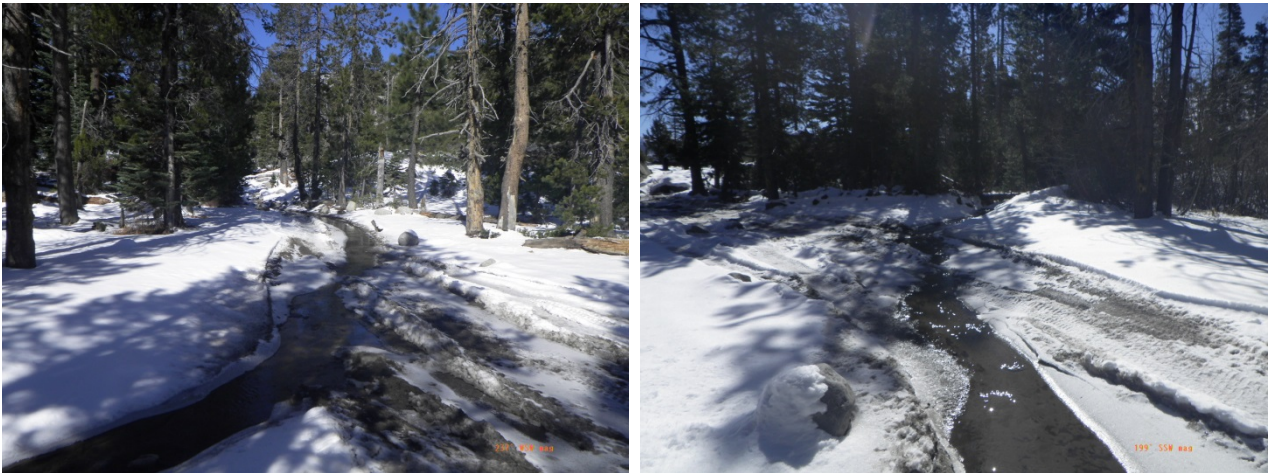
Soup Bowl  
RT Station 198+40

Water Depth: 0.1', 0.2', 0.2'

Notes: The Rock Ditch Crossing (RDX) was exposed with runoff flowing through it.

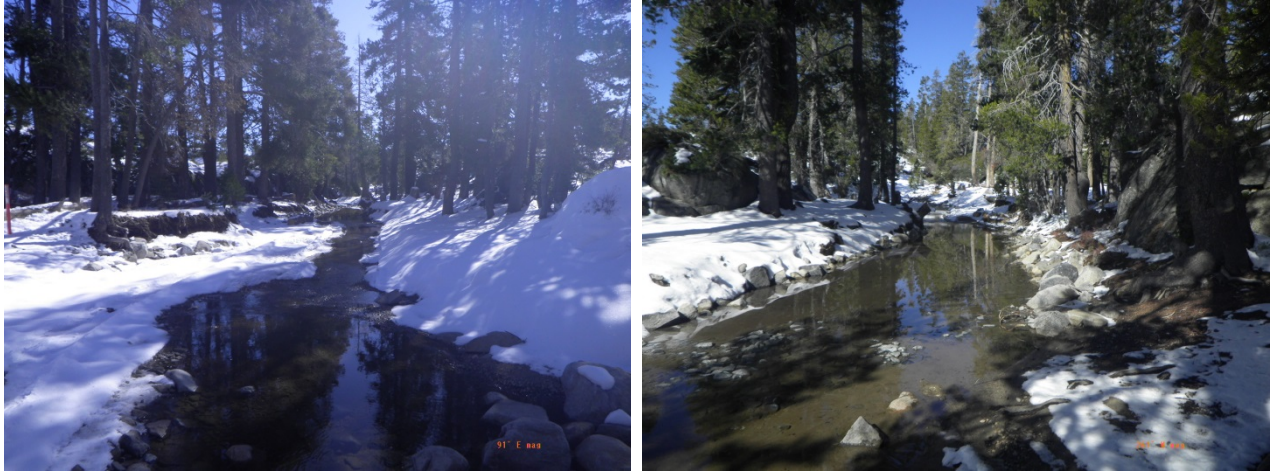
Winter Camp  
RT Station 209+58

Water Depth: 0.5', 0.5', 0.6'

The Rock Fill (RF) was exposed with runoff observed flowing over the RF. The measurements taken do not warrant a closure at this time.

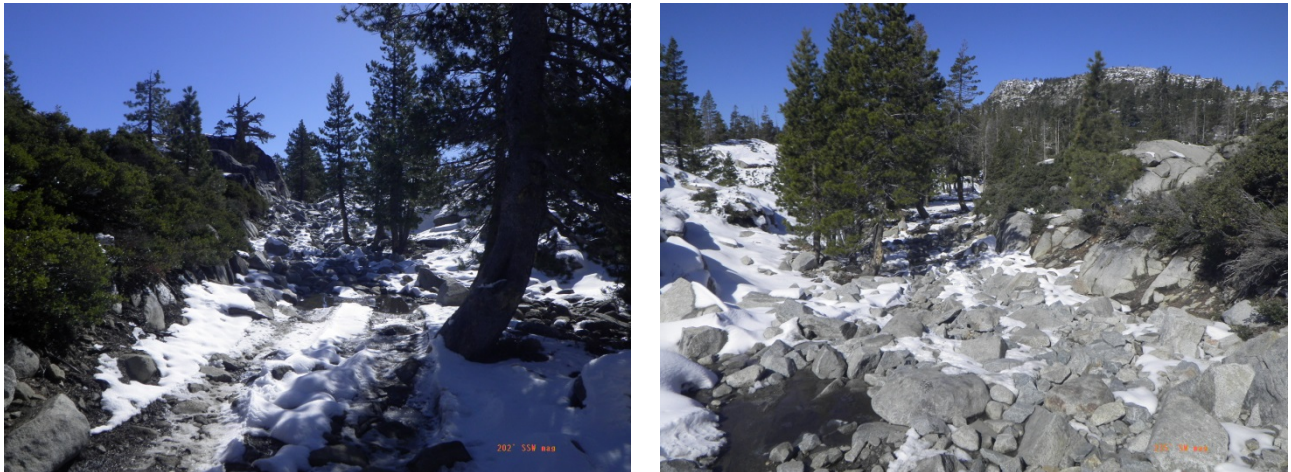
Little Sluice  
RT 213+50

Water Depth: 0.2', 0.2', 0.2'

The Rock Fill (RF) was covered with very minimal snow, with the runoff flowing over the RF that was exposed.
