Rubicon Trail Site Assessment

May 26, 2017

Rubicon Trail Site Assessment May 26, 2017

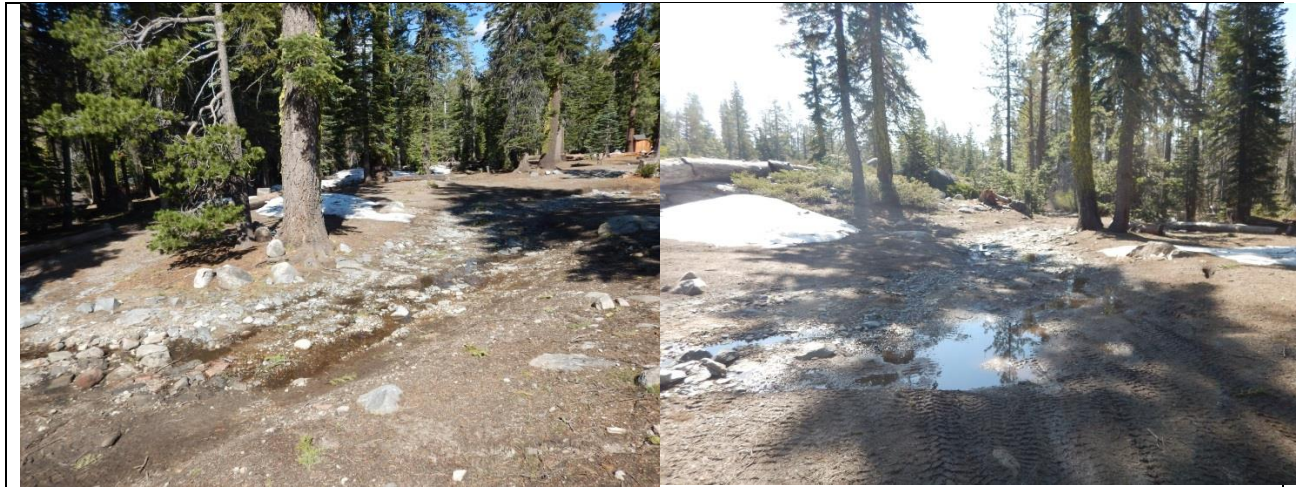
Wentworth Springs Campground
RT Station 33+65.67

Water Depths: 0.0, 0.0 0.0'
Length and Width Measured: 30'x6'

Notes: There was no water in this area and snow was minimal.

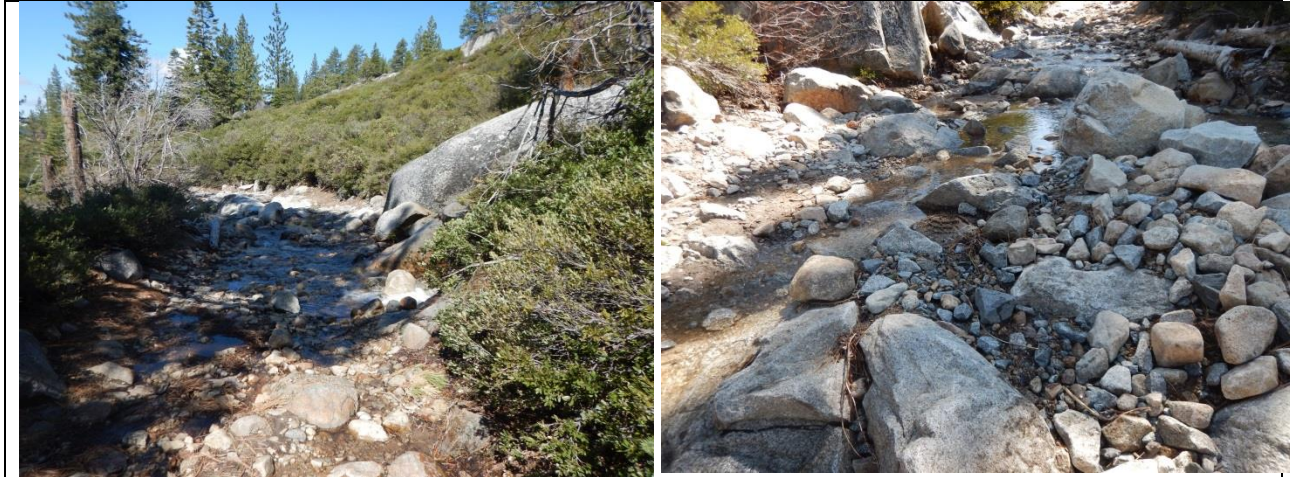
Post Pile
RT Station 75+00

Water Depths: 0.3', 0.3', 0.3'
Length and Width Measured: 30'x5'

Notes: The Rock Ditch Crossing (RDX) was observed and was functioning as designed. Snow melt run-off was observed flowing down the hardened surface of the Trail. Measurements were taken every 10' with no ponding water and areas were not connected.

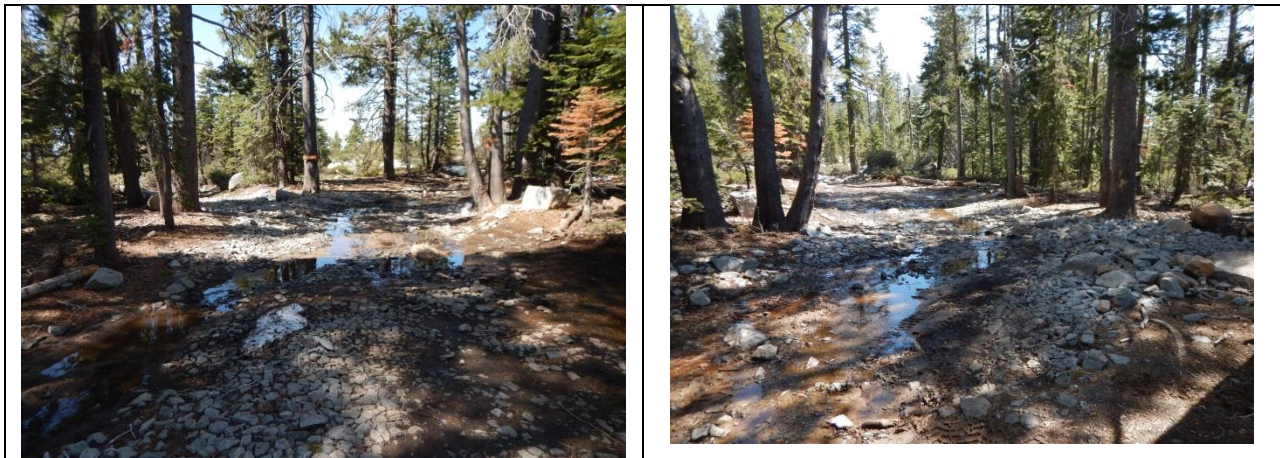
Ellis Creek Intertie
RT Station 99+86.95

Water Depths: 0.05', 0.1', 0.15'
Length and Width Measured: 30'x6'

Notes: The Rock Lined Channel (RLC) was rebuilt last year and functions as designed. The Rock Energy Dissipator (RED) was visible and with little water flowing through it.

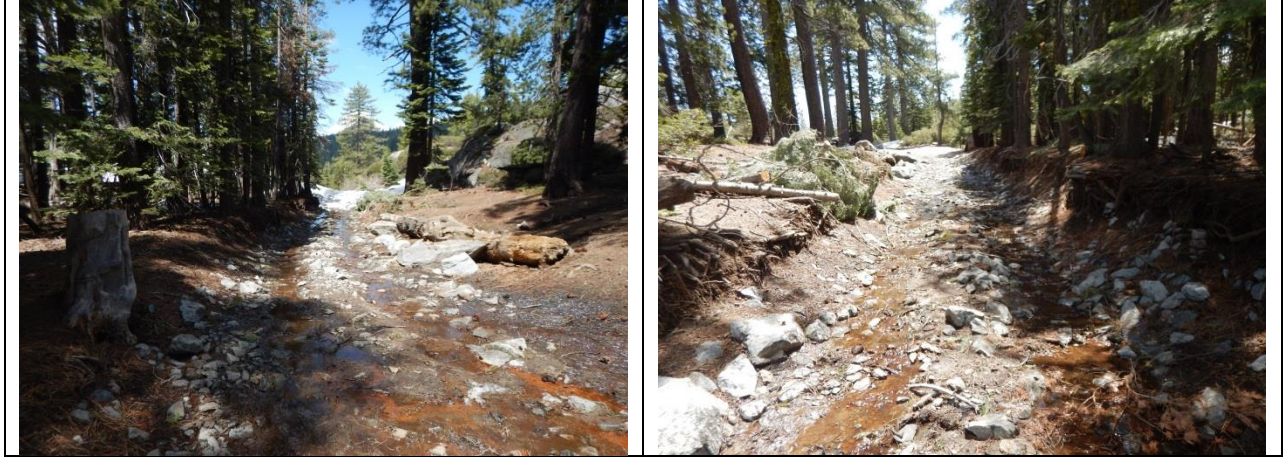
Walker Hill
RT Station 170+80

Water Depths: 0.05', 0.1', 0.05'
Length and Width Measured: 30'x6'

Notes: The Rock Slope Protection (RSP) was not fully exposed on one side of the Trail. There was snow melt run-off flowing down the hardened surface of the Trail, which discharges into a Rock Energy Dissipator. Snow observed on the Trail approaching Walker Hill.

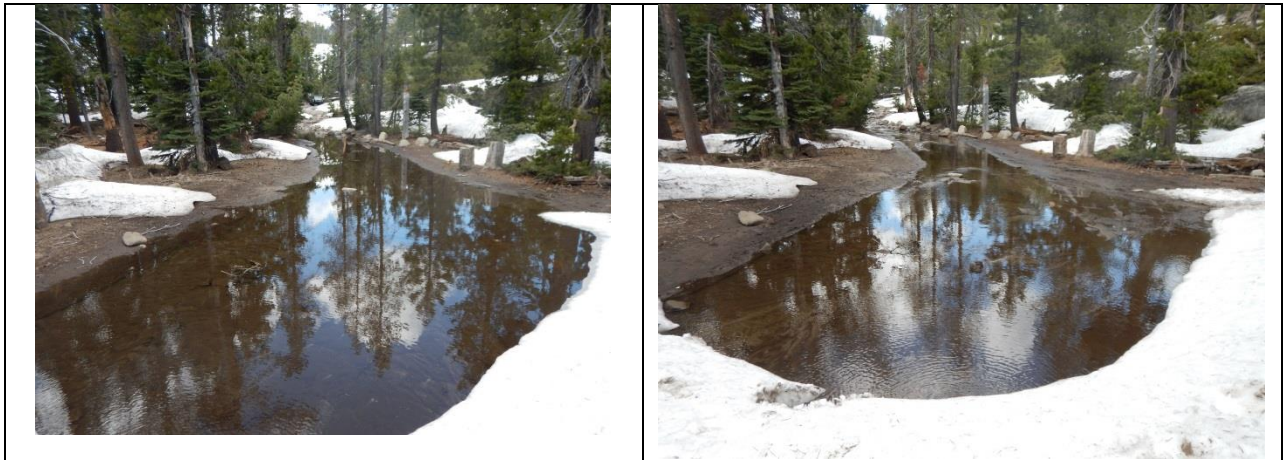
Soup Bowl
RT Station 198+40.84

Water Depth: 0.1', 0.2', 0.25'
Length and Width Measured: 30'x6'

Notes: The Rock Ditch Crossing (RDX) was blocked by two logs which prevented the area from draining. Prior to removing the blockage the measurements in this area were 0.2', 0.4, 0.3' (photo on left). After removal of blockage the area drained within 5 minutes to the water level measurements shown above (photo on right). The travel way is on the far right on this photo.

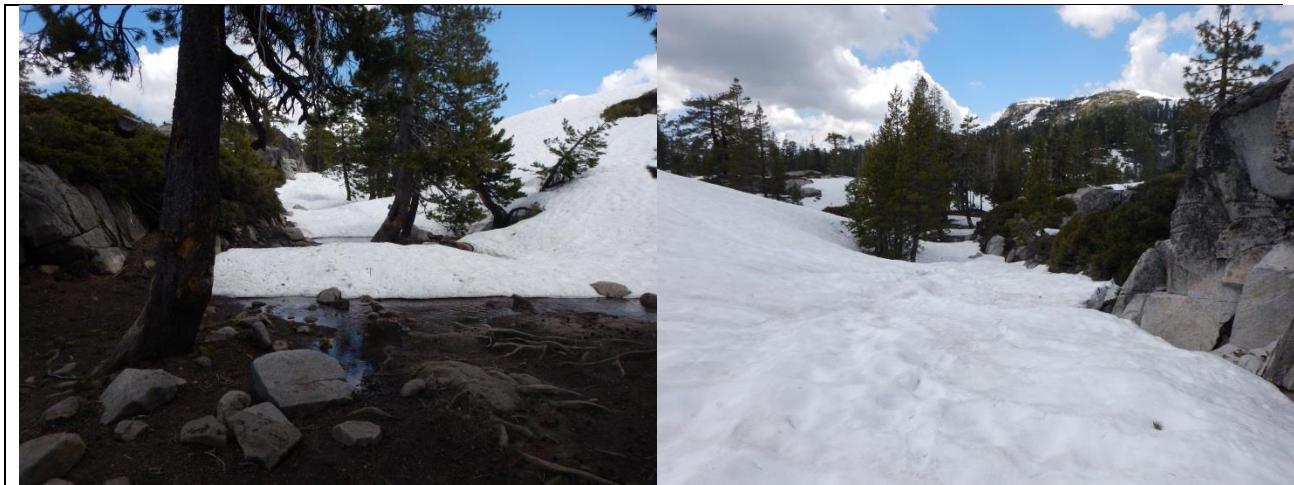
Little Sluice
RT 213+50.32

Water Depth: 0.15', 0.2', 0.3'
Length and Width Measured: 10'x6'

Large snowpack still exists in this area. The measurements taken were at a break in the snow.
