# Rubicon Trail Site Assessment May 20, 2017

## Photo Monitoring:

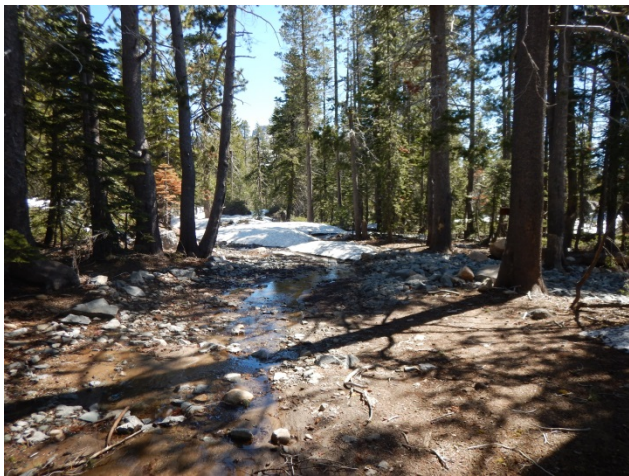
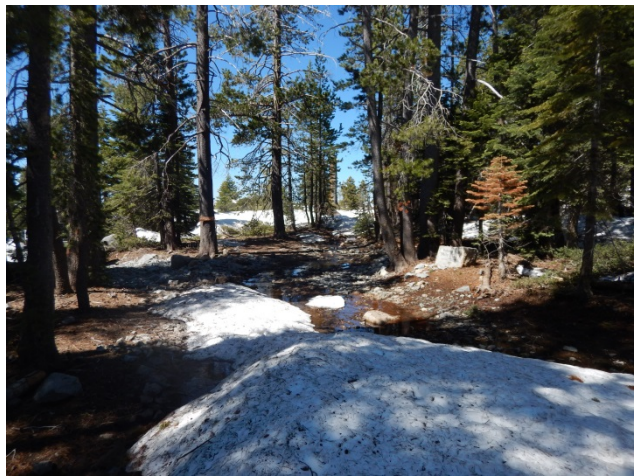
Ellis Creek Intertie  
RT Station 99+86

Water Depths: 0.1', 0.1', 0.25'  
Water Length and Width: 25'x4'

Notes: The water bar at the Intertie was functioning as designed. In November County staff determined that the water bar at this location needed to be rebuilt to better direct runoff to the Rock Energy Dissipater (RED), as opposed to flowing down the Intertie. With maintenance work to the water bar, the runoff was observed flowing across the hardened surface of the Trail to the RED and not down the Intertie. The BMP's were functioning as designed.

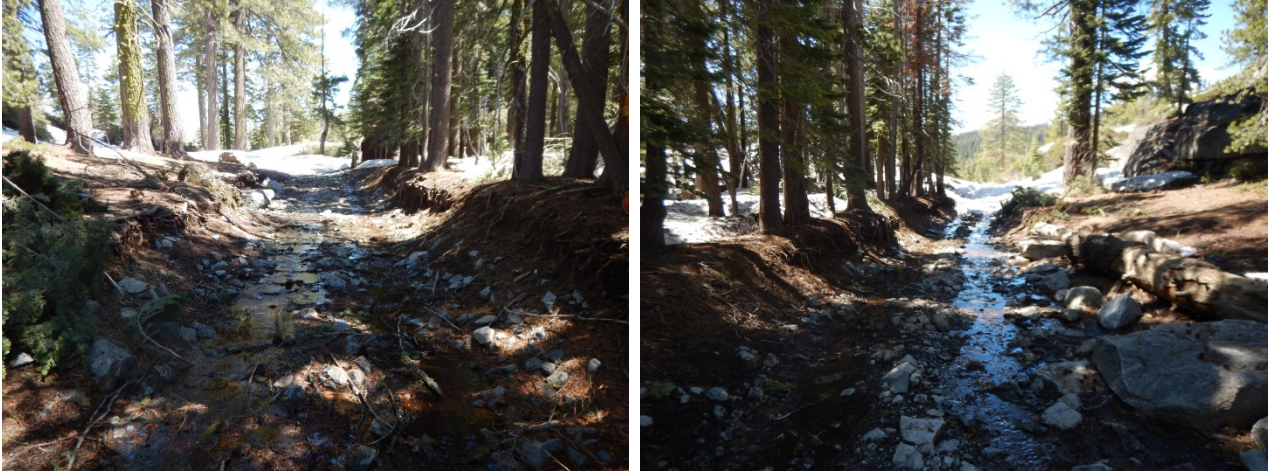
Walker Hill  
RT Station 170+80

Water Depths: 0.1', 0.1', 0.1'  
Water Length and Width: 50'x3'

Notes: Water was visible and was no deeper than 0.1' deep across the rock armored trail. The BMP's were functioning as designed.

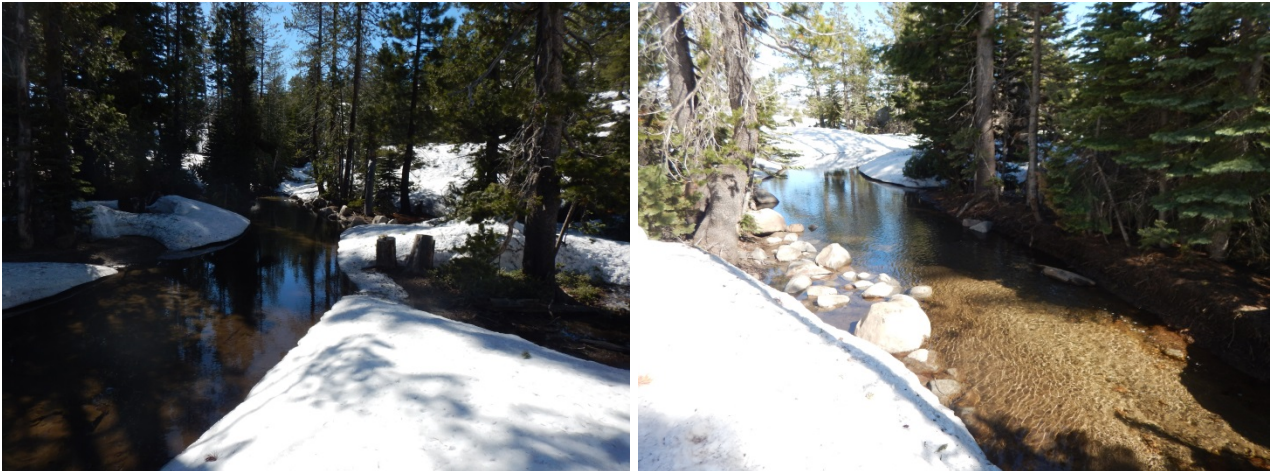
Soup Bowl  
RT Station 198+40

Water Depth: 0.9', 0.7', 0.9'  
Water Length and Width: 25'x20'

Notes: The depth measurements listed above were taken approximately 10' apart. The Rock Ditch Crossing (RDX) was covered in snow causing a snow dam preventing this area from draining. Based on the depths measured, Conditions 1, 2 and 3 of the Protocol for closure of the Rubicon Trail have been met.

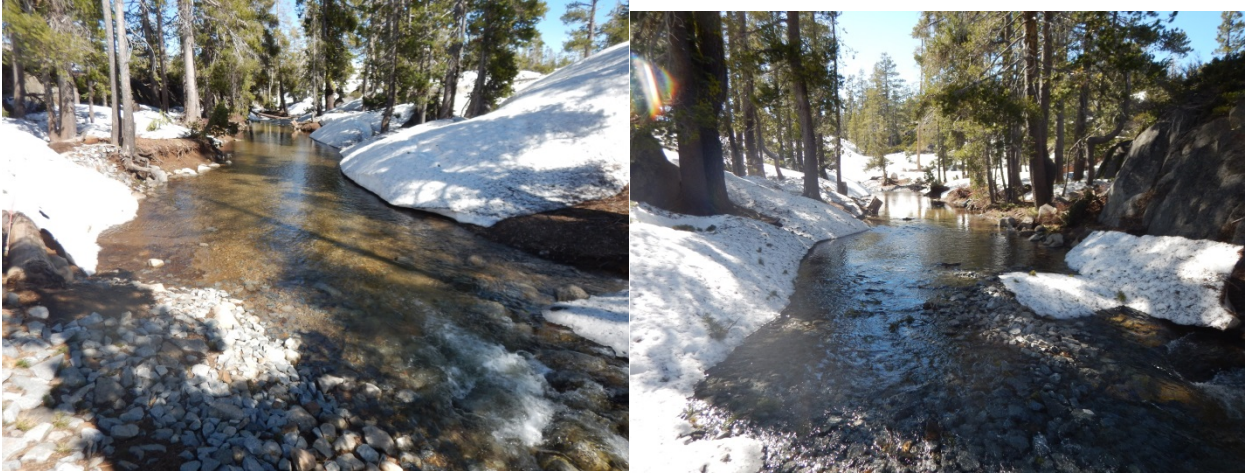
Winter Camp  
RT Station 209+58

Water Depth: 0.8', 0.6', 0.8'  
Water Length and Width: 30' x 15'

Notes: The depth measurements listed above were taken approximately 10' apart. In May of 2016 the BMP, Rock Fill (RF) with an underlying of chain link fencing was added to armor this area. In November a Rock-Lined Channel (RLC) was added to help with drainage outside of the travel way. All BMP's were functioning as designed.

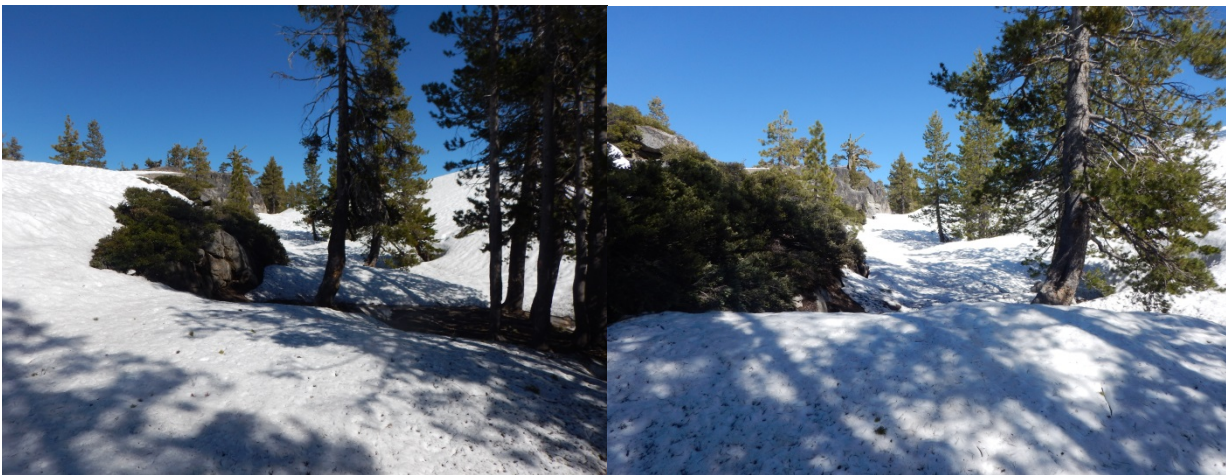
Little Sluice  
RT Station 213+50

Water Depth: 0.6', 0.35', 0.2'  
Water Length and Width: 10'x3'

Notes: The Rock Fill (RF) was covered with 3-8 feet of snow, with minimal areas exposed. The depth measurements shown were taken at one exposed area.
