Clear Creek Road (PM 1.82 & 0.25) Bridge Replacement Projects

Public Meeting, Wednesday, November 20, 2013

County of El Dorado Community Development Agency Transportation Division

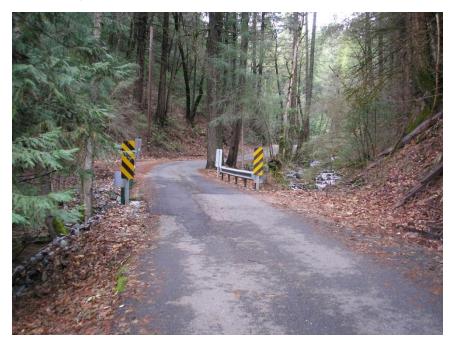
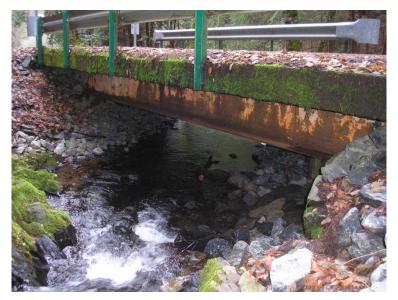
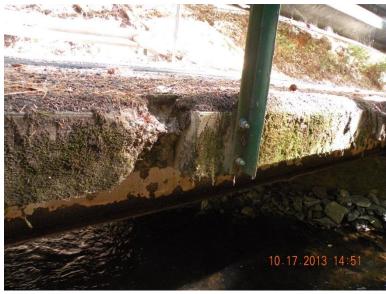
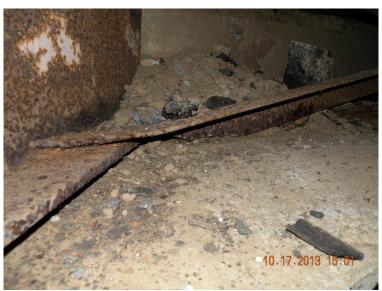
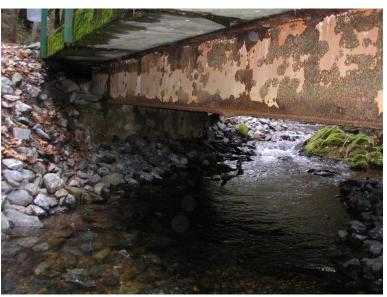
Clear Creek Rd PM 1.82 Bridge Photos 6/30/13

- Year Built: 1940 (73 years old), Expected life: 75 years
- One-lane,14-ft wide x 27-ft long
- Reinforced concrete slab deck on steel girders
- Avg. Daily Traffic: Approx. 150 (both directions, 2010 traffic count)
- Sufficiency Rating: 33.5 (2011 Inspection)
- Structurally Deficient
- Fracture Critical and Scour Critical
- 2011 inspection states:

scour on foundation, spalls on deck panel, broken welds connecting cross bracing and steel girders, rust and corrosion on steel girder, damaged bottom flange of left girder near mid span.

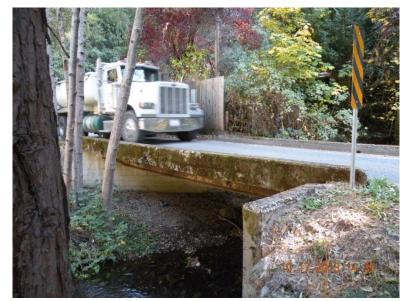
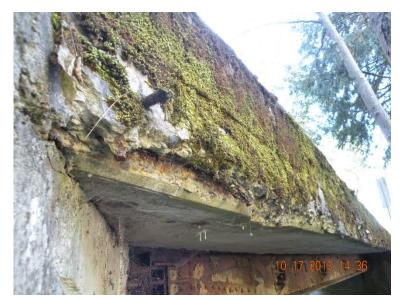
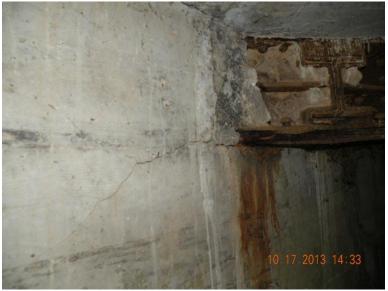
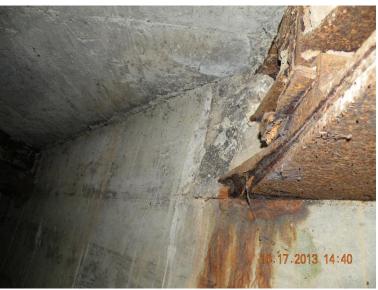
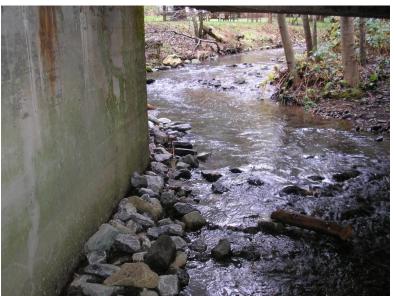
Clear Creek Rd PM 0.25 Bridge Photos 6/30/13

- Year Built: **1957** (56 years old), Expected life: 75 years
- One-lane, 10-ft wide x 34-ft long
- Reinforced concrete slab deck on steel stringers (R/R Car Frame)
- Avg. Daily Traffic: Approx. 450 (both directions, 2010 traffic count)
- Sufficiency Rating: 18.6 (2011 Inspection)
- Structurally Deficient
- Fracture Critical and Scour Critical
- 2011 inspection states:

concrete spall at edge of bridge deck and exposed rebar, diagonal crack on abutments, heavy rust on steel girders, minor section loss from pack rust at abutment, no railing on the structure,

8-inch high concrete curb, extensive scour.
