# Mt. Murphy Road Bridge Alternatives Analysis Project

Presented to Public Meeting January 28, 2015

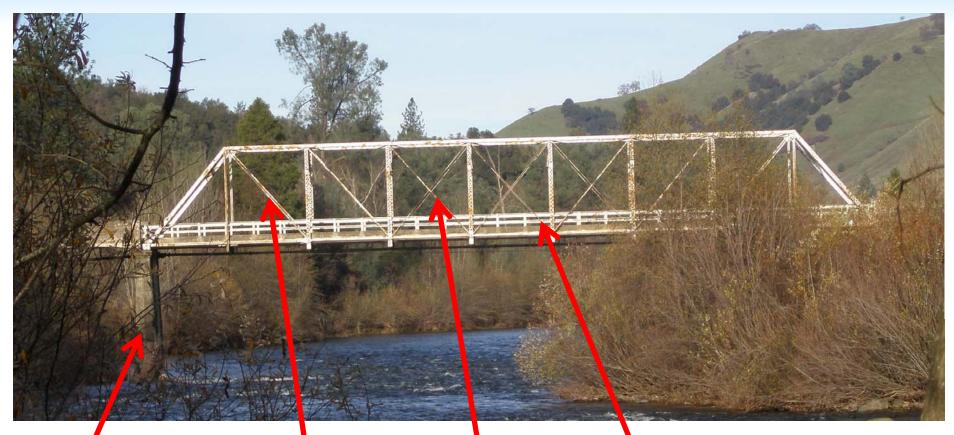
#### Mt Murphy Road Bridge – Structurally Deficient

Pier foundations are scour critical and lightly reinforced (seismic)

Eye-bar members are fracture critical and have cracks started Most truss members require strengthening or replacement Stringers and floor beams overstressed for permitted load

- Rehabilitation Analysis Completed in January 2014
- Key findings:
  - Functionally Obsolete
    - Substandard Geometry
      - Width, height, barriers
  - Structural Deficiency
    - Bridge does not meet structural condition ratings

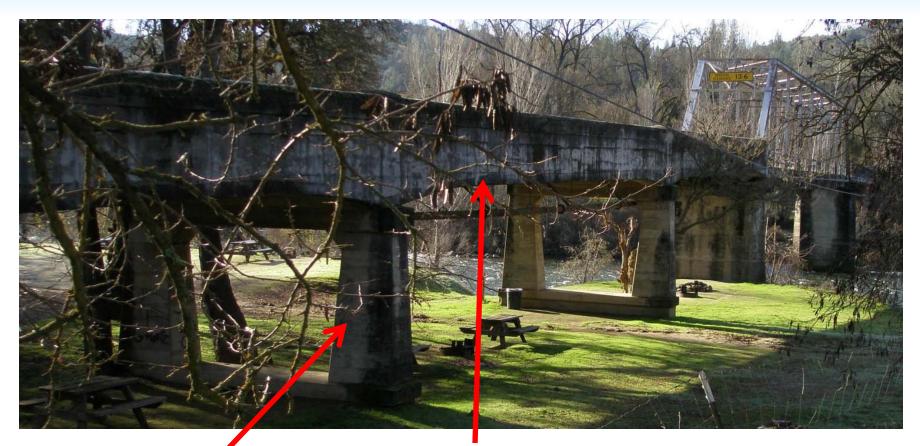
#### Mt Murphy Road Bridge - Structurally Deficient

Lightly reinforced columns

Some exposed rebar, low concrete cover. Large stone aggregate. Locations with visible hay, pine needles (and a hack saw blade) embedded in the concrete.

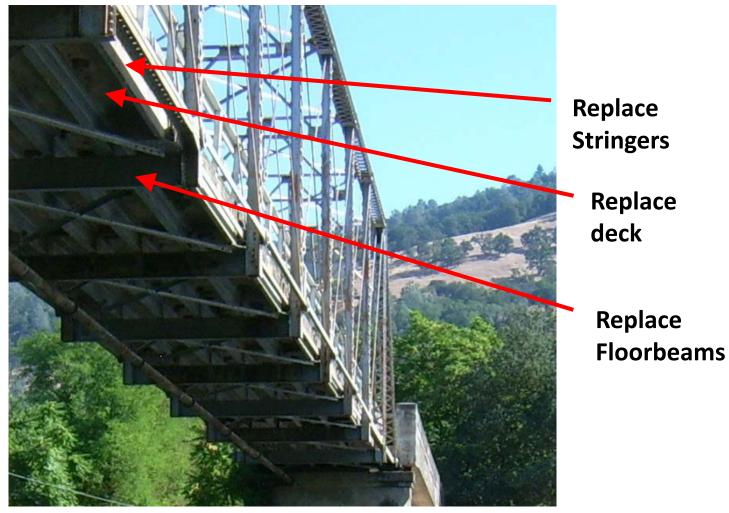
#### **Structure Status**

#### •Retrofit Needs
