COUNTRY CLUB HEIGHTS EROSION CONTROL PROJECT
Phase III
CIP No. 95191

Feasibility Report

County of El Dorado
Community Development Services
Department of Transportation

June 2019

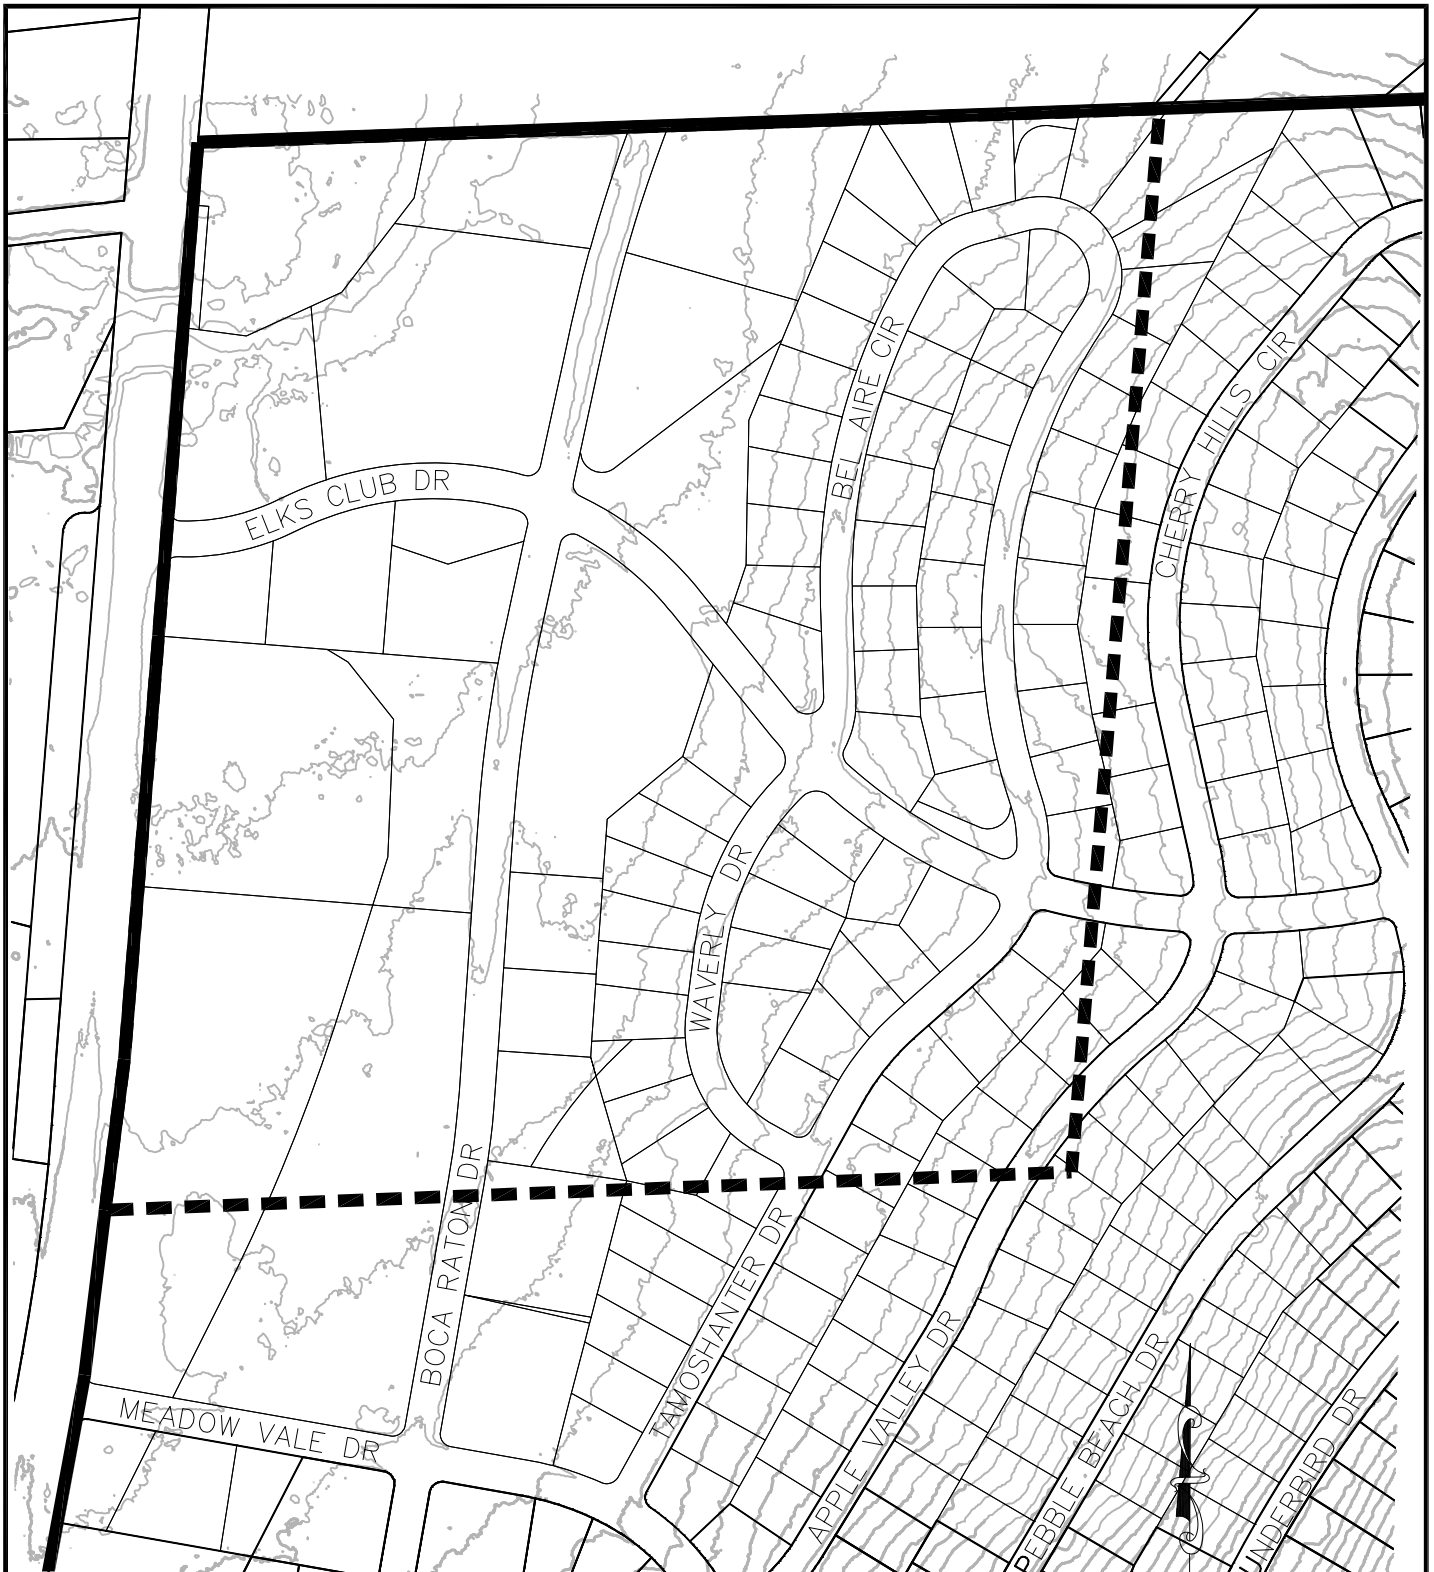
FIGURE

The Project is located on the Echo Lake USGS 7.5-minute quadrangle map. In general, the topography of the Project area is relatively flat/level with an average slope of approximately 5 percent, rising to east (Figures 2 and 3).

TOPOGRAPHIC MAP

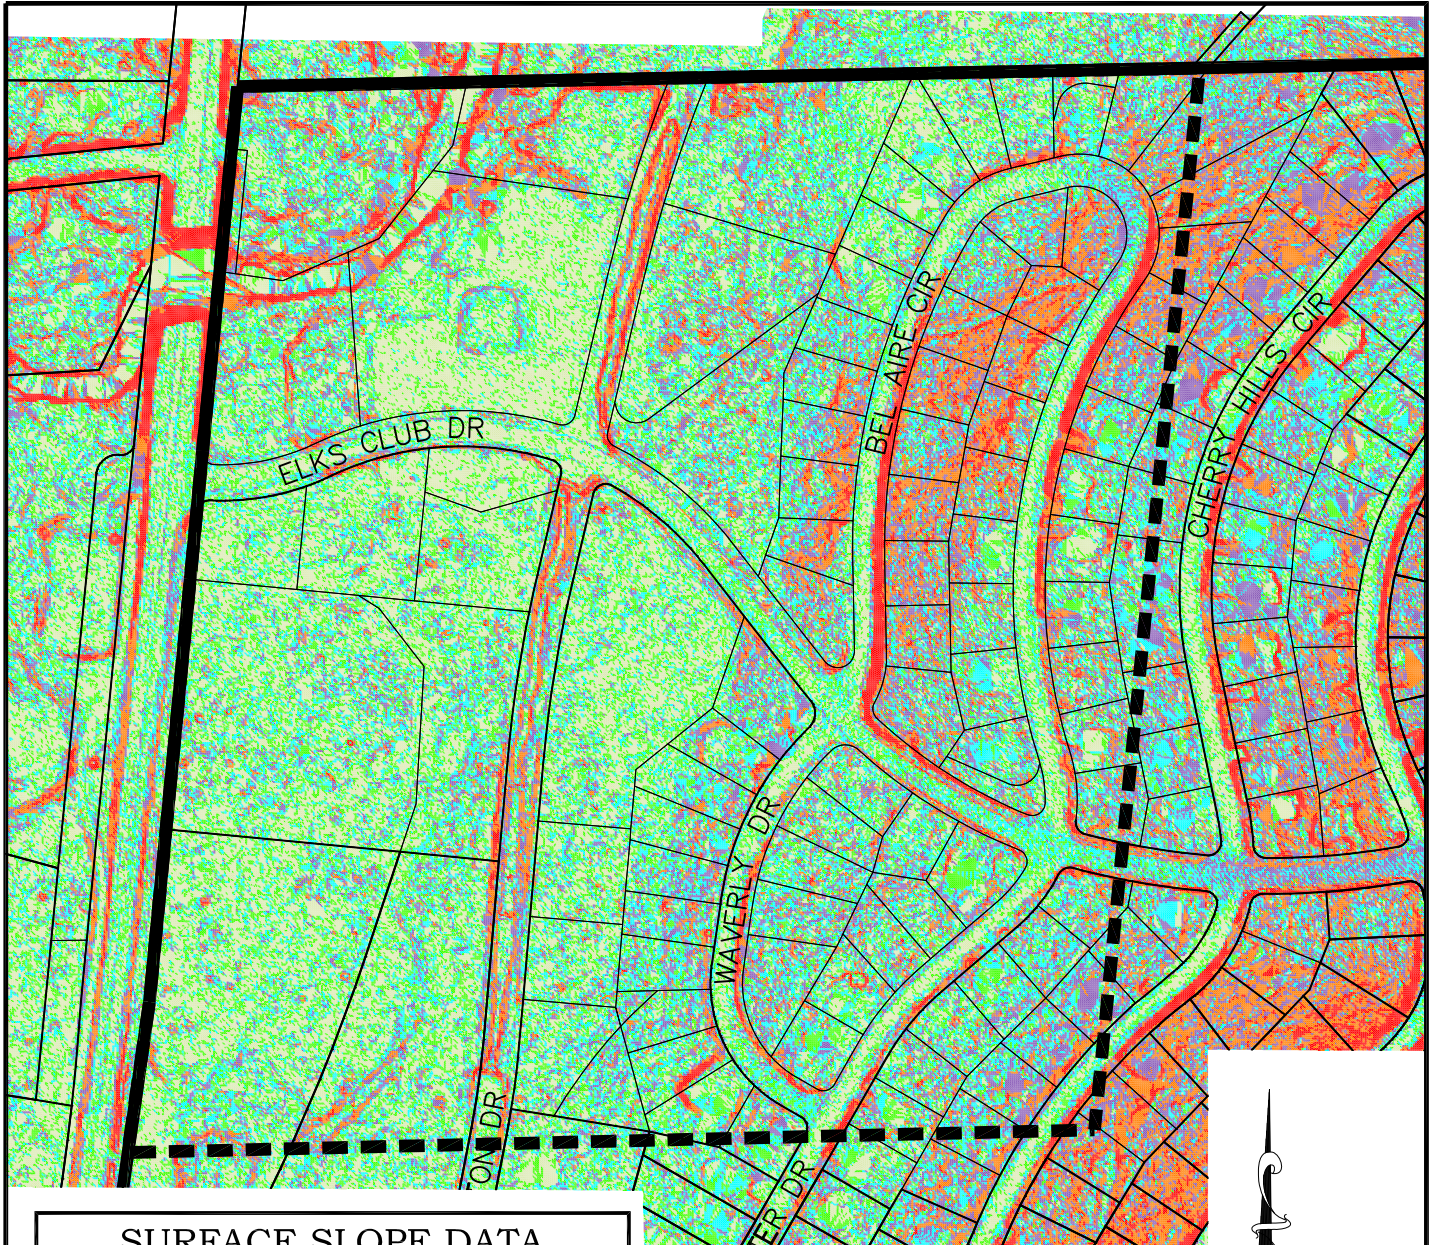
FIGURE
3

SURFACE SLOPE DATA

MINIMUM SLOPE	MAXIMUM SLOPE	COLOR
0%	3%	Light Green
3%	6%	Bright Green
6%	9%	Cyan
9%	14%	Purple
14%	23%	Orange
23%	≥60%	Red

COUNTRY CLUB HEIGHTS
 EROSION CONTROL PROJECT - PHASE III
 SLOPE MAP

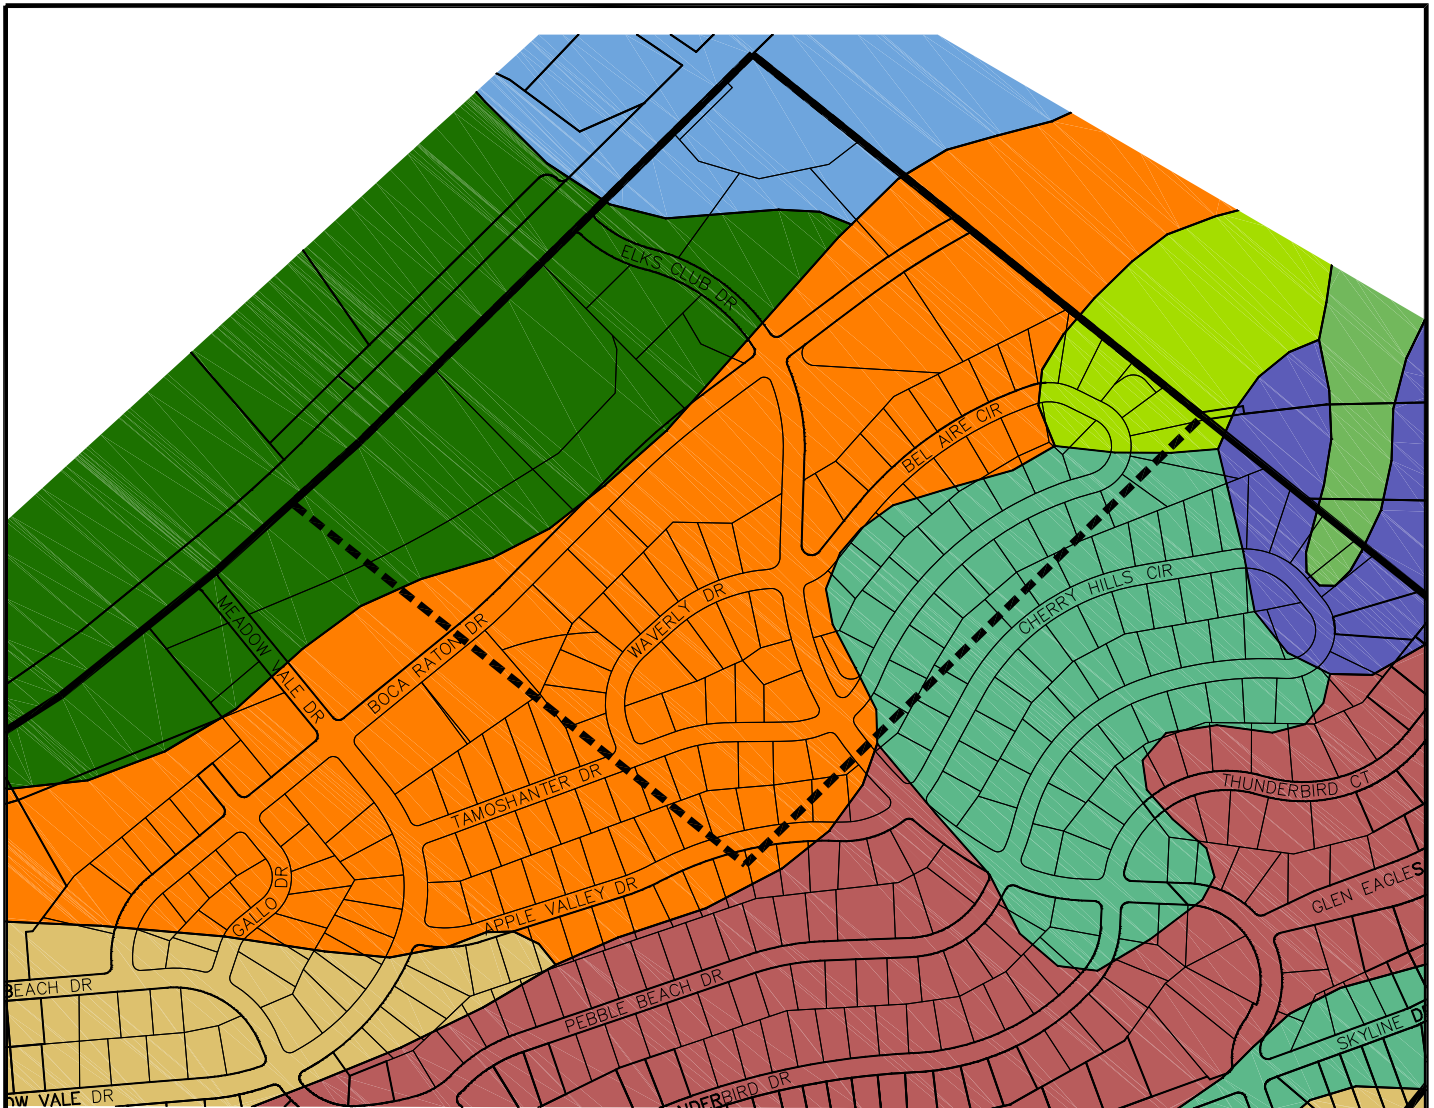
FIGURE

The 2007 National Resource Conservation Service (NRCS) soil survey data for the El Dorado County Tahoe Basin Area¹⁰ indicates the primary soils units within the Project area as described below and shown in Figure 4:

- Celio series, 0 to 5 percent slopes (7431). This complex is typically found in the southern part of the Basin. The parental material consists of alluvium and/or outwash. The soil is somewhat poorly drained. Shrink-swell potential is low and the soil is rarely flooded. Surface runoff is high. The hydrologic soil group is A/D.

- Christopher series, 0 to 9 percent slopes (7441). This series consists of very deep, somewhat excessively drained soils that formed in glacial outwash derived from granodiorite. These soils are on glacial outwash terraces in the Lake Tahoe Basin.

- Gefo series, 2 to 9 percent slopes (7451). This series consists of very deep, somewhat excessively drained soils that formed in glacial outwash derived mainly from granitic rocks. These soils are on outwash terraces and alluvial fans.

- Jabu series, 0 to 9 percent slopes (7461). This series consists of very deep, well drained soils that formed in outwash and alluvium derived from granitic rocks. These soils are on glacial outwash terraces and moraines.

**COUNTRY CLUB HEIGHTS
EROSION CONTROL PROJECT - PHASE III
SOILS MAP**

NRCS Series	Hydrologic Group	Erosion Hazard	% of Area
7431	A/D	slight	26.1
7441	A	slight	11.5
7451	A	slight	3.7
7461	A	slight	51.6
7471	A/D	slight	7.2
