P20-0001 SUNSHINE RANCH PARCEL MAP
EXHIBIT A - LOCATION MAP

TENTATIVE PARCEL MAP SUNSHINE RANCH

**P20-0001 SUNSHINE RANCH PARCEL MAP
EXHIBIT N - ARBORIST REPORT**

**P20-0001 SUNSHINE RANCH PARCEL MAP
EXHIBIT O - GEOTECHNICAL ENGINEERING STUDY**

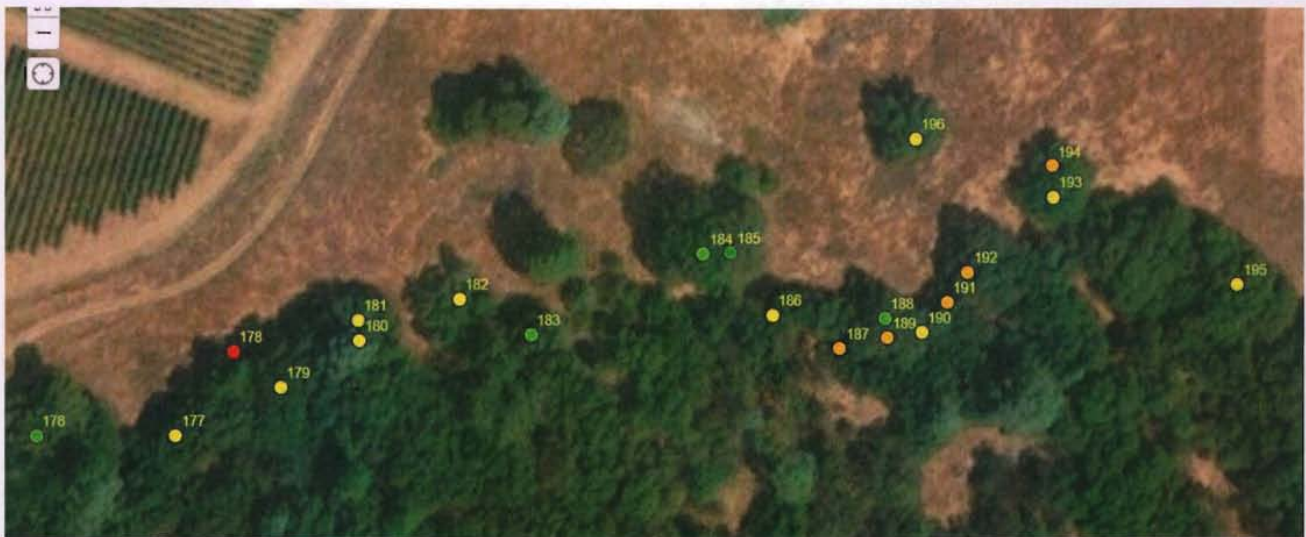
Aerial image enlarged with tree numbers in approximate locations; 5 individual trees in lower left along road

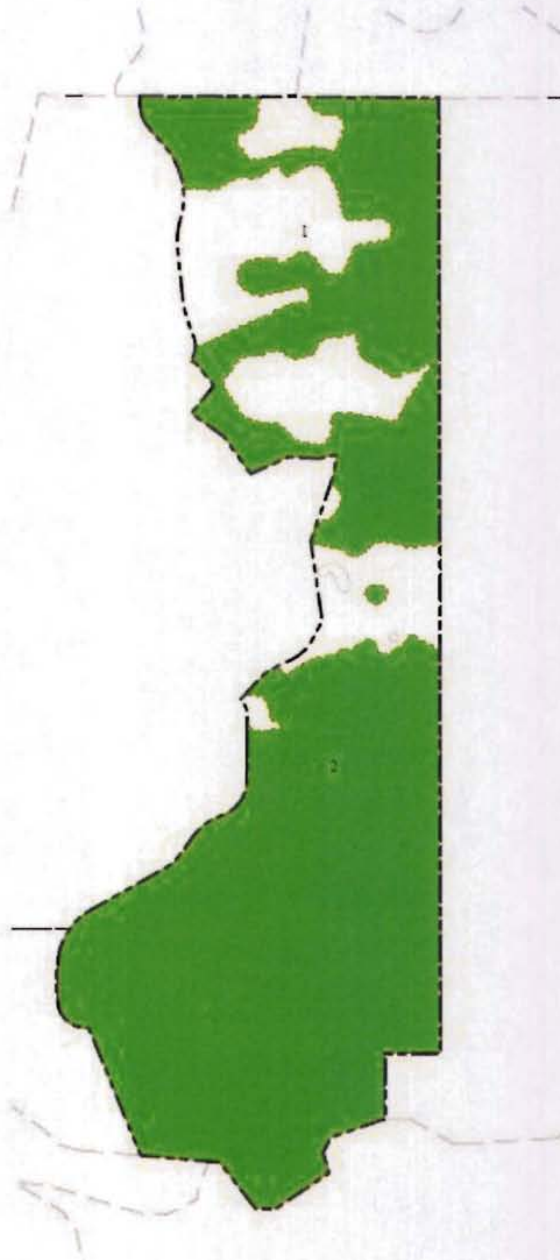
Tree Preservation Plan showing the oak woodland canopy on the property

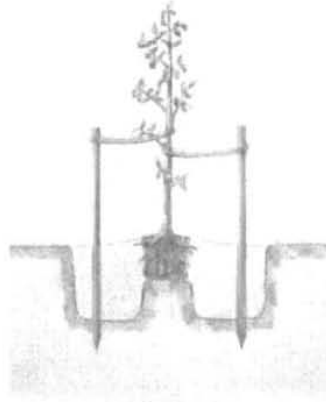
Detail for #1, #5 and #15 container planting stock

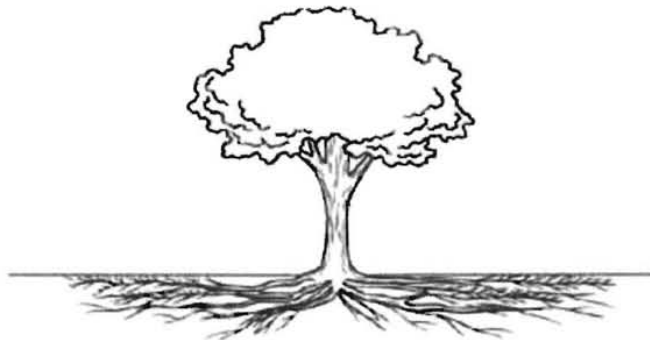
The roots of a tree extend far from the trunk and are found mostly in the upper 6 to 12 inches of soil.

Cutting of Roots. The digging and trenching that are necessary to construct a house and install underground utilities will likely sever a portion of the roots of many trees in the area. It is easy to appreciate the potential for damage if you understand where roots grow. The roots of a tree are found mostly in the upper 6 to 24 inches of the soil. In a mature tree, the roots extend far from the trunk. In fact, roots typically are found growing a distance of one to three times the height of the tree. The amount of damage a tree can suffer from root loss depends, in part, on how close to the tree the cut is made. Severing one major root can cause the loss of 5 to 20 percent of the root system.

Another problem that may result from root loss caused by digging and trenching is that the potential for the trees to fall over is increased. The roots play a critical role in anchoring a tree. If the major support roots are cut on one side of a tree, the tree may fall or blow over.

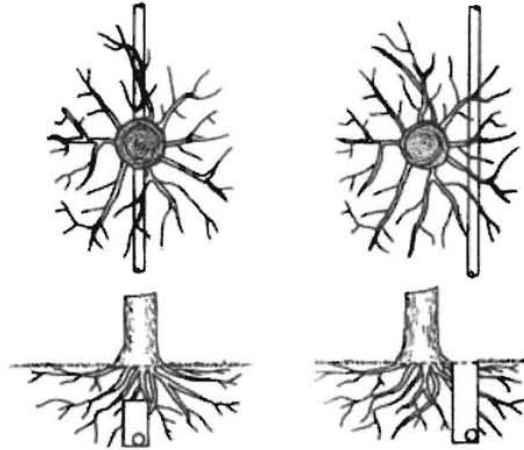
Less damage is done to tree roots if utilities are tunneled under a tree (right, top and bottom) rather than across the roots (left, top and bottom).

Less damage is done to tree roots if utilities are tunneled under a tree rather than across the roots.

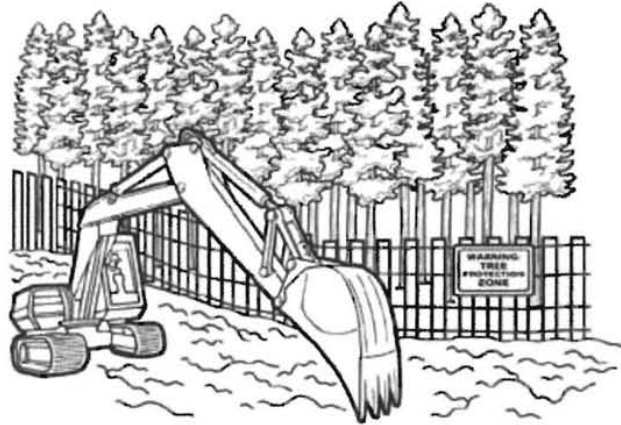
Protective fences should be erected as far out from the trunks as possible in order to protect the root systems.

Specify storage areas for equipment, soil, and construction materials. Limit areas for burning (if permitted), cement wash-out pits, and construction work zones. These areas should be away from protected trees.

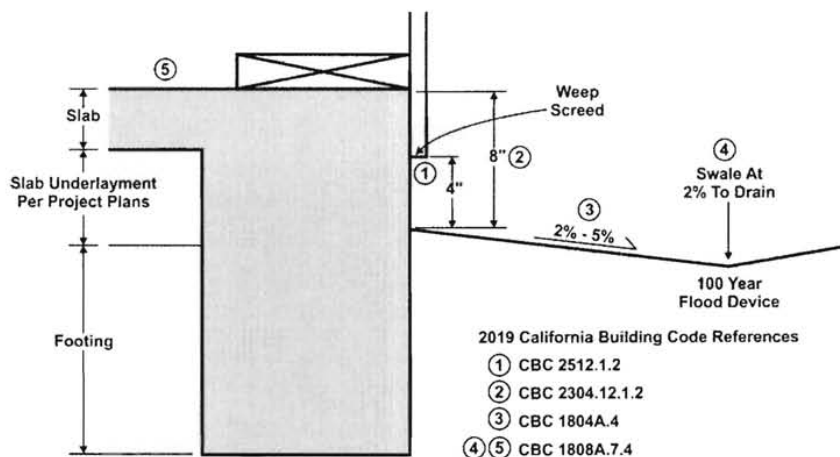
**Typical 2019 California Building Code
Drainage Requirements**

1804.4). Downspouts should be tight piped via an area drain network and discharged to an appropriate non-erosive outlet away from all foundations.

The above referenced elements pertaining to drainage of the proposed structures is provided as general acknowledgement of the California Building Code requirements, restated and graphically illustrated for ease of understanding. Surface drainage design is the purview of the Project

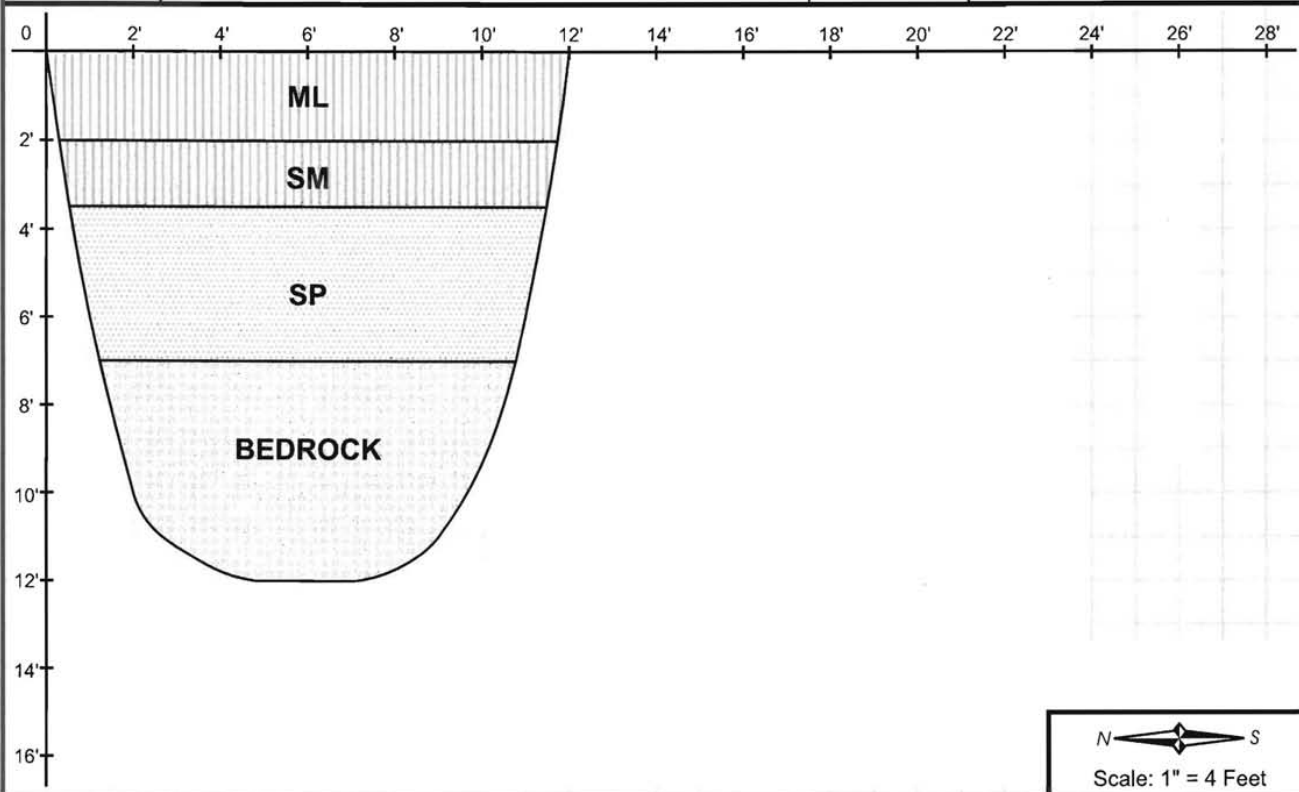
GEOTECHNICAL • ENVIRONMENTAL • MATERIALS TESTING	Project No.: E19418.000	EXPLORATORY TEST PIT LOG Sunshine Ranch Mt. Aukum, California	FIGURE A-3
	January 2020

Logged By: MRG	Date: 17 December 2019	Lat / Lon: N 38.56089° / W 120.76692°	Pit No. TP-1
Equipment: John Deere 410L with 18" Bucket	Pit Orientation: N - S	Elevation: ~

Depth (Feet)	Geotechnical Description & Unified Soil Classification	Sample	Tests & Comments
@ 0' - 2'	Brown sandy SILT (ML) with trace clay, soft, wet	TP-1 @ 2-3'	PP @ 1' = 1.25 tsf PP @ 3' = 3.5 tsf PP @ 4' = 4.5+ tsf
@ 2' - 3.5'	Red brown silty SAND (SM) , medium dense, moist	TP-1 @ 2'	
@ 3.5' - 7'	Yellow brown SAND (SP) with silt, medium dense, slightly moist	TP-1 @ 3.5'	
@ 7' - 9'	Yellow brown BEDROCK (DG) , completely weathered, slightly moist		
@ 9' - 12'	<i>Grades highly weathered</i>		
	Test pit terminated at 12' No free groundwater encountered No caving noted

Note: The test pit log indicates subsurface conditions only at the specific location and time noted. Subsurface conditions, including groundwater levels, at other locations of the subject site may differ significantly from conditions which, in the opinion of Youngdahl Consulting Group, Inc., exist at the sampling locations. Note, too, that the passage of time may affect conditions at the sampling locations.

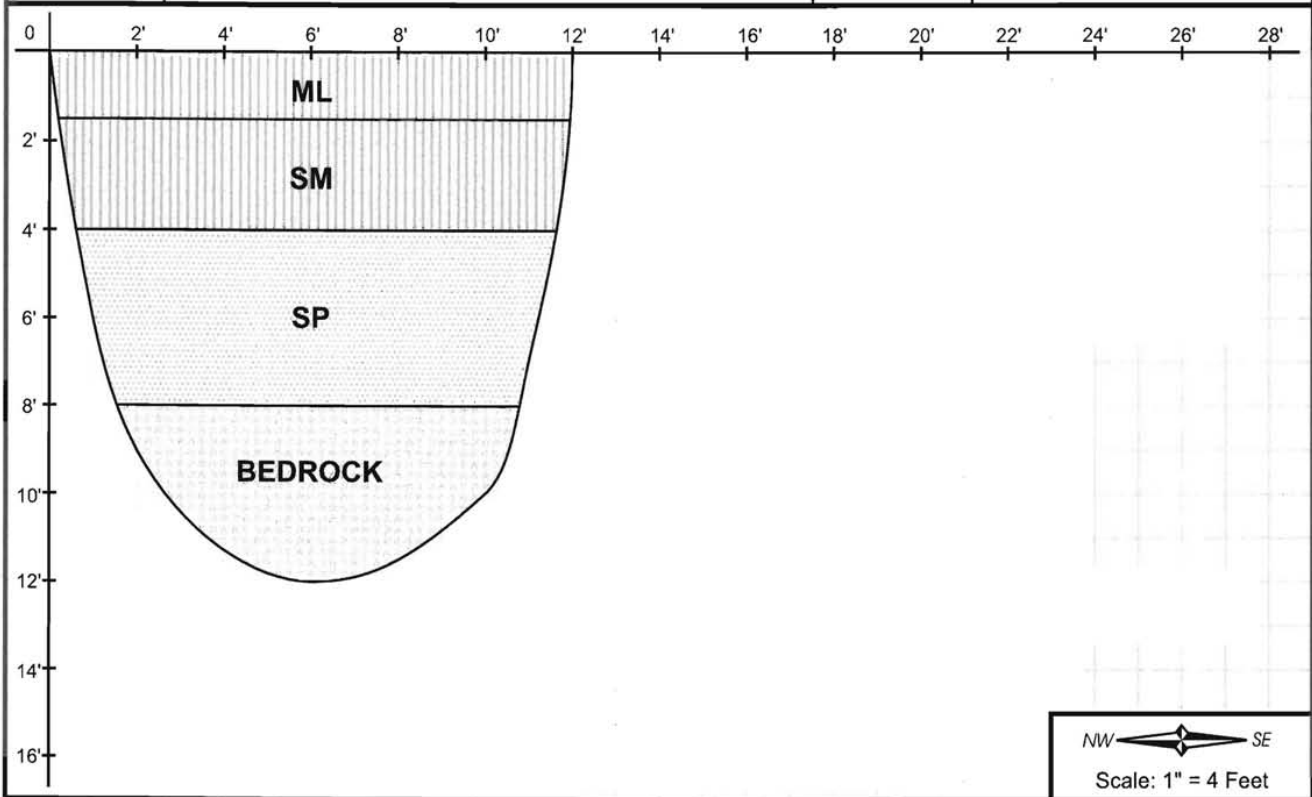
TP-2 @ 7'	
@ 8' - 10'	Yellow brown BEDROCK (DG) , completely weathered, slightly moist		
@ 10' - 12'	<i>Grades highly weathered</i>		
	Test pit terminated at 12' No free groundwater encountered No caving noted

Note: The test pit log indicates subsurface conditions only at the specific location and time noted. Subsurface conditions, including groundwater levels, at other locations of the subject site may differ significantly from conditions which, in the opinion of Youngdahl Consulting Group, Inc., exist at the sampling locations. Note, too, that the passage of time may affect conditions at the sampling locations.

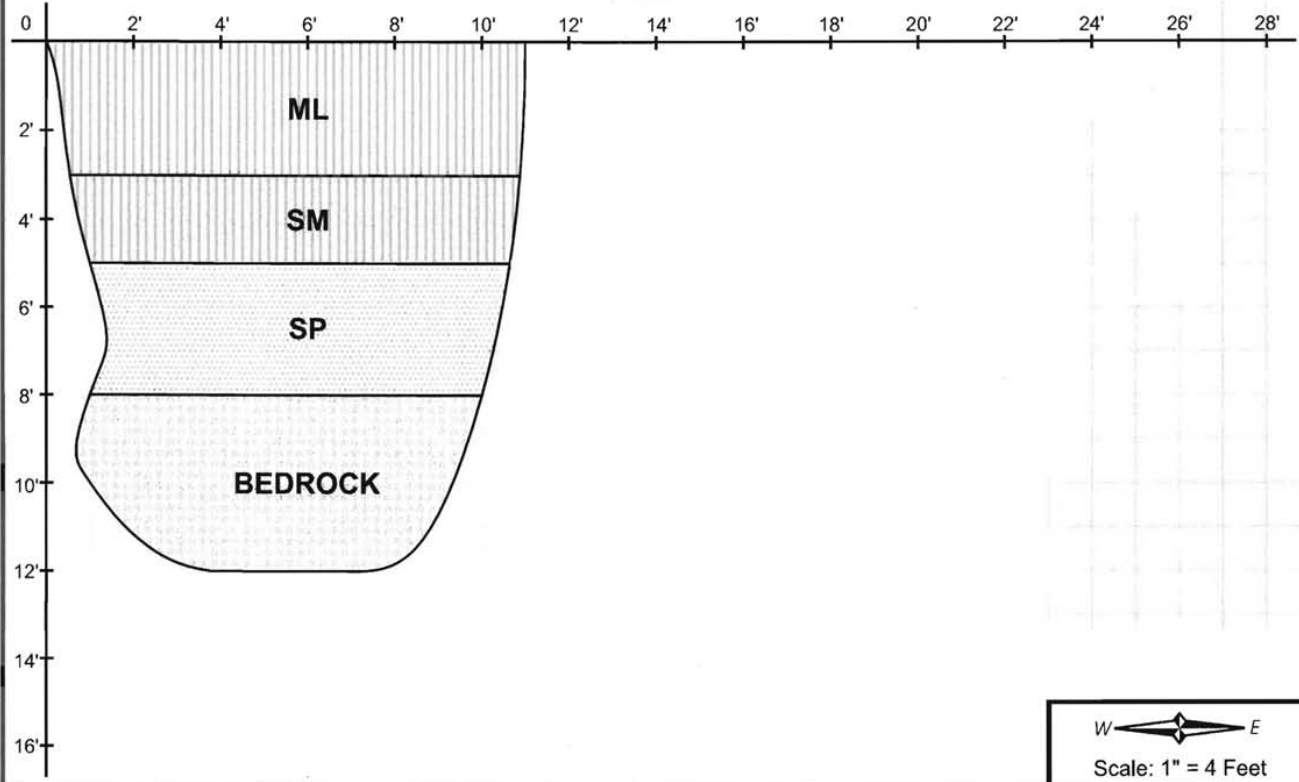
GEOTECHNICAL • ENVIRONMENTAL • MATERIALS TESTING	Project No.: E19418.000	EXPLORATORY TEST PIT LOG Sunshine Ranch Mt. Aukum, California	FIGURE A-5
	January 2020

Logged By: MRG	Date: 17 December 2019	Lat / Lon: N 38.56117° / W 120.76722°	Pit No. TP-3
Equipment: John Deere 410L with 18" Bucket	Pit Orientation: W - E	Elevation: ~	
Depth (Feet)	Geotechnical Description & Unified Soil Classification	Sample	Tests & Comments
@ 0' - 1.5'	Brown sandy SILT (ML) with trace clay, soft, moist		<i>PP @ 1' = 0.5 tsf</i> <i>PP @ 3' = 3.5 tsf</i> <i>PP @ 5' = 4.5+ tsf</i>
@ 1.5' - 4'	Red brown silty SAND (SM) , medium dense, moist		
@ 4' - 8'	Yellow brown SAND (SP) with silt, dense, slightly moist		
@ 7' - 8'	<i>Grades without silt</i>		
@ 8' - 10'	Yellow brown BEDROCK (DG) , completely weathered, slightly moist		
@ 10' - 12'	<i>Grades highly weathered</i>		
	Test pit terminated at 12' No free groundwater encountered No caving noted

Note: The test pit log indicates subsurface conditions only at the specific location and time noted. Subsurface conditions, including groundwater levels, at other locations of the subject site may differ significantly from conditions which, in the opinion of Youngdahl Consulting Group, Inc., exist at the sampling locations. Note, too, that the passage of time may affect conditions at the sampling locations.

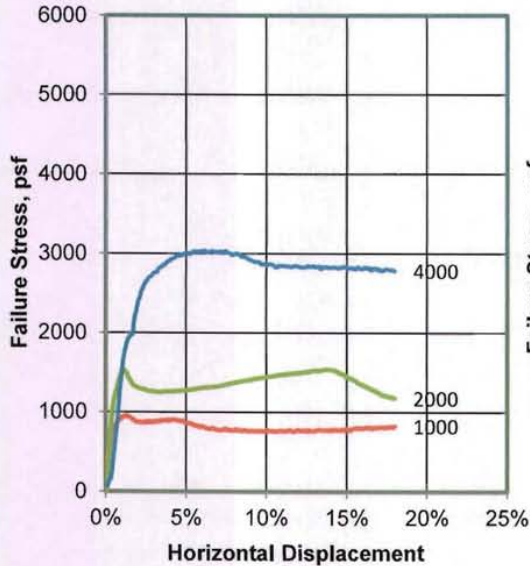
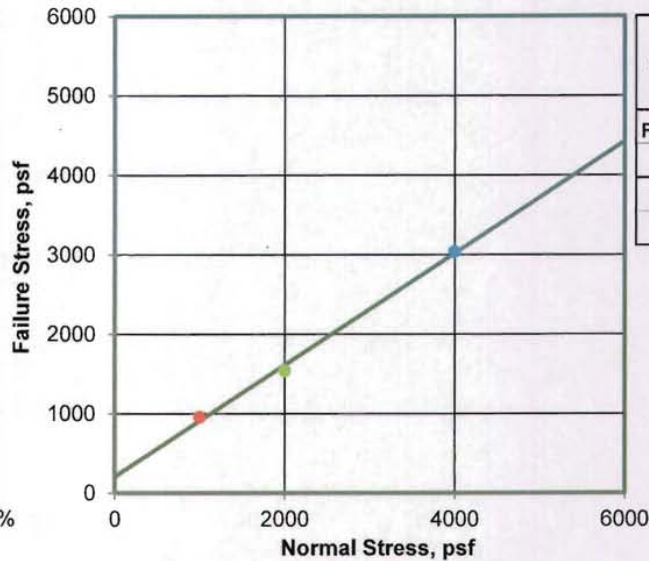
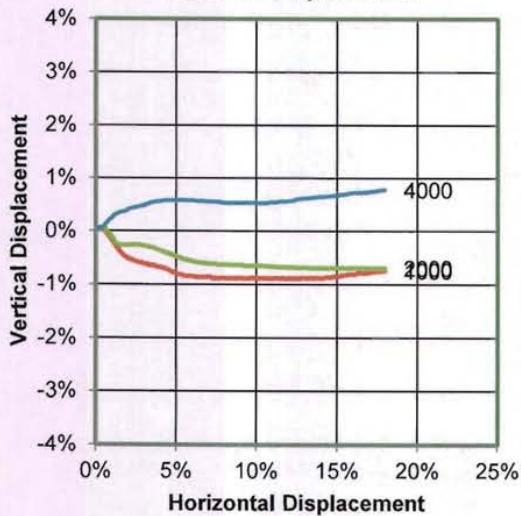
Direct Shear Test of Soils Under Consolidated Drained Conditions, ASTM D3080

Direct Shearbox Results	
Friction Angle	35.1°
Cohesion	206 psf

Test No.	1	2	3	
Initial	Wet Density, pcf	126.5	126.5	126.5
	Dry Density, pcf	114.6	114.6	114.6
	Moisture Content, %	10.4	10.4	10.4
	Diameter, in	2.50	2.50	2.50
	Height, in	1.00	1.00	1.00
Pre Shear	Wet Density, pcf	137.7	140.6	134.9
	Dry Density, pcf	116.0	116.4	114.6
	Moisture Content, %*	18.7	20.8	17.7
	Diameter, in	2.50	2.50	2.50
	Height, in	0.99	0.98	1.00
Normal Stress, psf	1000	2000	4000	
Failure Stress, psf	955	1540	3039	
Failure Strain, %	1.30	13.75	6.06	
Rate, in/min	0.002

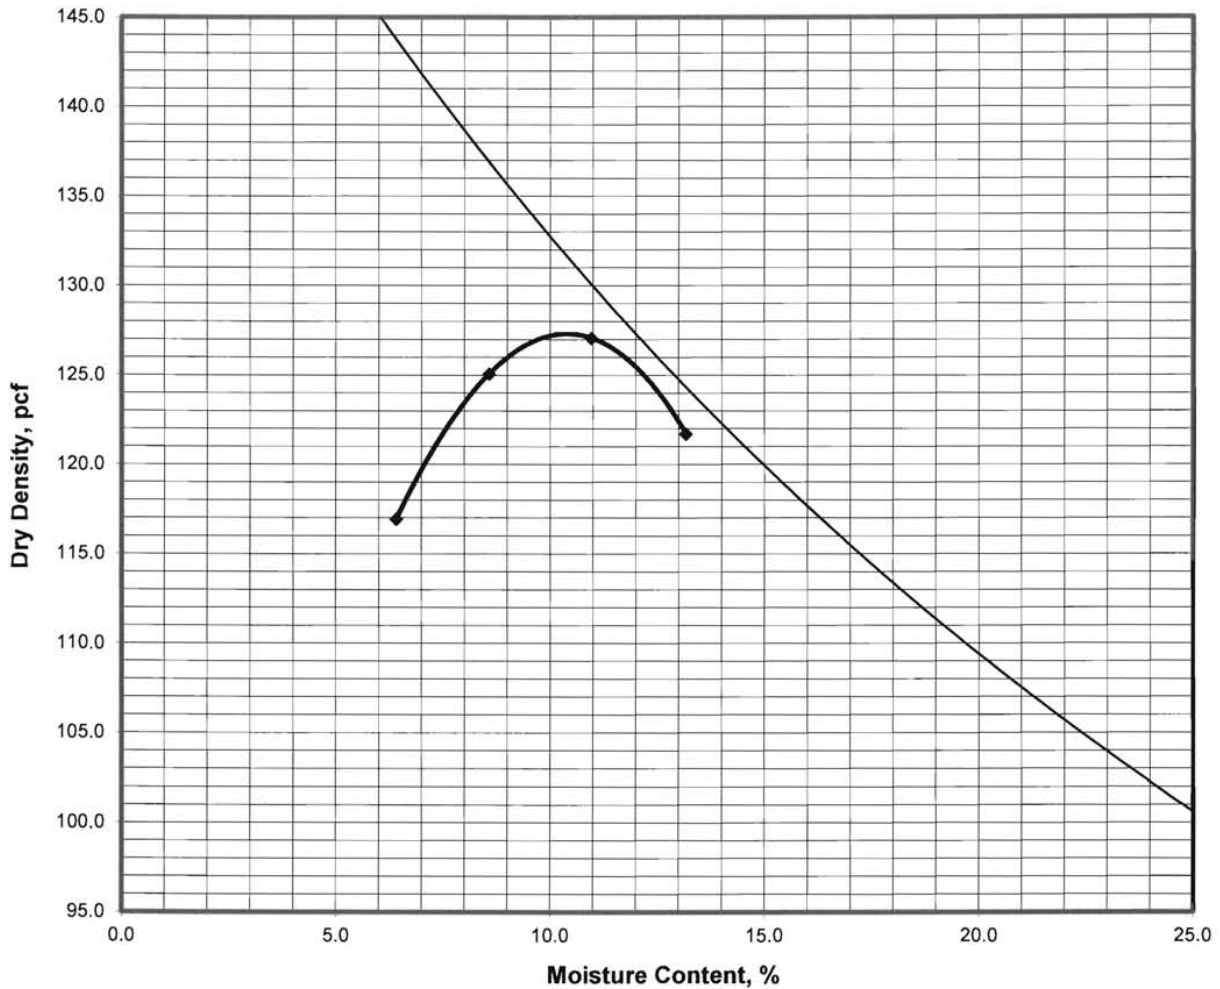
**Laboratory Compaction Characteristics of Soil
Using Modified Effort (56,000 lbf/ft³), ASTM D1557, Method A**

— Zero Air Voids Curve at 100% Saturation;
Specific Gravity Estimated at: 2.70

Maximum Dry Density, pcf: 127.3	Optimum Moisture Content, %: 10.4
--	--

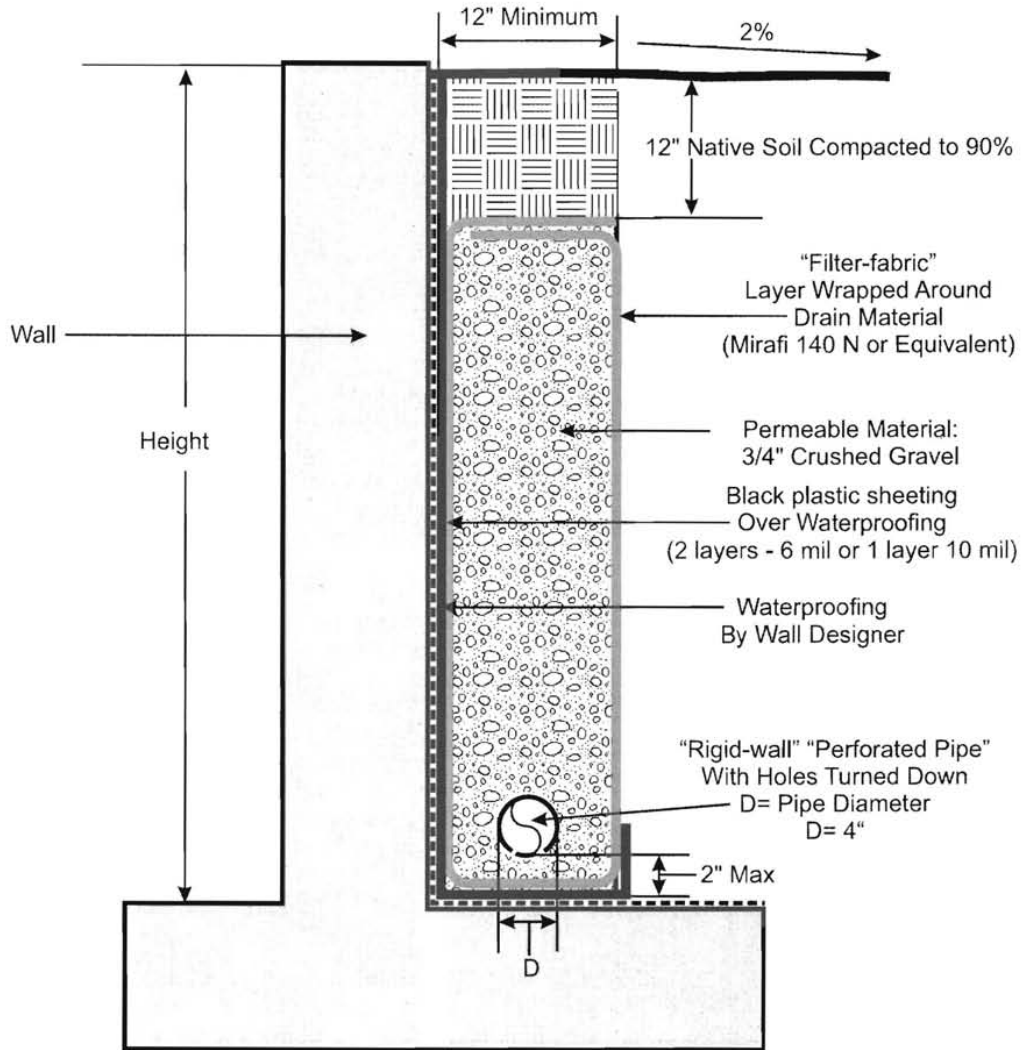
Retaining Wall With "Perforated Pipe Sub-Drain" (Typical Cross Section)

- Notes:
1. Slope footing and "rigid-wall" pipes along flow line parallel to wall at least 1% gradient to drain to an appropriate outfall area away from residence.
 2. Use "sweeps" for directional changes in pipe flow (**do not use 90°elbows**).
 3. Provide periodic "clean-outs".
 4. Washed clean permeable material.
