1	Impacts of Pavement Condition on Fine Sediment Particle Load in Roadway Stormwater Runoff
2	
3	
4	
5	
6	
7	
8	Hyun-Min Hwang ^{1*} , Russell Wigart ² , Andrea Buxton ³
9	
10	¹ Department of Environmental Science, Texas Southern University, Houston, Texas, USA,
11	77094
12	² Tahoe Planning and Stormwater Division, El Dorado County, California, USA
13	³ Tahoe Resource Conservation District, South Lake Tahoe, California, USA
14	
15	
16	*Corresponding author: hyun-min.hwang@tsu.edu

Impacts of Pavement Condition on Fine Sediment Particle Load in Roadway Stormwater Runoff

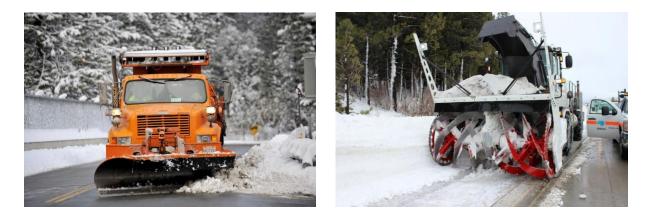
Figure S3. Snow plow equipped with a metal blade (left) and rotary blades mounted on a snow blower (right), operated by El Dorado County to remove snow from roads.

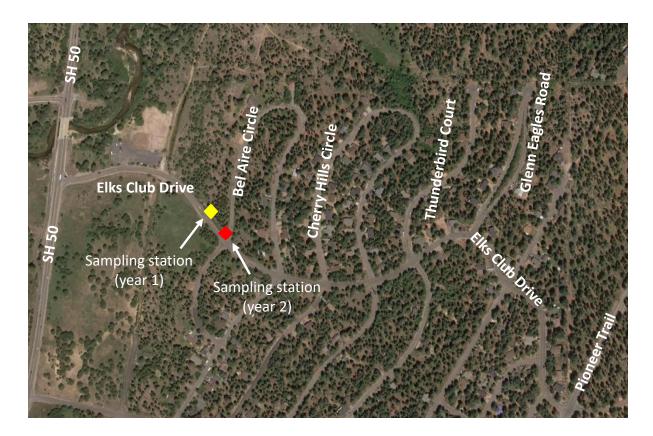
Figure S5. Aerial view of the study site and locations of sampling stations.

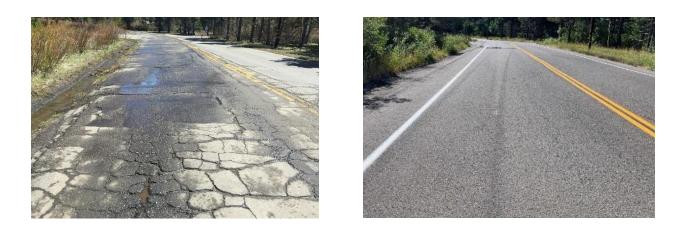
Figure S6. Pavement condition of Elks Club Drive before (left) and after (right) the installation of new asphalt overlay.

Figure S6. Pavement condition of Elks Club Drive before (left) and after (right) the installation of new asphalt overlay.

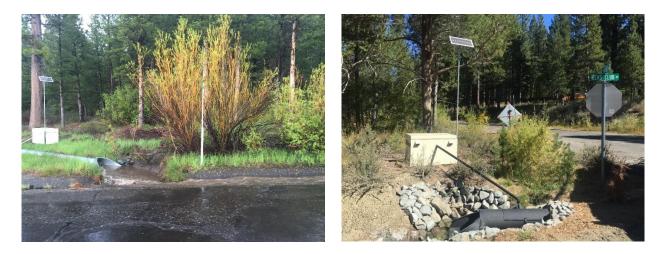
Figure S7. Sampling stations installed on Elks Club Drive for stormwater runoff collection before (year 1, left) and after (year 2, right) pavement rehabilitation.

Automated sampling stations were installed in the drainage ditch on the north side of Elks 117 Club Drive (Figure S7). The locations of the sampling stations in year 1 and year 2 were slightly 118 different. In year 2, the sampling station was moved 60 m east of the point used in year 1. A 119 Tracom (Atlanta, GA, USA) Palmer Bowlus fiberglass flume instrumented with a pressure 120 121 transducer to measure water level, an FTS (Victoria, BC, Canada) DTS-12 digital turbidity 122 sensor, and a Teledyne (Lincoln, NE, USA) ISCO 6712 automated sampler were installed in the 123 drainage ditch. Stormwater runoff samples were collected using the ISCO sampler in twenty-four 1 L bottles. The ISCO sampler was programed to fill one bottle every 8,500 L or 14,200 L across 124 the entire hydrograph for each runoff event sampled depending on the size of the storm. Sample 125 126 collection duration, which is time between the first sample and the last sample, of each event ranged from 6 hours to 135 hours. Water level and turbidity of the runoff were measured on site 127 128 every 5 minutes from October 1 to September 30 in both years. Water levels were converted to 129 flow rates using an equation provided by flume manufacturer.

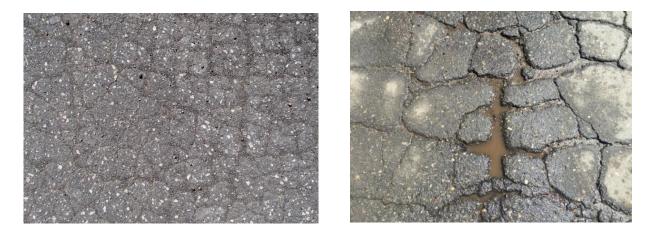
Figure S9. Fatigue cracks (left) and severely enlarged cracks (right) developed on asphalt pavement surface on Elks Club Drive in County.

changes in the binder characteristics make the pavement surface experience a faster loss of 365 binder and aggregates through weathering and cracking (Figure S9). Snow removal practices 366 367 also damage the pavement surface substantially (Figures S3 and S4) and accelerate the generation of FSP from pavement materials. So, a greater amount of FSP is likely to be 368 generated from older and more damaged pavements commonly observed in the Tahoe Basin. In 369 370 El Dorado County, asphalt pavements in poor or fail condition with a PCI of 50 or lower account 371 for more than 50% of all roads (Figure S10), indicating that improvement of pavement in poor or 372 fail condition can significantly reduce FSP loads from pavements. 373 Percent contribution of traction abrasives was significantly reduced from $17.4 \pm 5.4\%$ in year 1 to $8.9 \pm 3.7\%$ in year 2. Volume weighted mean concentration of FSP from traction abrasives 374 declined by 92% from 9.23 mg/L in year 1 to 0.76 mg/L in year 2. This reduction in FSP 375 concentration cannot be explained by the amount of traction abrasives applied in years 1 and 2. 376 The total annual amount of traction abrasives applied on the roads in the County of El Dorado 377 378 were significantly greater in year 2 (450 tons) than in year 1 (318 tons), probably due to more precipitation between December and March in year 2 when the ambient temperatures were often 379 below freezing. Therefore, this reduction in FSP originating from traction abrasives was likely 380 381 associated with pavement condition improvement. Pavement in poor condition with many cracks and potholes, like Elks Club Drive in year 1, can retain greater amounts of FSP associated with 382 383 traction abrasives. Additionally, road sweeping is less effective in removal of FSP on pavement in poor condition,^{16, 17} so a significant fraction of FSP originating from traction abrasives was 384 likely retained on the pavement and washed off by stormwater runoff in year 1. 385 386 Percent contribution of native soil increased from $33.0 \pm 6.8\%$ in year 1 to $42.6 \pm 6.7\%$ in 387 year 2 after pavement habilitation. Again, this is just a proportional increase and does not mean

Figure S9. Fatigue cracks (left) and severely enlarged cracks (right) developed on asphalt pavement surface on Elks Club Drive in County.
