PUBLIC BUILDINGS AND PROPERTY GJ04-042

MENTAL HEALTH BUILDINGS – South Lake Tahoe

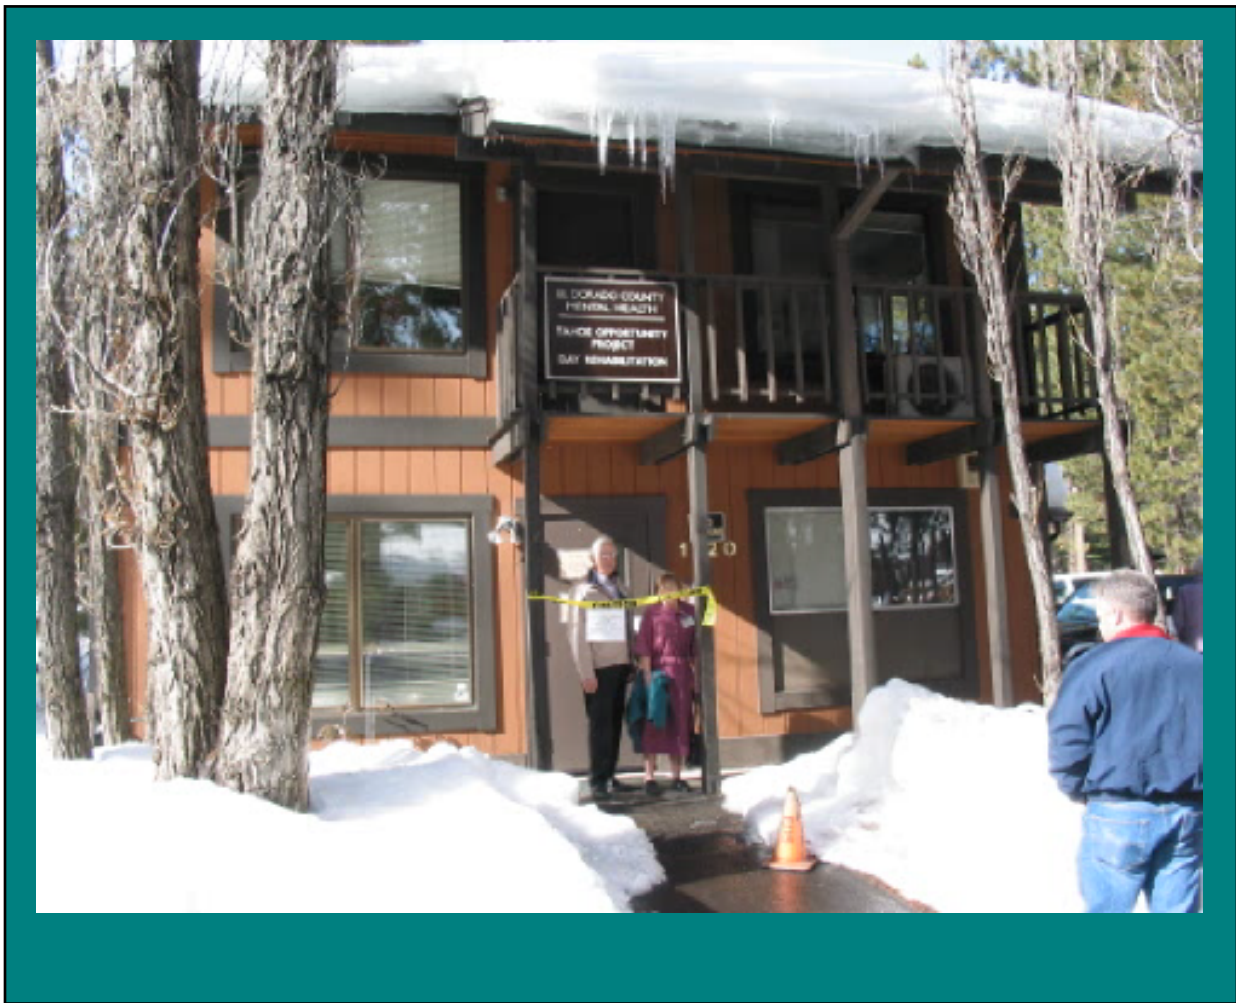
6a. **Finding:** The front entrance is hazardous in the winter due to melting snow and ice falling off the roof. The outside basement entrance is a concrete stairwell where ice accumulates. The rear entrance is icy and uneven. Sign on outside building wall warns of falling ice and snow. This dangerous condition should not be allowed to exist. *See photo on page 26.*

Front entrance of Mental Health Facility, Third St., South Lake Tahoe.

6b. **Recommendation:** Ensure entrances and fire exits are free of ice and snow as needed (daily or hourly).
