# Meyers, El Dorado County, California Road Safety Audit

## Conducted February 8-9, 2016

Prepared By: FHWA Resource Center and in Cooperation with Tahoe Regional Planning Agency

FINAL REPORT April 2016

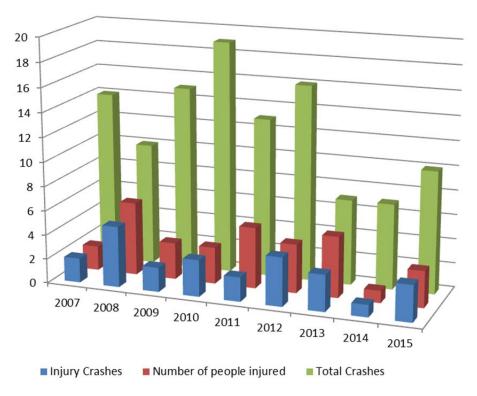
Figure 7: Crash Data from 2007 to 2015 (Data Source: CHP)

Crash data from 2007 to 2015 was provided by CHP from N Upper Truckee Rd to Pioneer Trail as shown in Figures 7 and 8. There were 111 crashes reported in this 1.3 mile stretch through Meyers with concentrations near SR 89, the CA Ag Inspection Station and Pioneer Trail. That averages over 12 reported crashes per year in Meyers. The data shows consistent crash trends in terms of total and injury crashes from 2007 to 2012 and then a decrease in total crashes from 2013 to 2015. The injury crashes remained average from 2013 to 2015. The ratio of injury crashes to total crashes is consistent at 25% based on a rolling five years average over the nine years. Twenty-eight percent of the total crashes in the study area occurred at intersection while forty-four percent of the injury crashes occurred at the intersections. Figure 9 shows the number of total crashes per intersection.

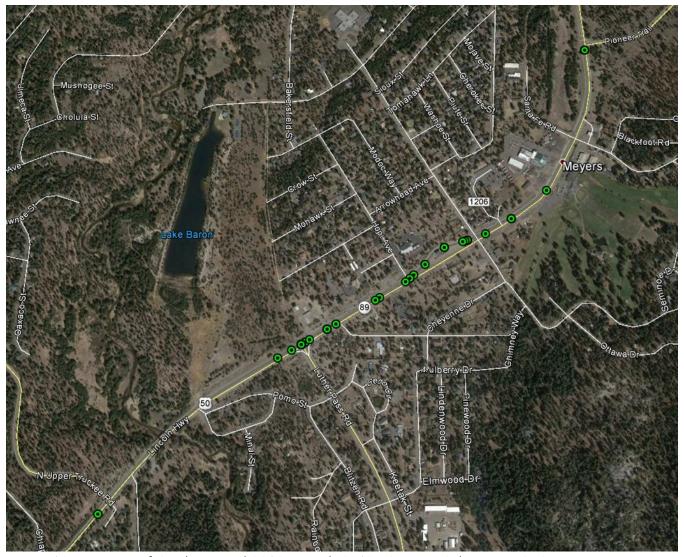
Figure 10: Location of Crashes, April 2010 -March 2013. (Source: Caltrans, TASAS)

The 2015 US 50/ SR 89 Caltrans Project Study Report, states this intersection experienced total crashes above statewide average for similar facilities in a 3-year period from April 1, 2010 to March 31, 2013, as shown in Figure 10. There were nine total crashes including five crashes that resulted in injuries. Of the nine crashes, five were rear end crashes and the other four were broad side crashes. Four of the five rear end collisions occurred on SR 89 which is stop controlled approach. All four broad side crashes occurred on US 50 which has uncontrolled approaches. The crash data was obtained from the TASAS.
