## Fwd: Variance: V18-0005/Chellappan & Notice of Public Hearing on August 21, 2019 (at 3:00PM)

## Response to V18-0005/Chellappan Variance

File Number: V18-0005/Chellappan Variance

Request: A Variance request to reduce the required 20-foot front yard setback from the edge of the 32-foot wide road and public utilities easement for Guadalupe Drive to zero feet to allow for development of a single-family residence and attached garage.

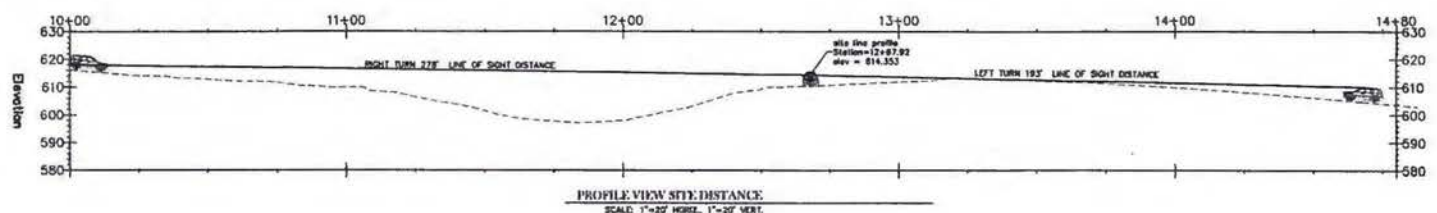
**V18-0005 EXHIBIT J - DRIVEWAY LINE OF SIGHT ANALYSIS**

**SIGHT DISTANCE EXHIBIT MAP FOR:  
 PARCEL A OF 22 PM 49  
 APN: 110-460-017-000  
 GUADALUPE DRIVE  
 EL DORADO COUNTY, CA 95762**

EXISTING SITE DISTANCE  
 EXHIBIT  
 GUADALUPE DRIVE  
 APRIL 30, 2019

**TOPOGRAPHIC SURVEY**  
 TOPOGRAPHIC SURVEY HAS BEEN PROVIDED BY  
 ALAN DIVERS DATED 4/7/2019 AND ADDITIONAL  
 ROADWAY CENTERLINE GRADES WERE PROVIDED BY  
 TSD ENGINEERING SURVEYING 4/15/2019.

Also, I have attached "marked up" portions of Exhibit J (Driveway Line of Sight Analysis) and Exhibit O (Project Site Plan) with additional comments regarding the impacts of the zero-foot offset. These marked up drawings are for your information and for the record. In addition, I have attached a Road Evaluation created by ACE Quality Control documenting the condition of Guadalupe Drive within the Lake Pointe View neighborhood. This Road Evaluation details the substandard condition of this portion of Guadalupe Drive.

In Exhibit J, the analysis notes that the proposed driveway would have an adequate sight distance based on "DOT figure 201.2", and that the driveway would have "safe stopping sight distances of 100 feet for a left turn and 225 feet for a right turn". Again, this analysis does not appear to take into consideration the steepness of the proposed driveway, or if the vehicle were backing out of the driveway and onto Guadalupe Drive.

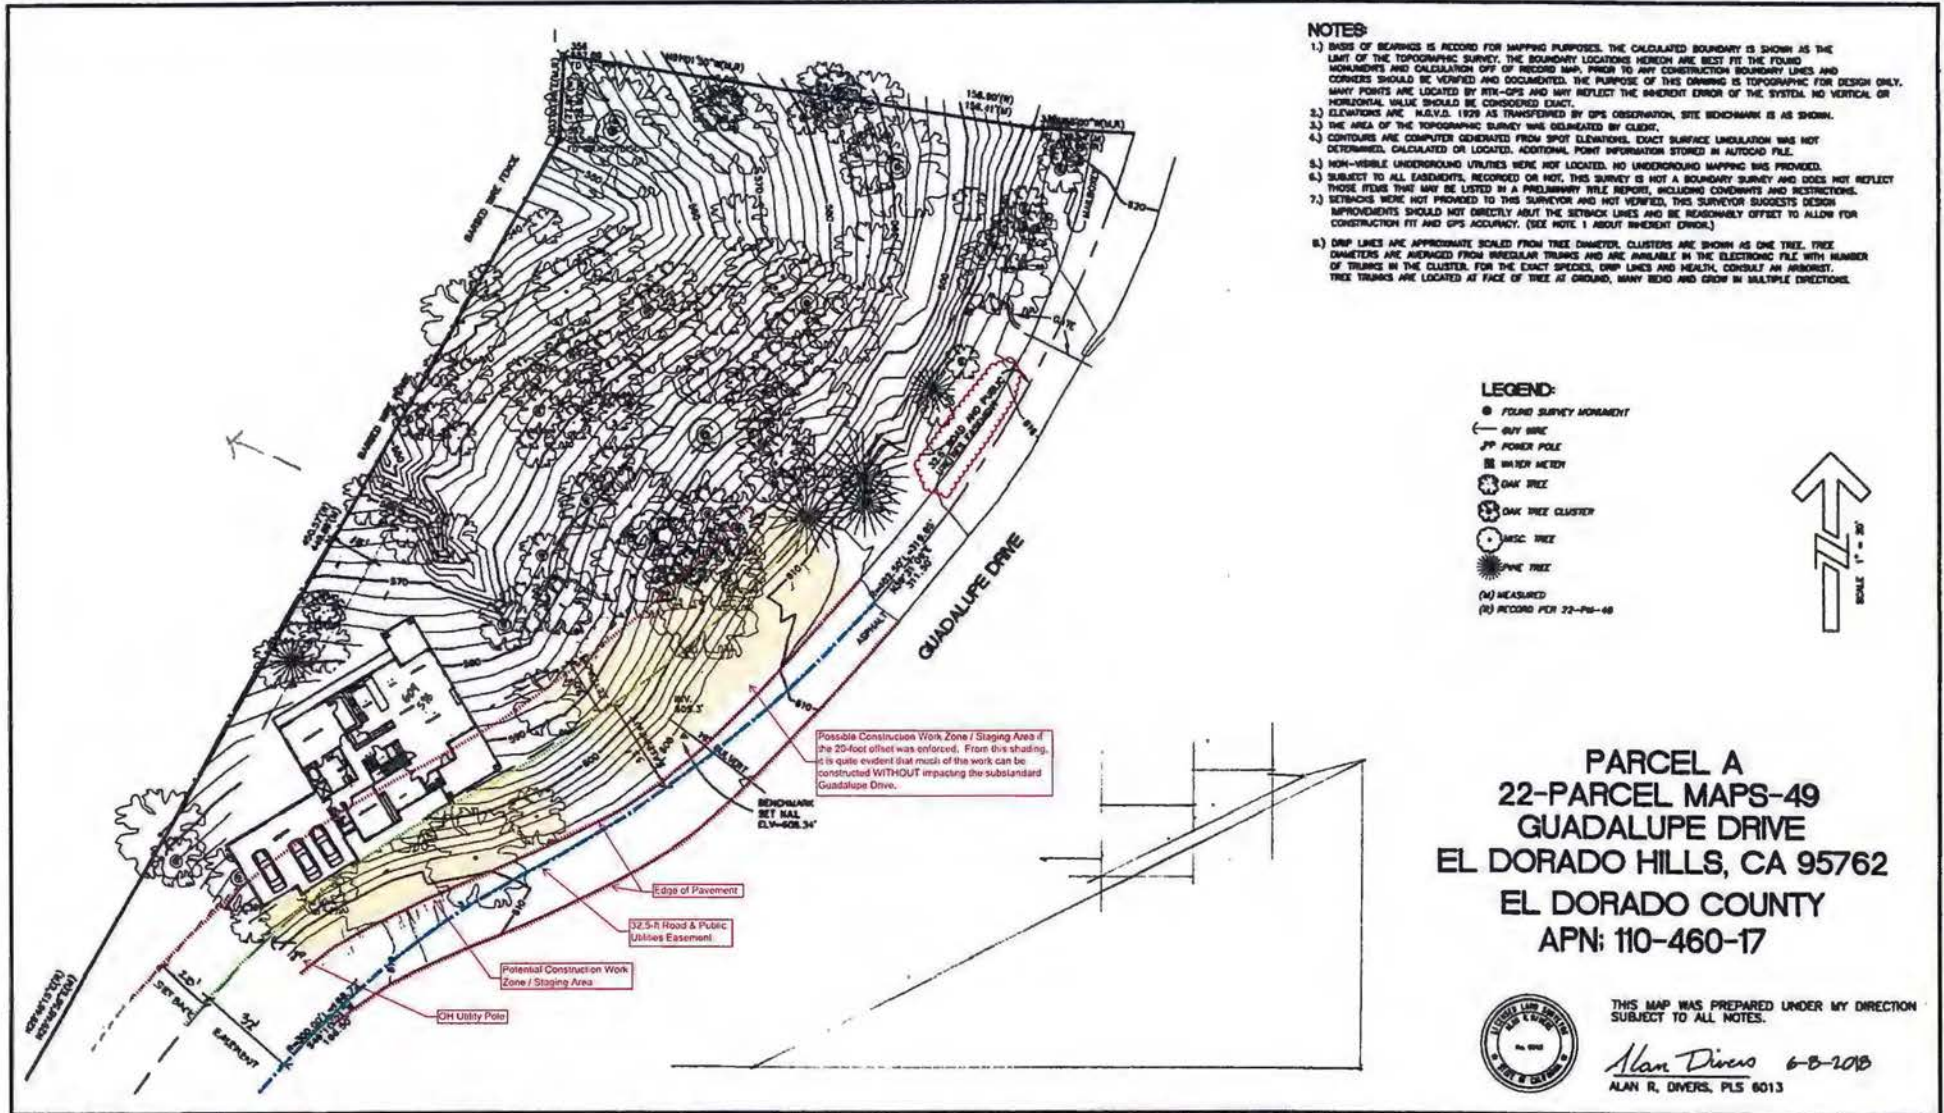
# V18-0005 EXHIBIT O - PROJECT SITE PLAN

DATE: 6-8-2018  
 SCALE: 1"=20'  
 JOB NUMBER: 18-42  
 DWG NAME: TOPO

**TOPOGRAPHIC SURVEY**  
**FOR**  
**SATHEESH CHELLAPPAN**

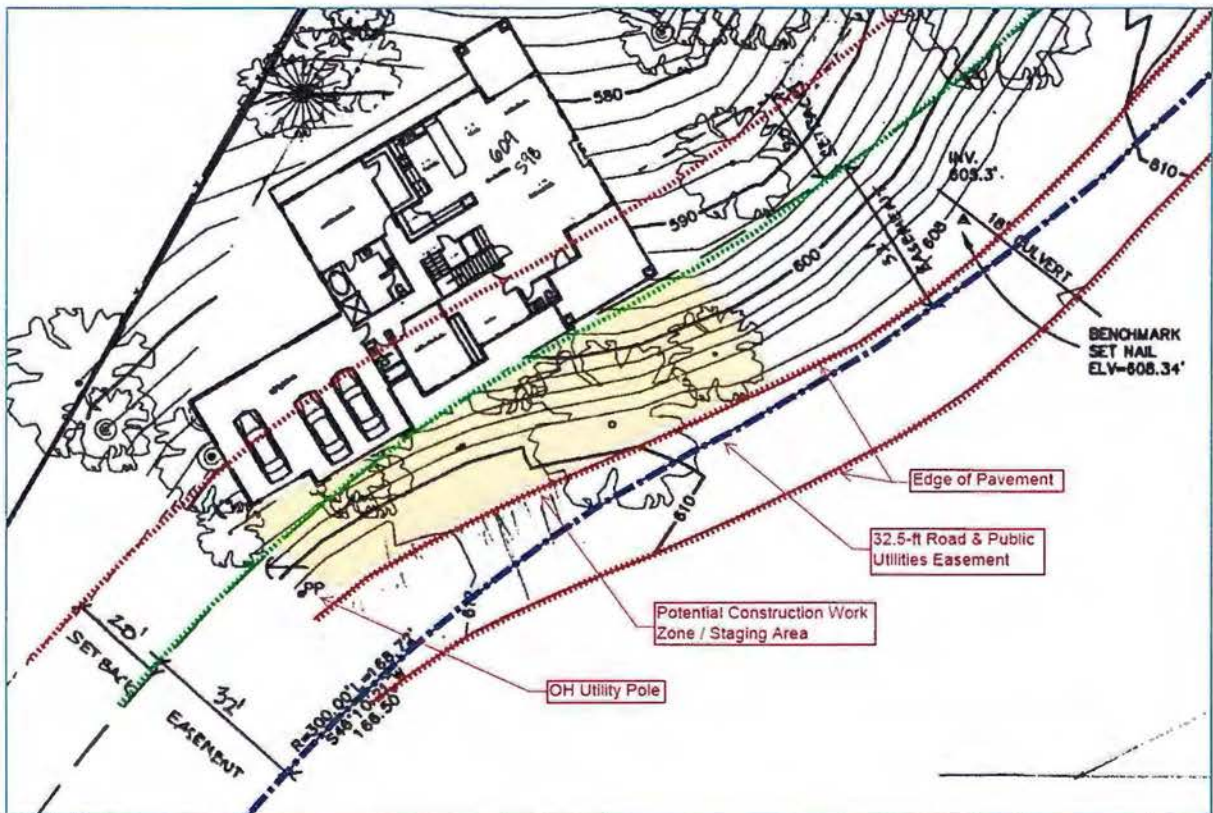
Figure 1 - Portion of Exhibit O - Color Coded to show limited Construction Work Zone

It should be noted that because the centerline of the existing roadway does not follow the alignment of the 32.5-ft Road and Public Utilities Easement, there are instances where the distance between the edge of pavement and the limits of the zero foot setback is less than 32.5-ft easement (See Figure 1). Because the edge of pavement is much closer to the proposed zero-foot setback, the future contractor's Construction Work Zone / Staging Area will be significantly reduced such that there is a high potential that the work will damage the existing roadway.

In the figure below, the it is quite clear to see that the northern edge of pavement is extremely close to the edge of the 32.5-ft easement. The limited Construction Wok Zone / Staging Area has a high potential to damage Guadalupe Drive within these limits. In addition, this limited work zone has a high potential to block the roadway and cause potential safety issues due to the blind corner west of the work zone.

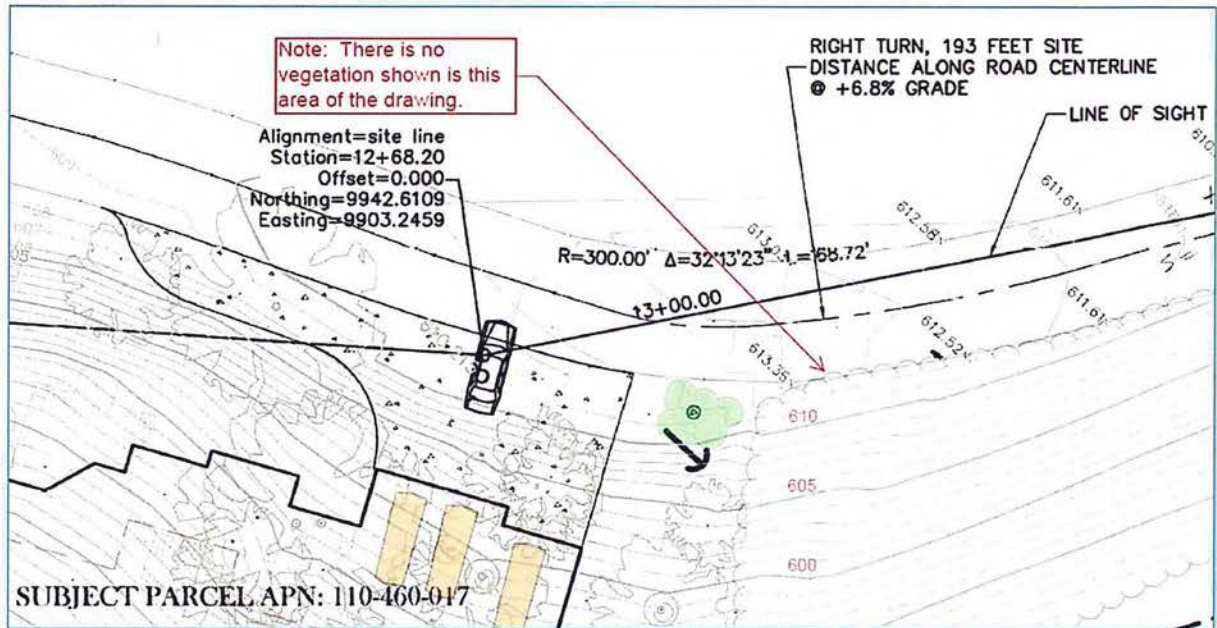
Figure 3 - Automobile is approximately four feet into Guadalupe Drive for this analysis.

In Figure 3 (below) a portion of Exhibit J is shown. From this figure, it is clear that the vehicle is approximately four feet into the roadway when determining a "Line of Sight". Also, if the front of the vehicle were "pushed back" to the edge of pavement, it's clear that due to the steepness of the existing ground, the proposed driveway may not be a level for the entire length of the vehicle and that the driver's vision may be obstructed by vegetation and the overhead power pole (color coded in green) adjacent to the roadway.

Note: As there are no building plans yet available for this project, there is no way to know exactly how steep the future driveway will be and its exact location relative Guadalupe Drive. In Figure 3, the vehicle is at an approximate elevation of 612 feet, while the existing ground elevation of the western corner of the garage is approximately 603 feet. So, there is a difference of nine feet between the existing ground and the location of the vehicle in this analysis.

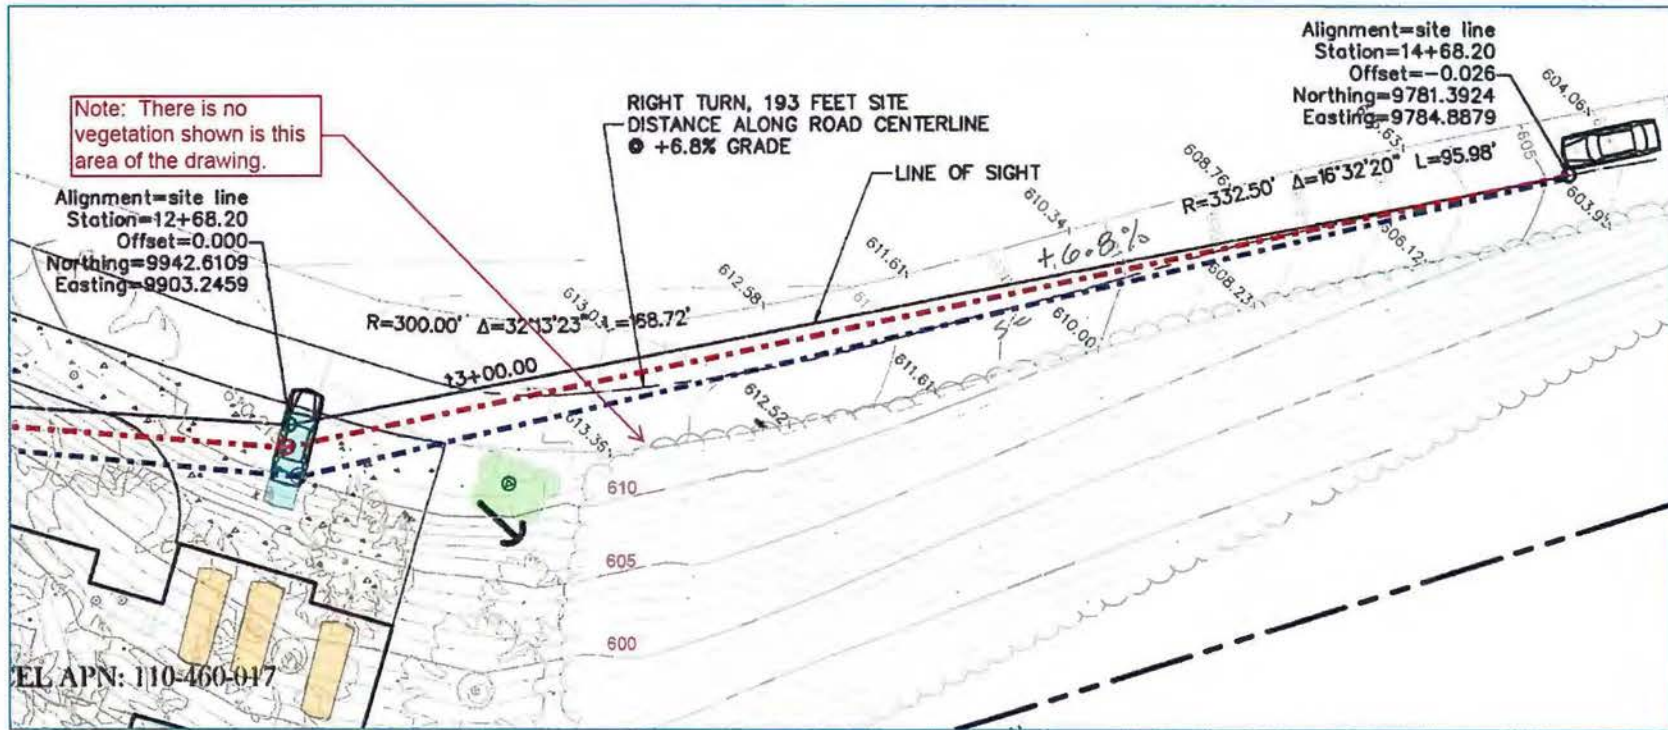
Figure 4 - What If Examples of Vehicle Location and Right Turn Sight Distances

In Figure 4, the location of the vehicle (as shown in light blue) was adjusted so that it was not four feet into Guadalupe Drive. The red line represents what the "Line of Sight" would be if the vehicle was driving forward out of the proposed driveway. From this scenario, it is apparent that the line of sight could be obstructed by the slope of a steep driveway. In the second scenario, the blue line represents a vehicle backing out of the driveway onto Guadalupe Drive. Again, from this scenario, it is apparent that the line of sight could be severely obstructed by the slope of a steep driveway and possible the horizontal and vertical curves of the roadway. Note: The Left Turn alignments of the red and blue lines seem to be partially obstructed by existing trees. This portion of the drawing was not shown for brevity purposes.

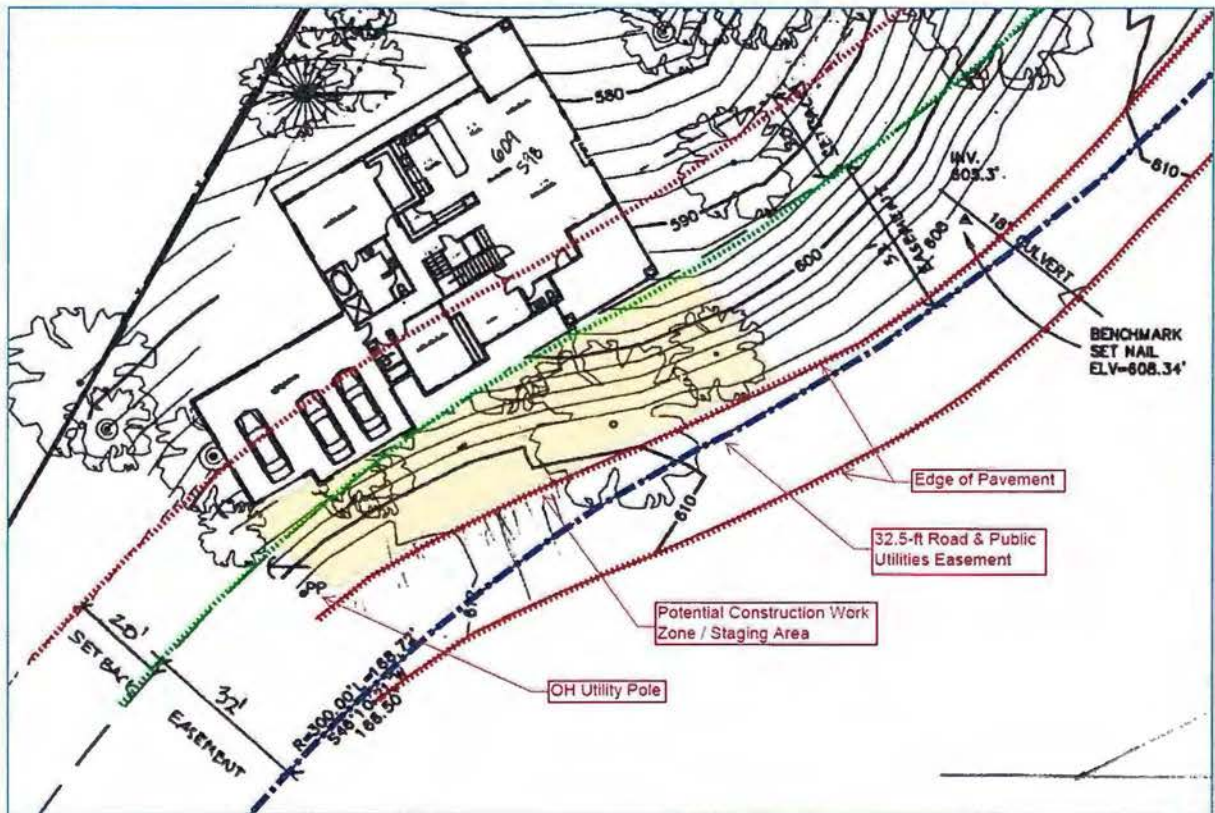
Figure 1 - Portion of Exhibit O - Color Coded to show limited Construction Work Zone

It should be noted that because the centerline of the existing roadway does not follow the alignment of the 32.5-ft Road and Public Utilities Easement, there are instances where the distance between the edge of pavement and the limits of the zero foot setback is less than 32.5-ft easement (See Figure 1). Because the edge of pavement is much closer to the proposed zero-foot setback, the future contractor's Construction Work Zone / Staging Area will be significantly reduced such that there is a high potential that the work will damage the existing roadway.

In the figure below, the it is quite clear to see that the northern edge of pavement is extremely close to the edge of the 32.5-ft easement. The limited Construction Wok Zone / Staging Area has a high potential to damage Guadalupe Drive within these limits. In addition, this limited work zone has a high potential to block the roadway and cause potential safety issues due to the blind corner west of the work zone.

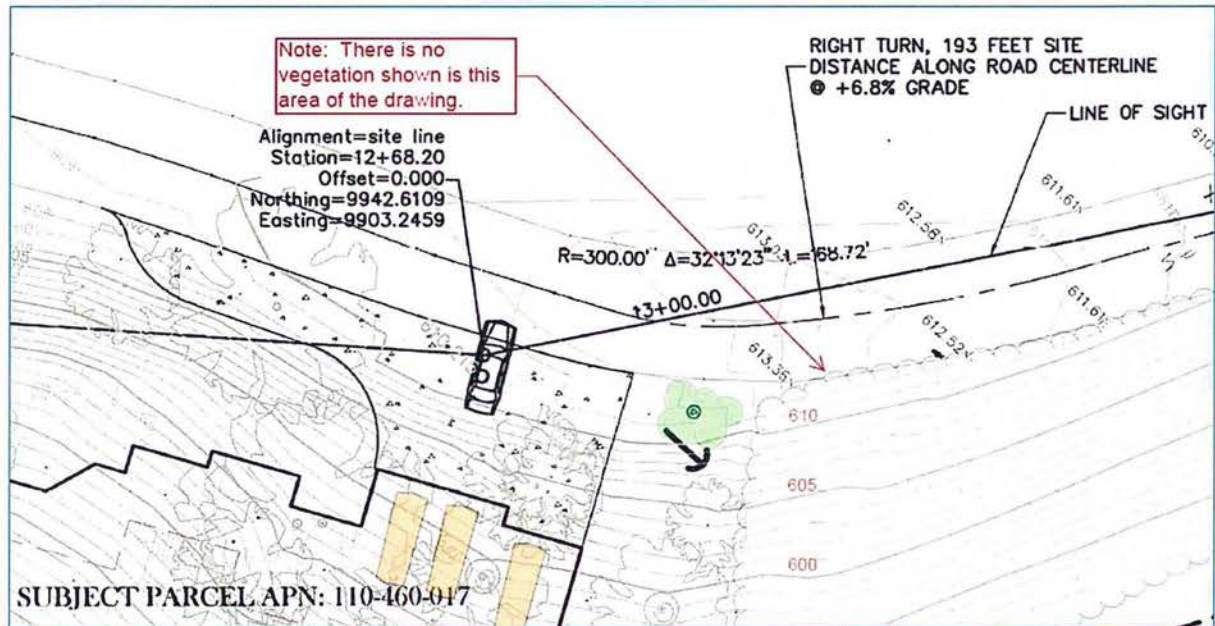
Figure 3 - Automobile is approximately four feet into Guadalupe Drive for this analysis.

In Figure 3 (below) a portion of Exhibit J is shown. From this figure, it is clear that the vehicle is approximately four feet into the roadway when determining a "Line of Sight". Also, if the front of the vehicle were "pushed back" to the edge of pavement, it's clear that due to the steepness of the existing ground, the proposed driveway may not be a level for the entire length of the vehicle and that the driver's vision may be obstructed by vegetation and the overhead power pole (color coded in green) adjacent to the roadway.

Note: As there are no building plans yet available for this project, there is no way to know exactly how steep the future driveway will be and its exact location relative Guadalupe Drive. In Figure 3, the vehicle is at an approximate elevation of 612 feet, while the existing ground elevation of the western corner of the garage is approximately 603 feet. So, there is a difference of nine feet between the existing ground and the location of the vehicle in this analysis.

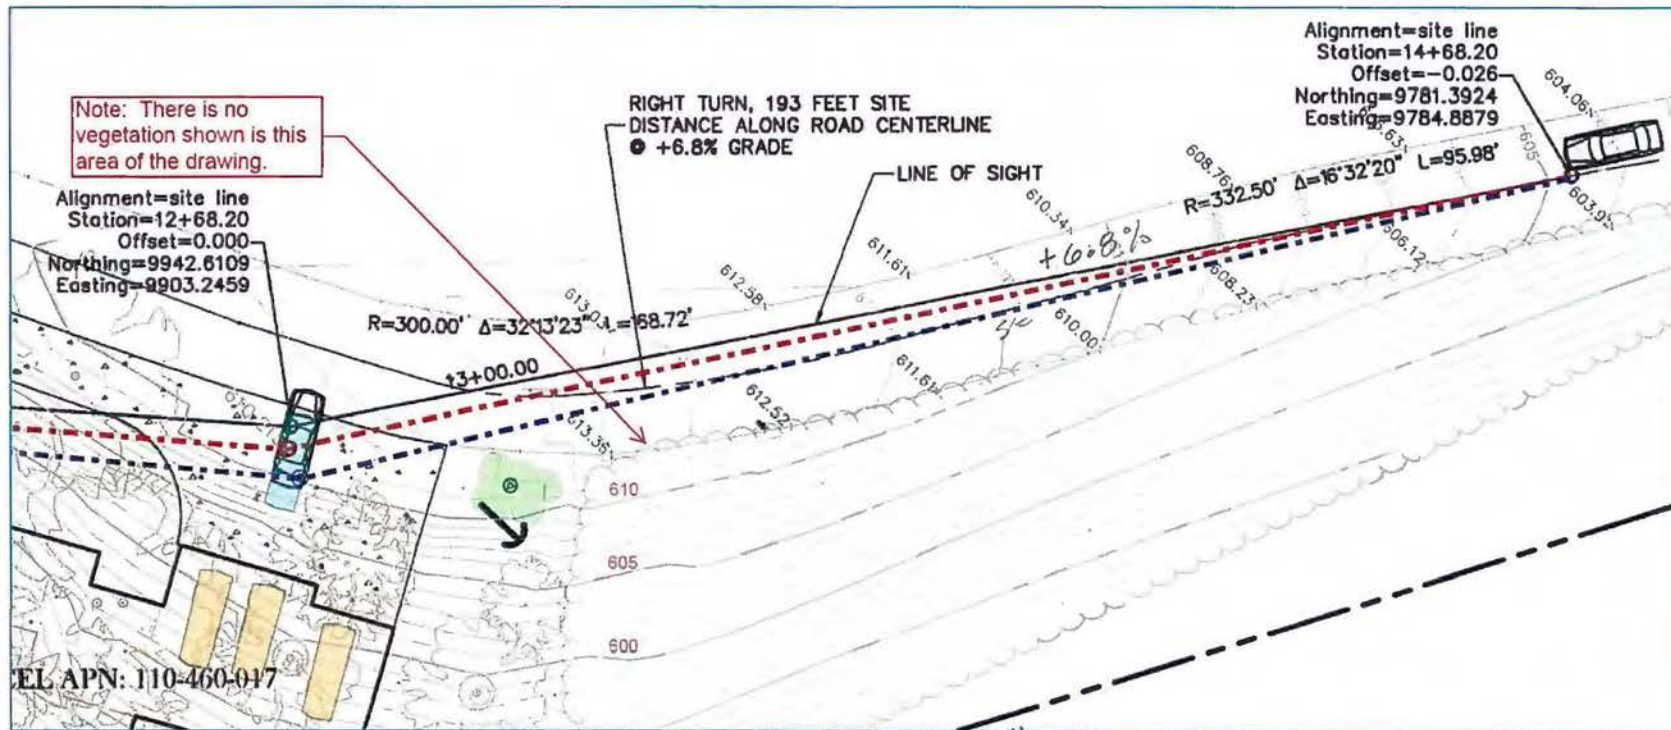
Figure 4 - What If Examples of Vehicle Location and Right Turn Sight Distances

In Figure 4, the location of the vehicle (as shown in light blue) was adjusted so that it was not four feet into Guadalupe Drive. The red line represents what the "Line of Sight" would be if the vehicle was driving forward out of the proposed driveway. From this scenario, it is apparent that the line of sight could be obstructed by the slope of a steep driveway. In the second scenario, the blue line represents a vehicle backing out of the driveway onto Guadalupe Drive. Again, from this scenario, it is apparent that the line of sight could be severely obstructed by the slope of a steep driveway and possible the horizontal and vertical curves of the roadway. Note: The Left Turn alignments of the red and blue lines seem to be partially obstructed by existing trees. This portion of the drawing was not shown for brevity purposes.

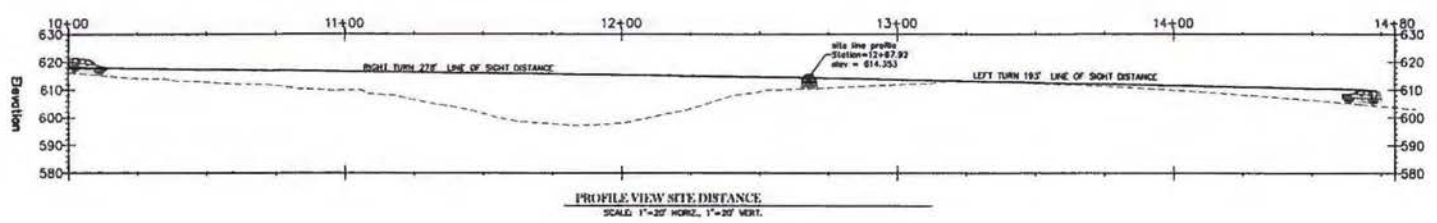
**SIGHT DISTANCE EXHIBIT MAP FOR:  
 PARCEL A OF 22 PM 49  
 APN: 110-460-017-000  
 GUADALUPE DRIVE  
 EL DORADO COUNTY, CA 95762**

EXISTING SITE DISTANCE  
 EXHIBIT  
 GUADALUPE DRIVE  
 APRIL 30, 2019

**TOPOGRAPHIC SURVEY**  
 TOPOGRAPHIC SURVEY HAS BEEN PROVIDED BY  
 ALAN DIVERS DATED 4/30/2019 AND ADDITIONAL  
 ROADWAY CENTERLINE GRADINGS WERE PROVIDED BY  
 TSD ENGINEERING SURVEYING 4/13/2019.

In Exhibit J, the analysis notes that the proposed driveway would have an adequate sight distance based on "DOT figure 201.2", and that the driveway would have "safe stopping sight distances of 100 feet for a left turn and 225 feet for a right turn". Again, this analysis does not appear to take into consideration the steepness of the proposed driveway, or if the vehicle were backing out of the driveway and onto Guadalupe Drive.
