Mt. Murphy Road Bridge Project

Public Workshop, Thursday, February 7, 2013 Gold Trail Grange Hall, 319 State Highway 49, Coloma

County of El Dorado Community Development Agency Transportation Division

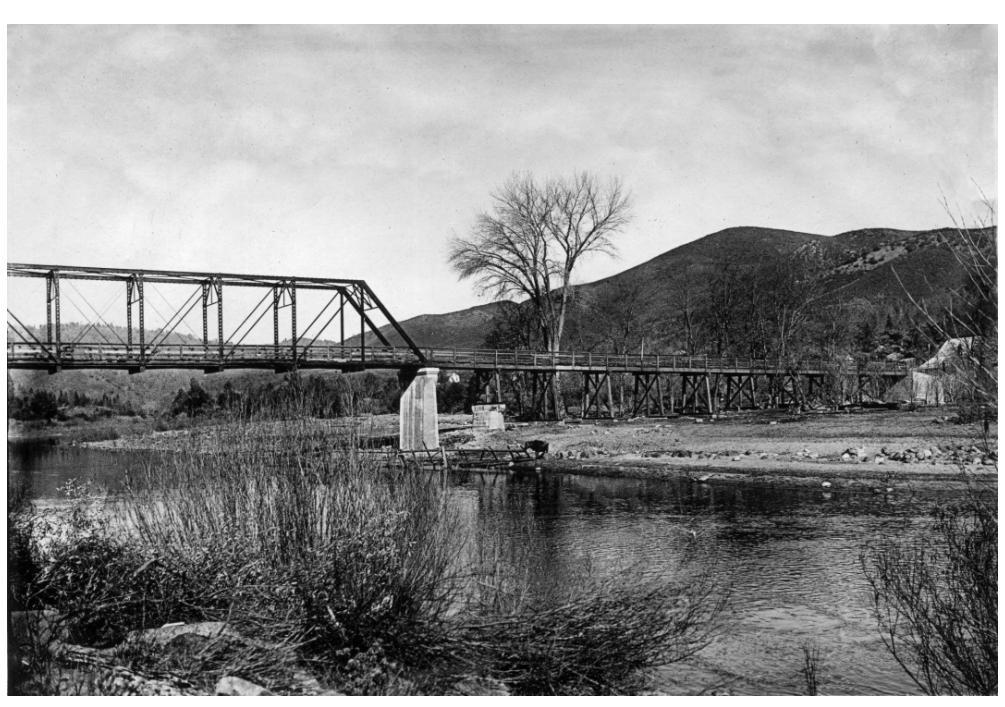
Mt. Murphy Road Bridge Facts

- Current bridge built in 1915 – 98 years old
- 10.5 foot wide one-lane steel truss structure
- 160-ft long span over South Fork Amer. River
- Two concrete approaches (140-ft & 60-ft long)
- 280 Vehicles/Day (2012 traffic counts)
- 1 of 77 bridges maintained by County

- Routine inspections every 2 years by Caltrans
- Rated on 140 elements; Score of 0 to 100
- Sufficiency Rating (SR) < 80 = eligible for rehabilitation
- Sufficiency Rating (SR) < 50 = eligible for replacement
- 2006 SR = 2.0; 2011 SR = 0.00 (lowest rating of all County maintained bridges)
- Structurally Deficient (per 2011 SR)
- Functionally Obsolete (per deck geometry rating of 2; less than 3 is "FO")
- Structure has Fracture Critical (FC) members;
 FC inspections by Caltrans annually

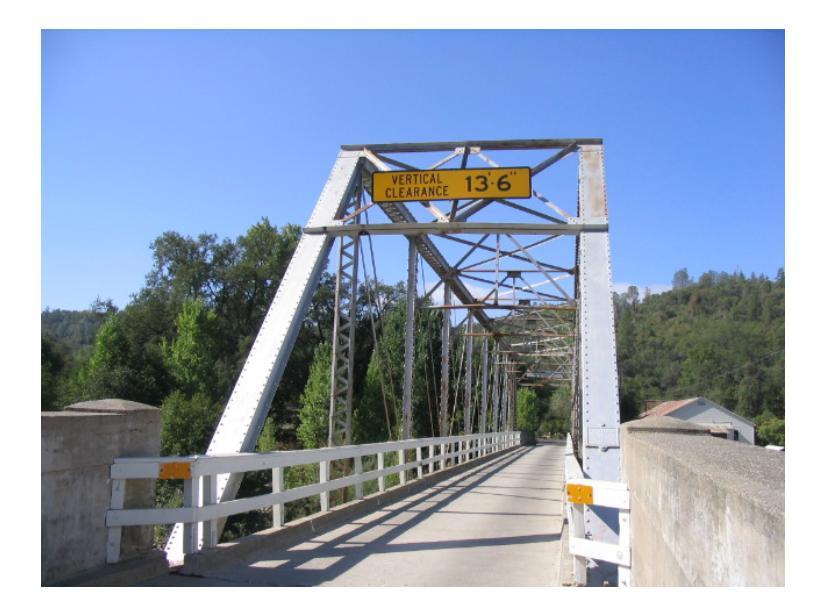
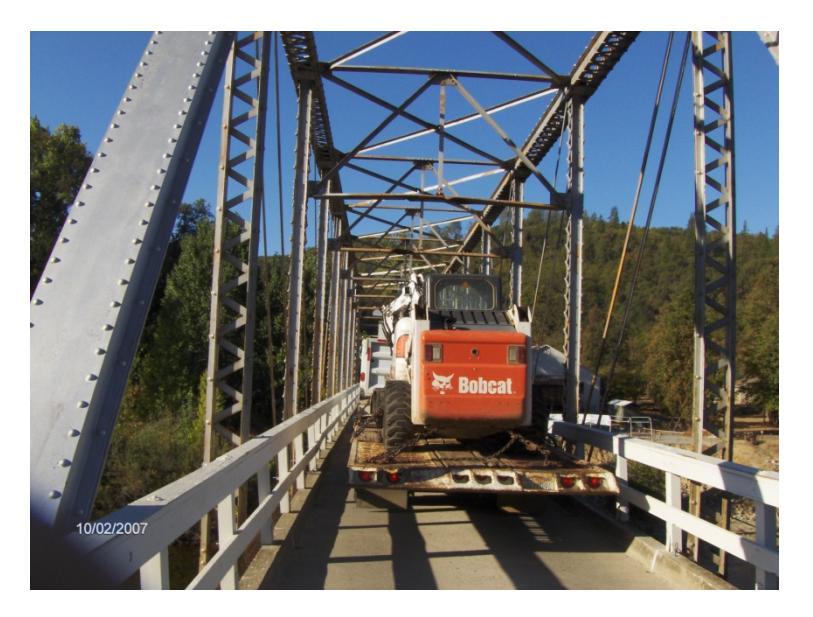
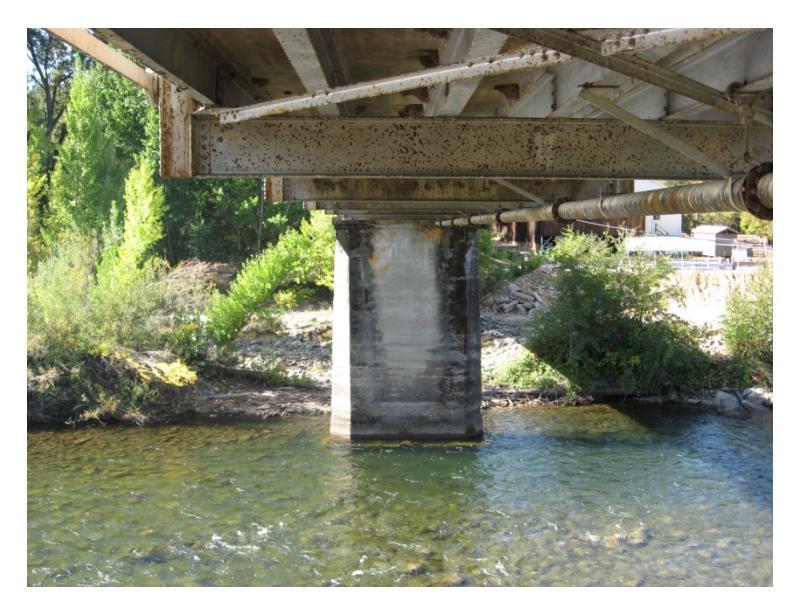
- Routine maintenance by County bridge crew as recommended per Caltrans inspection reports
- Sept 2007 crew found one deck section slid 4 inches sideways; required immediate inspection and repair
 - Deck moved back into place by jacking the concrete slab against temporary bracing and beams below
 - Emergency repair cost \$90K, took about 3 weeks of 530 man hours to complete

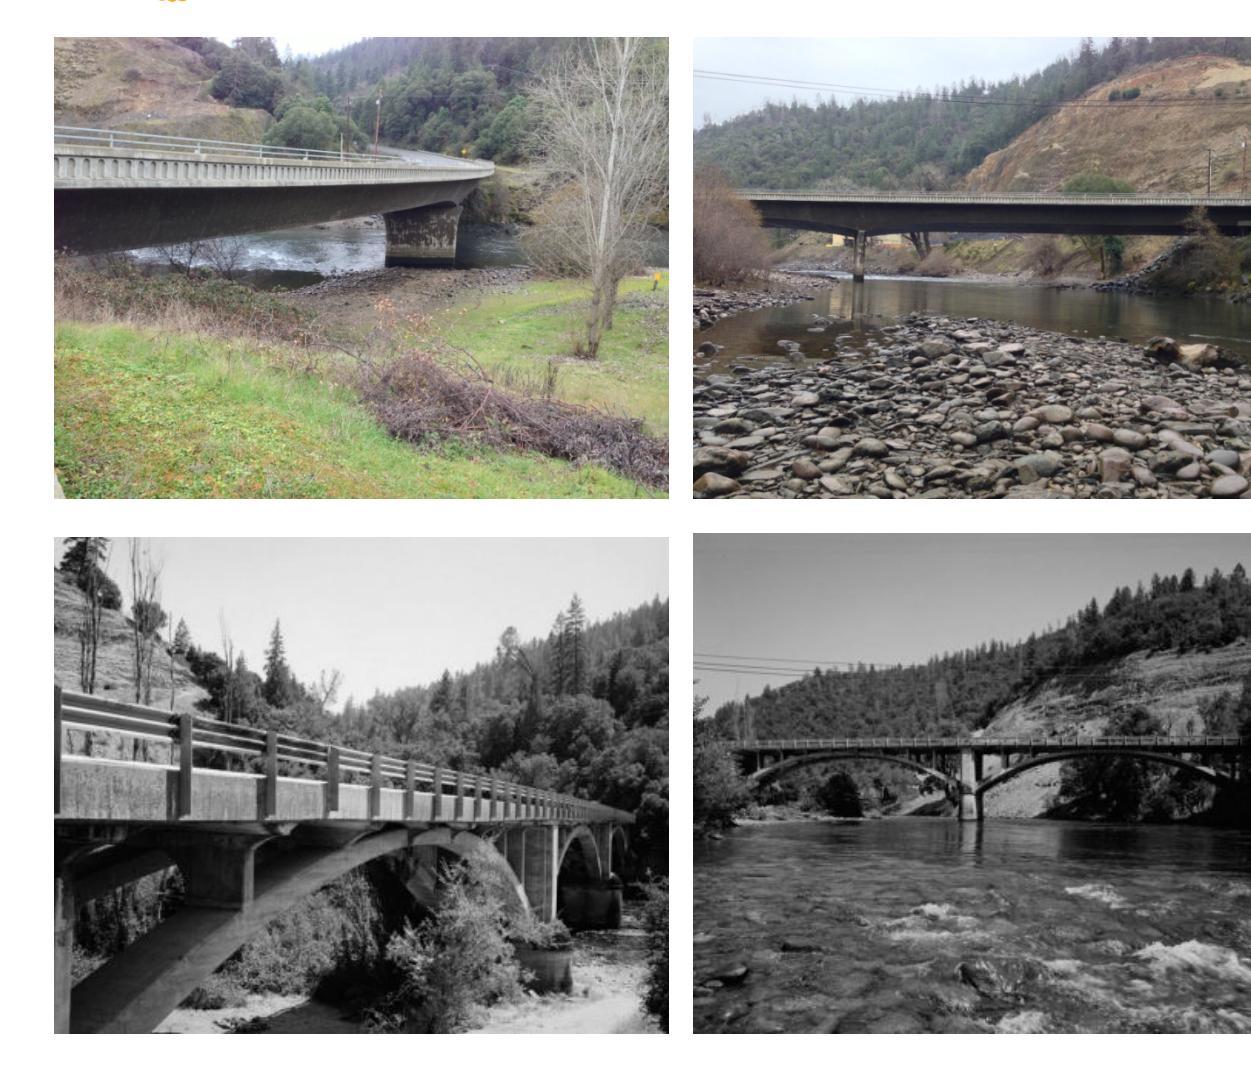
Prestressed Concrete Box Girder

Current Chili Bar Bridge over South Fork American River at State Hwy 193 in El Dorado County

Built in 1993, replaced historic bridge pictured below.

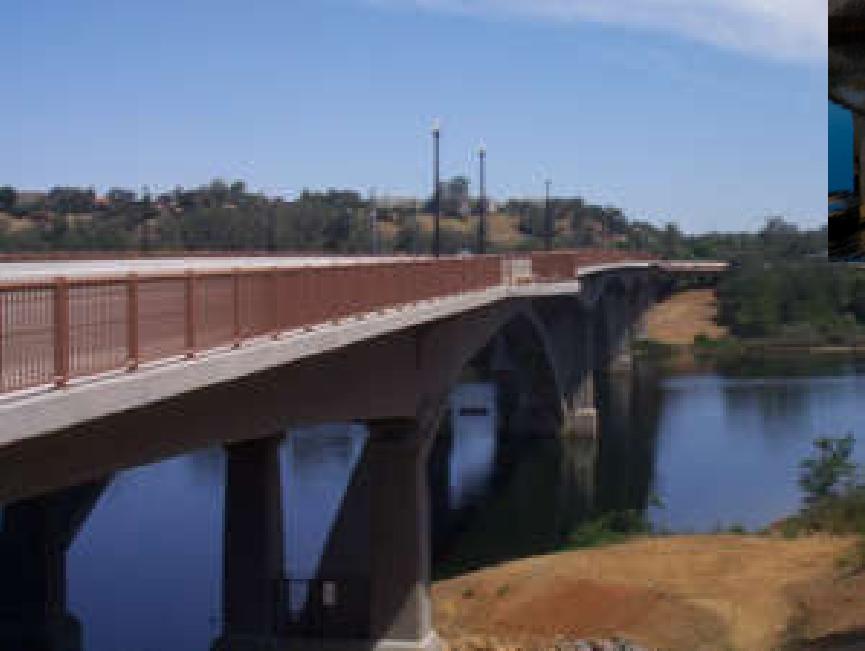
Concrete Box Girder Design Lake Natoma Crossing, Folsom

Post-tensioned concrete box girder, with false deck arches; 4 traffic lanes; opened in 1999; designed to mimic key features of the original historic Rainbow bridge; includes pedestrian walkways with outlook areas, decorative vintage looking railing and lights.

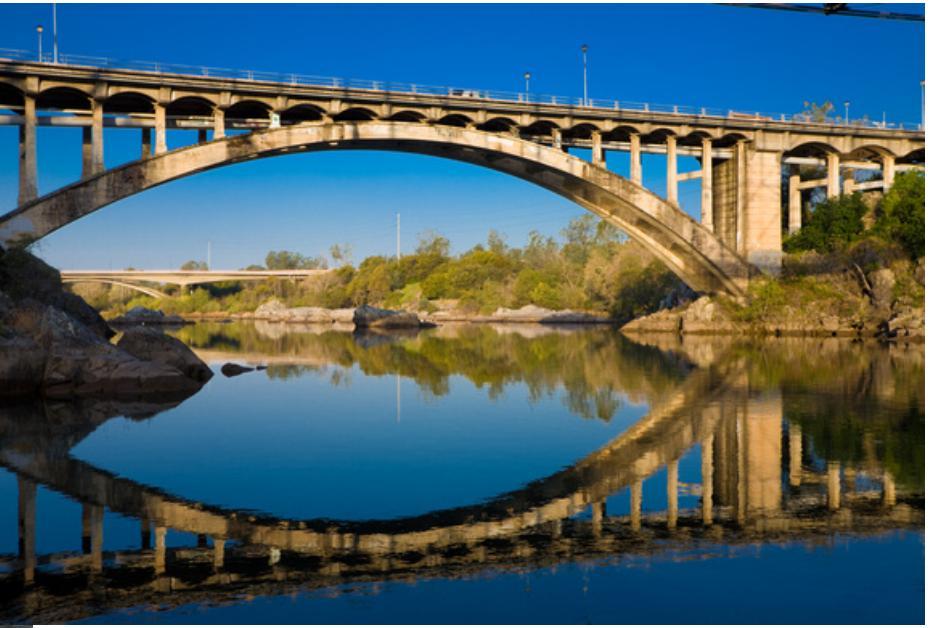
Concrete Arch Design Rainbow Bridge, Folsom

208' long main concrete arch span with open spandrel columns and 7 span north and 4 span south T-girder approaches totaling 511' in length. Built in 1917, underwent major reconstruction in 1969. Was the only means of crossing the American River in the City of Folsom until 1999 when the Lake Natomas Crossing was completed.

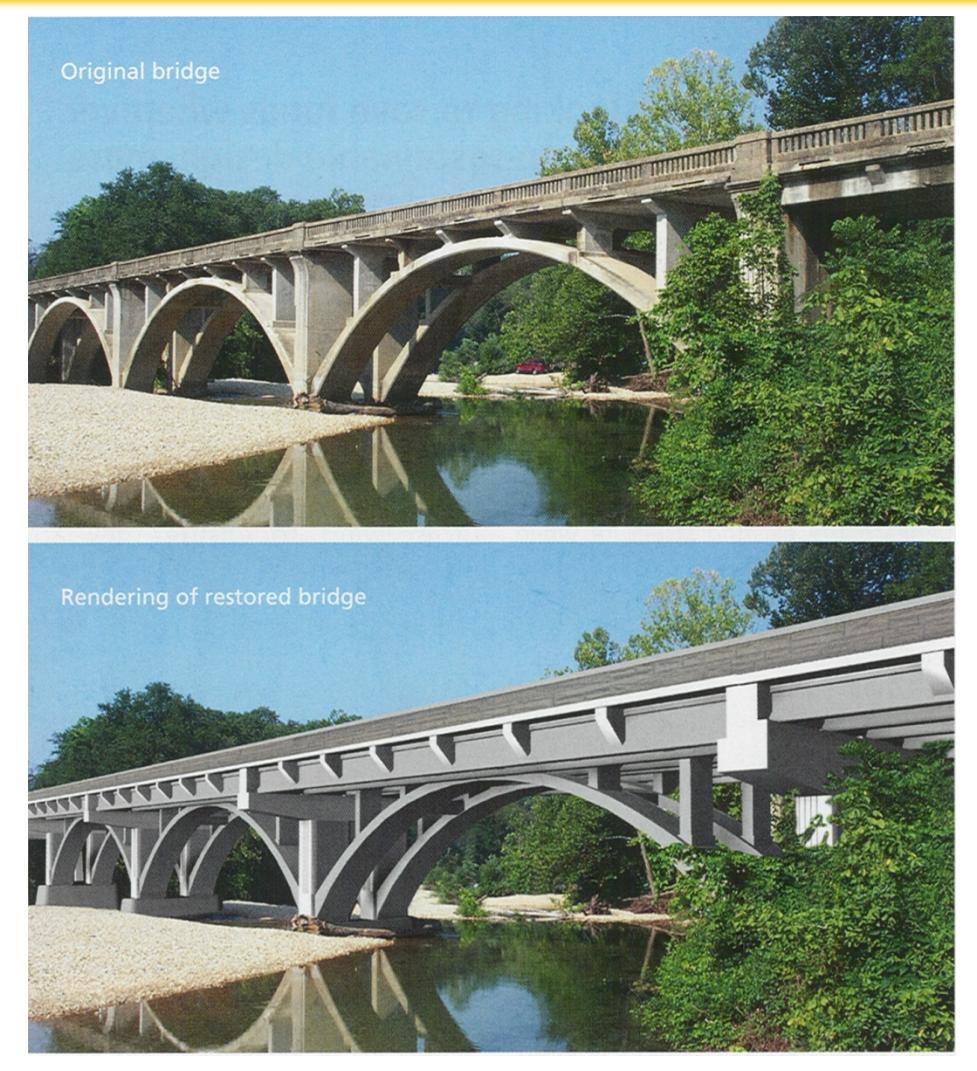
Precast Concrete

Sinking Creek Bridge, Ozark Scenic Riverways National Parkland

Precast concrete solution allows attractive arches on the bridge to remain in place which appearing to support the bridge loads.

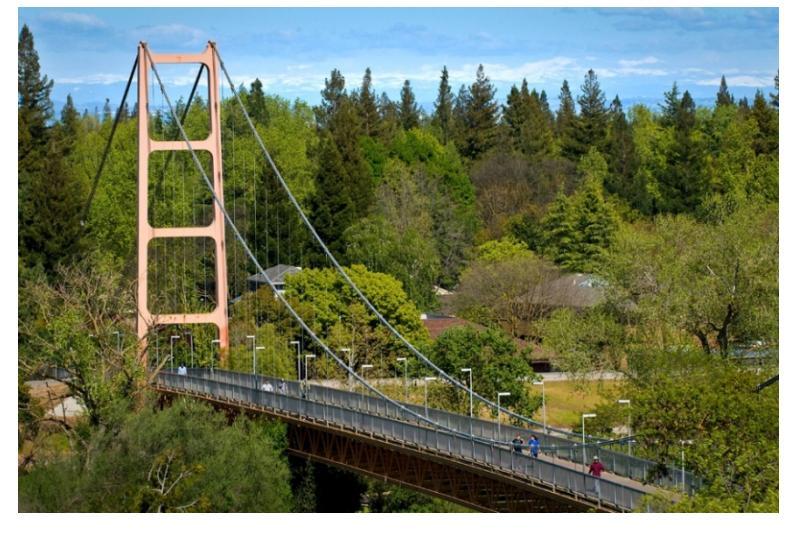
Suspension Cable

Guy A. West Memorial Bridge, Sacramento

Spans the American River between Sacramento State University and Campus Commons. Built in 1966, the pedestrian bridge is 1,144-ft long and 16-ft wide. New Steel Truss at Wentworth Springs/Gerle Creek
