Rubicon Trail Site Assessment

March 27, 2013

Photo Monitoring:

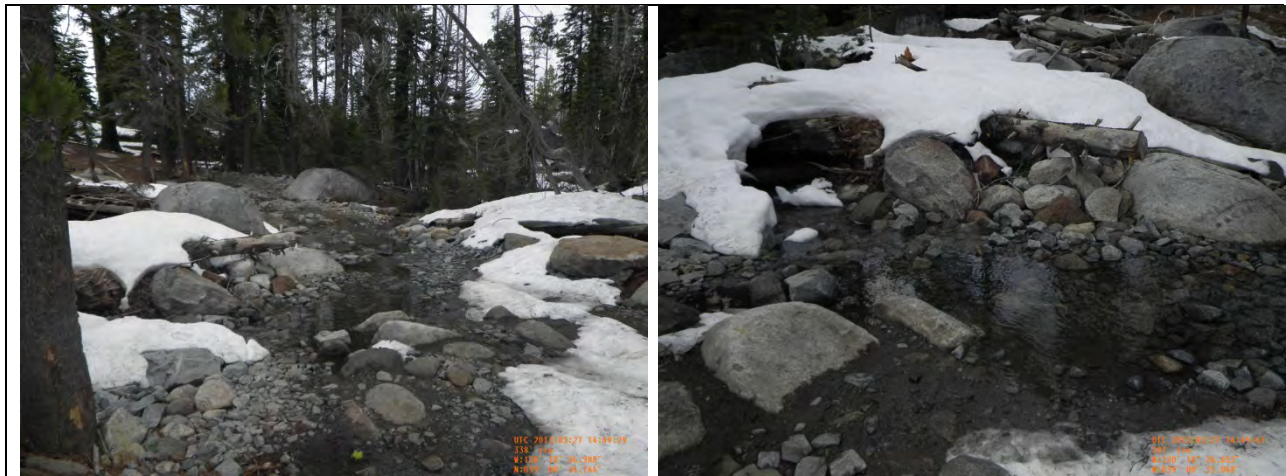
Gate Keeper

LL Station 146+77.03

Water Depths: 0.3', 0.5', 0.5'

Mean: 0.4', Median: 0.5', Mode: 0.5'

Notes: The Rock Outlet Protection (ROP) was exposed through the snow, with snow melt run-off flowing within the ROP. The water was flowing towards the snow covered Rock Energy Dissipator (RED).

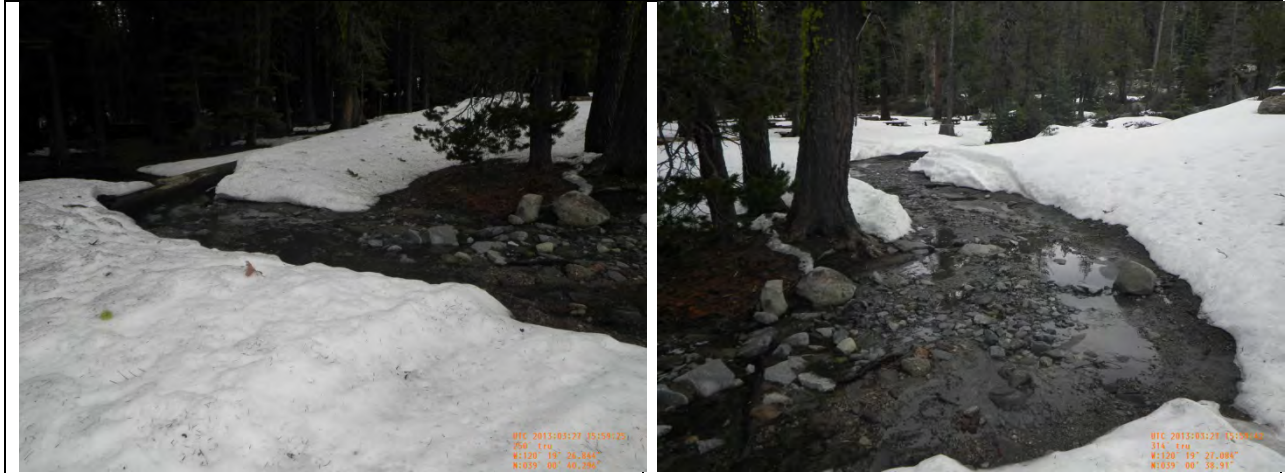
Wentworth Springs Campground

RT Station 33+65.67

Water Depths: 0.2', 0.2', 0.4'

Mean: 0.3', Median: 0.2', Mode: 0.2'

Notes: The Rock Ditch Crossing (RDX) was exposed through the snow, with snow melt run-off flowing across the RDX.

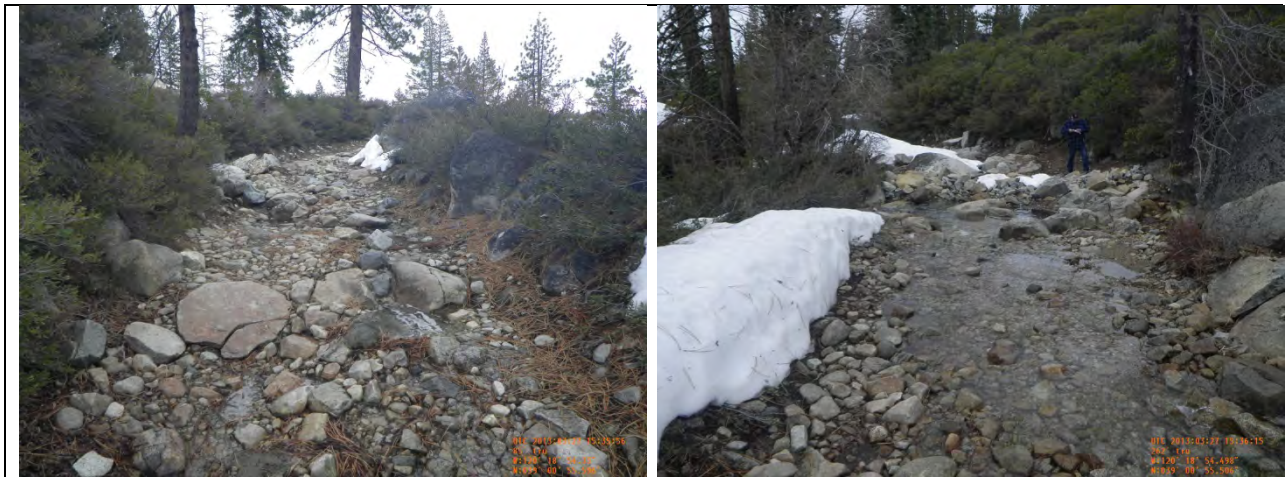
Post Pile

RT Station 75+00

Water Depths: 0.5', 0.6', 0.7'

Mean: 0.6', Median: 0.6', Mode: all values

Notes: The Rock Ditch Crossing (RDX) was observed and was functioning as designed. Snow melt run-off was observed flowing down the hardened surface of the Trail.

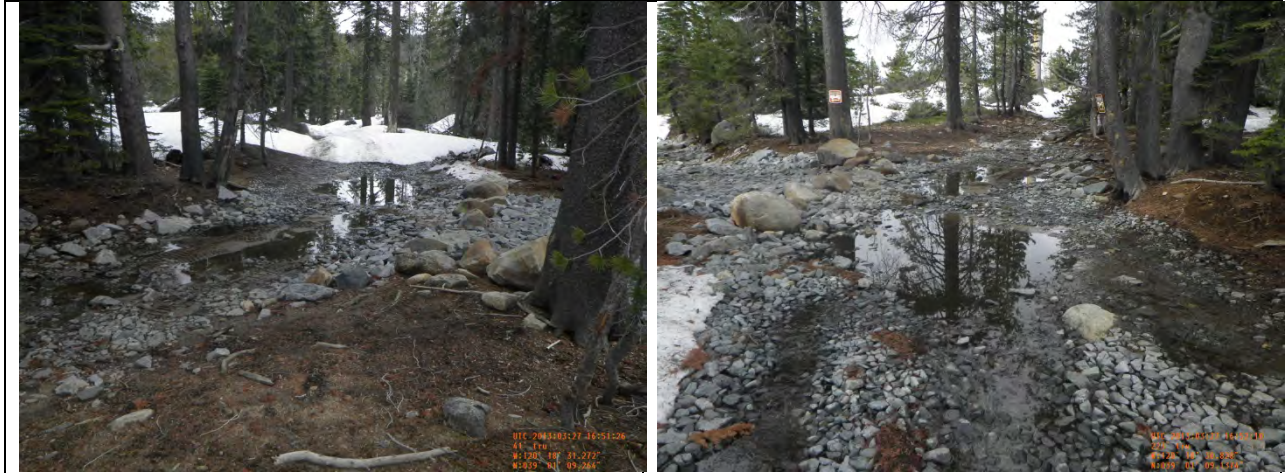
Ellis Creek Intertie

RT Station 99+86.95

Water Depths: 0.2', 0.2', 0.4'

Mean: 0.3', median: 0.2', Mode: 0.2'

Notes: The Rock Lined Channel (RLC) was exposed through the snow, with snow melt run-off moving in the RLC. The water was properly draining towards the Rock Energy Dissipator (RED) which was no longer covered with snow and functioning as designed.

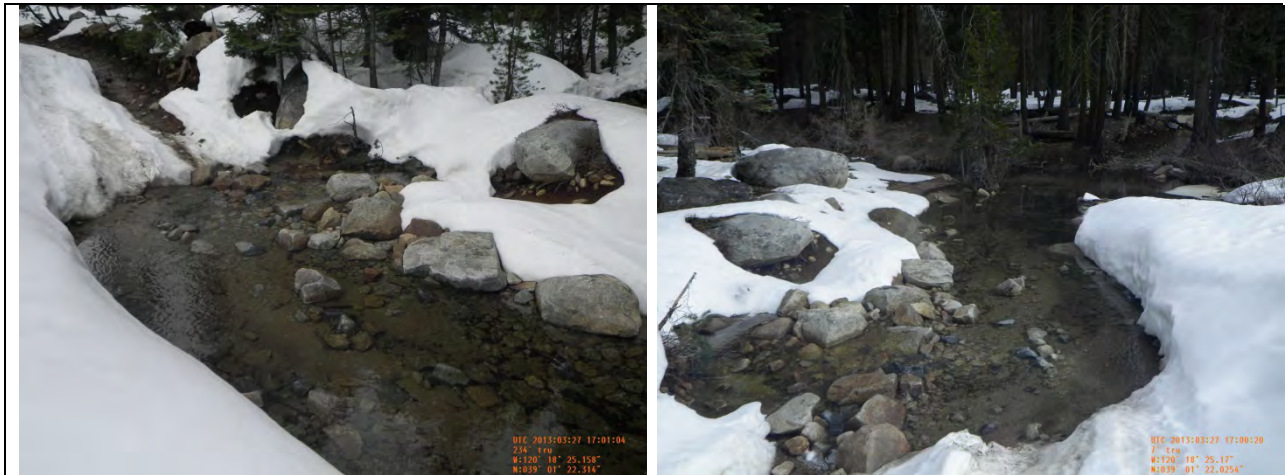
Ellis Creek

RT Station 115+00

Water Depths: 0.7', 0.8', 0.8'

Mean: 0.8', Median: 0.8', Mode: 0.8'

Notes: Snow melt run-off from the northerly drainage was flowing into Ellis Creek.

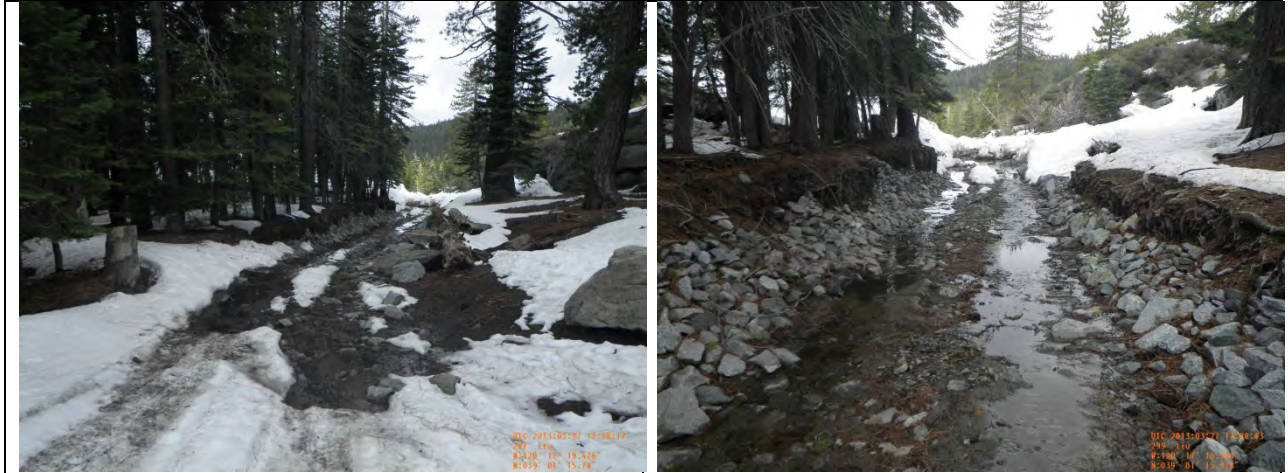
Walker Hill

RT Station 170+80

Water Depths: 0.1', 0.1', 0.2'

Mean: 0.1', Median: 0.1', Mode: 0.1'

Notes: The Rock Slope Protection (RSP) was exposed on both sides of the Trail. There was minimal snow melt run-off flowing down the hardened surface of the Trail, which discharges into a Rock Energy Dissipator.

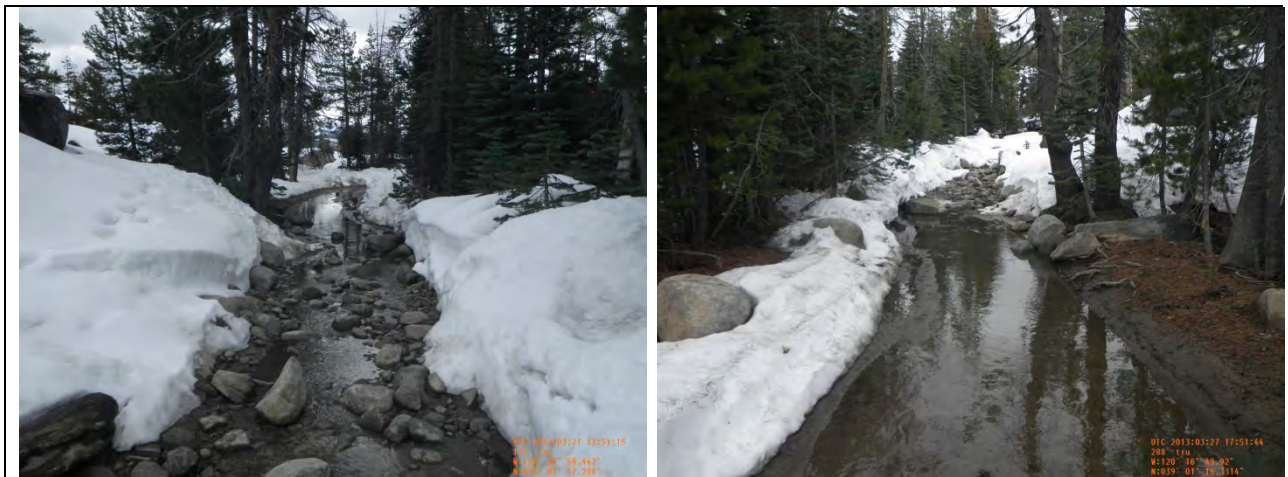
Soup Bowl

RT Station 198+40.84

Water Depth: 0.1', 0.2', 0.2'

Mean: 0.2', Median: 0.2', Mode: 0.2'

Notes: The Rock Ditch Crossing (RDX) was exposed through the snow with snow melt run-off moving through it.
