Rubicon Trail Site Assessment

April 24, 2013

County Assessment: As of this site visit for the conditions observed, the County has determined that the goals of the Saturated Soil Water Quality Protection Plan (SSWQPP) are being met. Observed water levels were low enough to not pose a risk of washing contaminants from the under carriage of vehicles pursuant to the monitoring protocols.

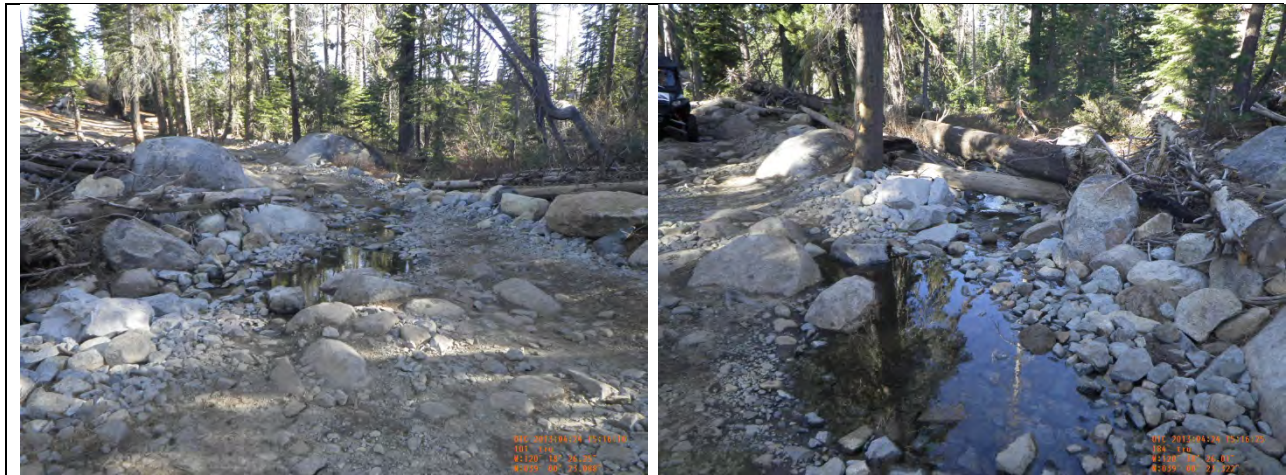
Gate Keeper

LL Station 146+77.03

Water Depths: 0.3', 0.3', 0.3'

Mean: 0.3', Median: 0.3', Mode: 0.3'

Notes: The Rock Outlet Protection (ROP) was seen on the trail, with snow melt runoff flowing within the ROP. The water was flowing towards Rock Energy Dissipator (RED).

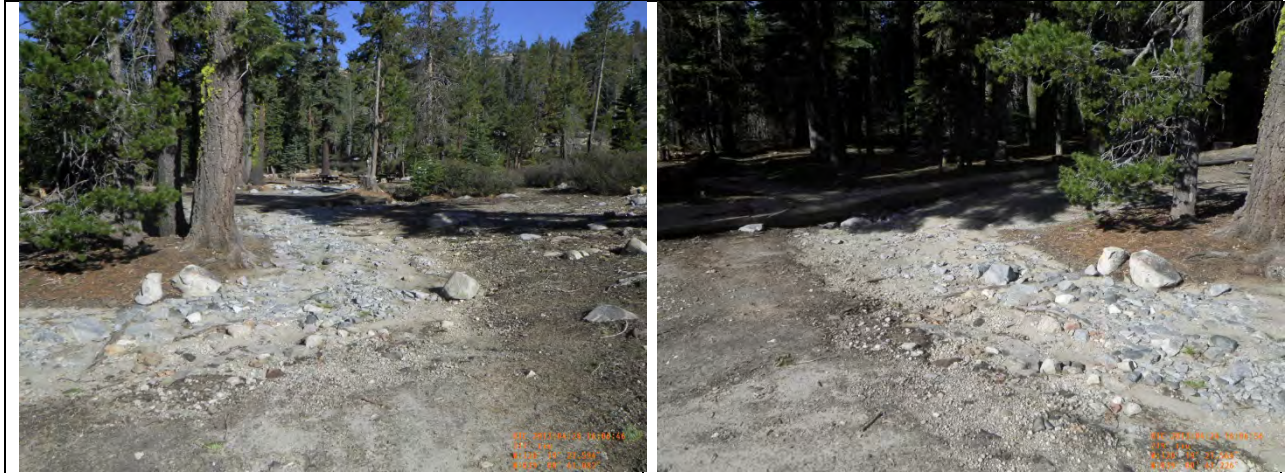
Wentworth Springs Campground

RT Station 33+65.67

Water Depths: 0.0', 0.0', 0.0'

Mean: 0.0', Median: 0.0', Mode: 0.0'

Notes: The Rock Ditch Crossing (RDX) was completely exposed with no snow remaining. There was no runoff at this time.

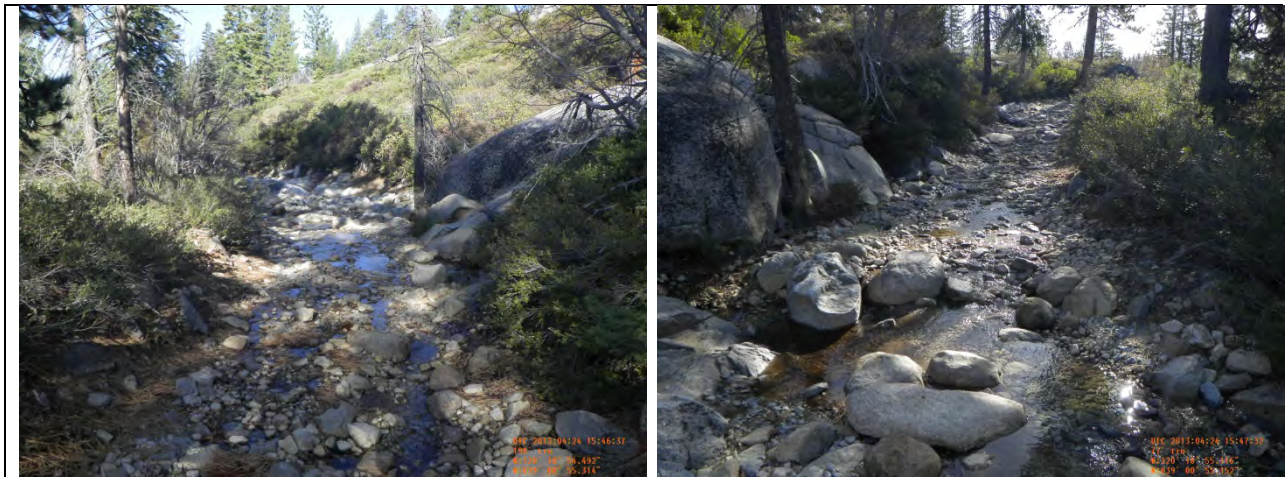
Post Pile

RT Station 75+00

Water Depths: 0.3', 0.4', 0.5'

Mean: 0.4', Median: 0.4', Mode: N/A

Notes: The Rock Ditch Crossing (RDX) was observed and was functioning as designed. Snow melt runoff was observed flowing down the hardened surface of the Trail.

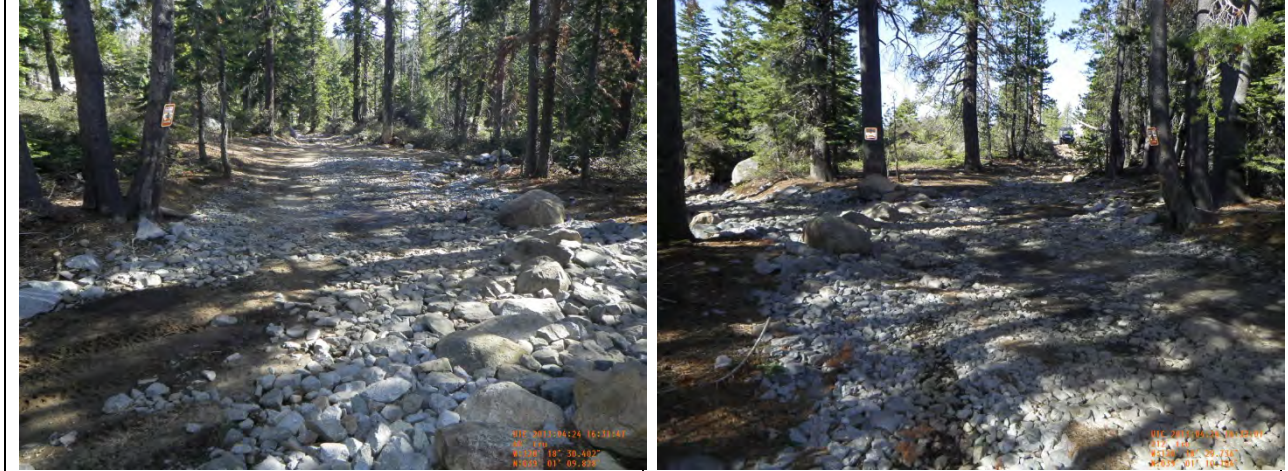
Ellis Creek Intertie

RT Station 99+86.95

Water Depths: 0.0', 0.0', 0.0'

Mean: 0.0', median: 0.0', Mode: 0.0'

Notes: The Rock Lined Channel (RLC) was completely exposed and there was no runoff at this time. The Rock Energy Dissipator (RED) was no longer covered with snow.

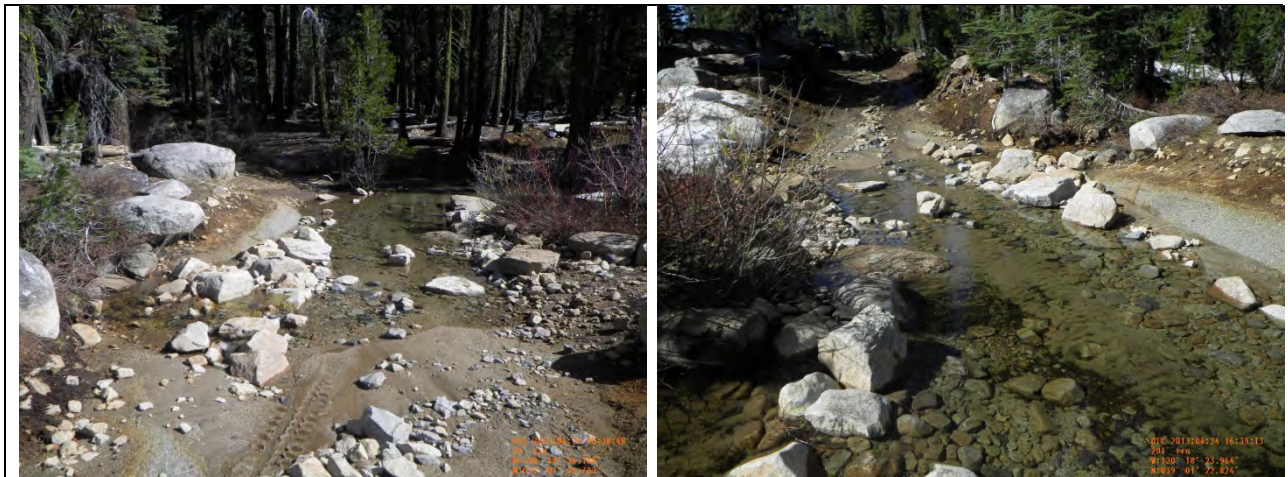
Ellis Creek

RT Station 115+00

Water Depths: 0.4', 0.8', 0.9'

Mean: 0.7', Median: 0.8', Mode: N/A

Notes: Snow melt runoff from the northerly drainage was flowing into Ellis Creek.

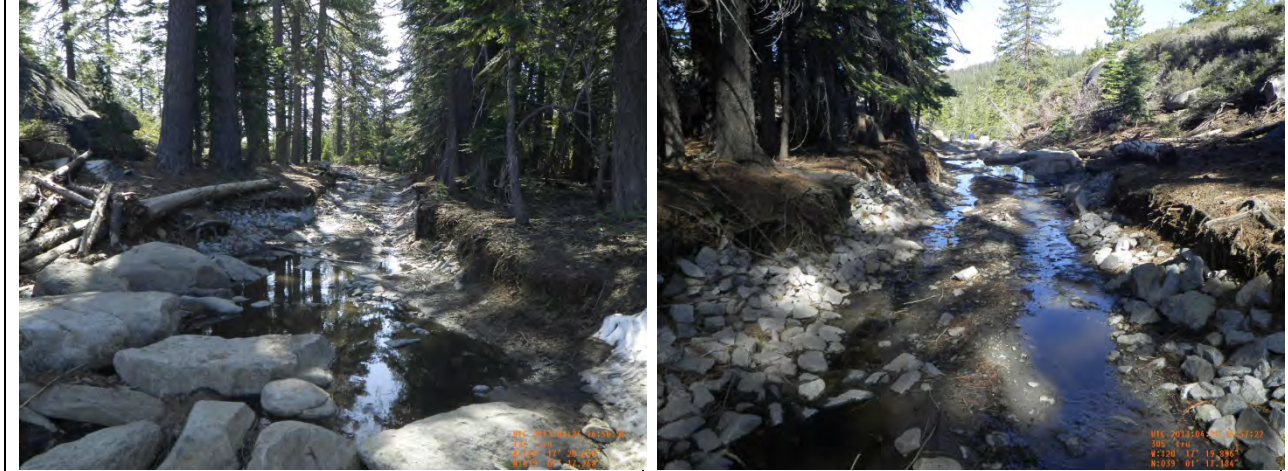
Walker Hill

RT Station 170+80

Water Depths: 0.2', 0.2', 0.3'

Mean: 0.2', Median: 0.2', Mode: 0.2'

Notes: The Rock Slope Protection (RSP) was completely exposed on both sides of the Trail. There was minimal snow melt run-off flowing down the hardened surface of the Trail, which discharges into a Rock Energy Dissipator.

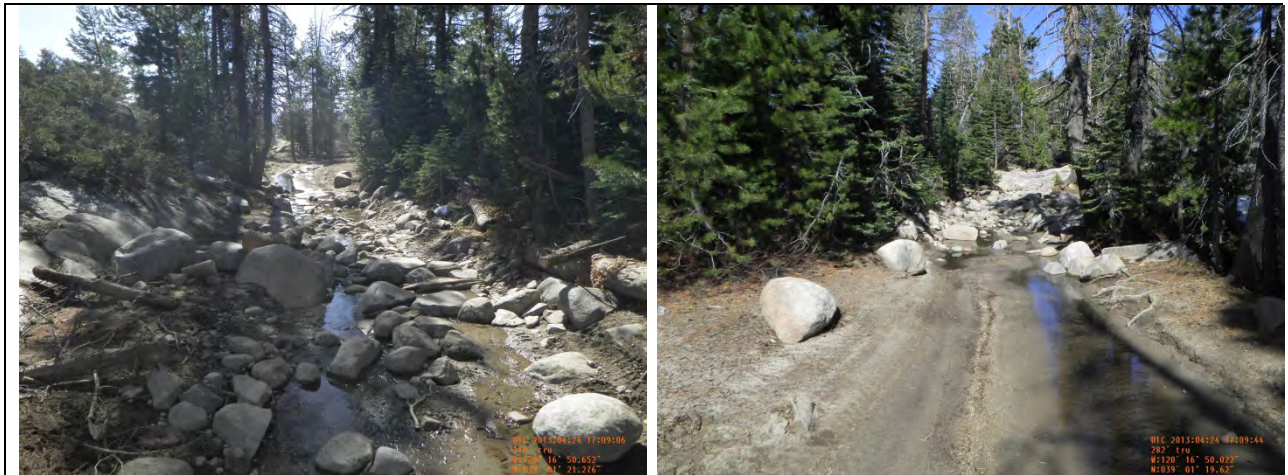
Soup Bowl

RT Station 198+40.84

Water Depth: 0.1', 0.2', 0.2'

Mean: 0.2', Median: 0.2', Mode: 0.2'

Notes: The Rock Ditch Crossing (RDX) was completely exposed with snow melt run-off moving through it.

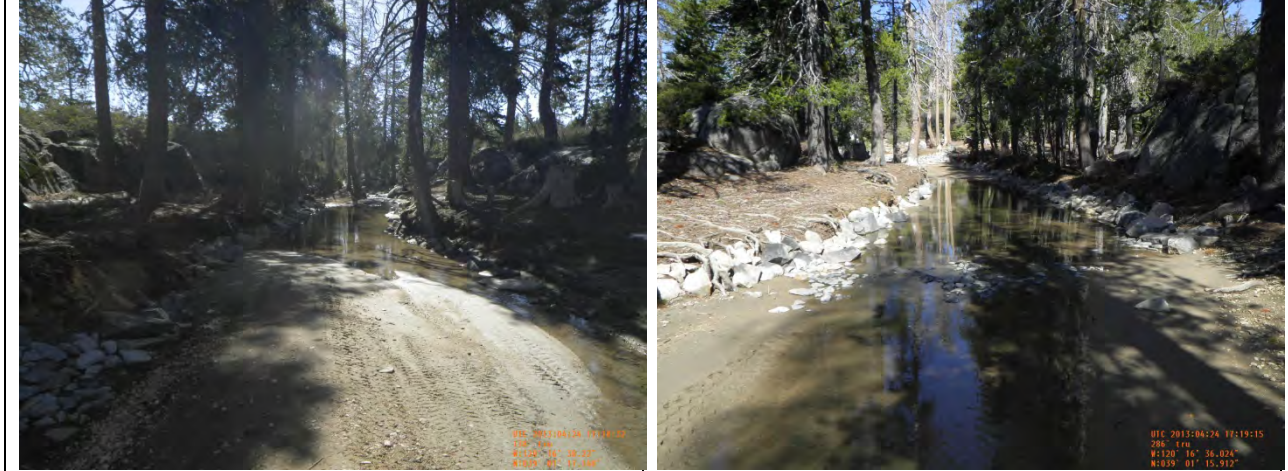
Winter Camp

RT Station 209+58.39

Water Depth: 0.2', 0.6', 0.6'

Mean: 0.5', Median: 0.6', Mode: 0.6'

The Rock Fill (RF) was completely exposed with no snow remaining. There was runoff moving over the RF.
