Rubicon Trail Site Assessment

February 11, 2015

Photo Monitoring:

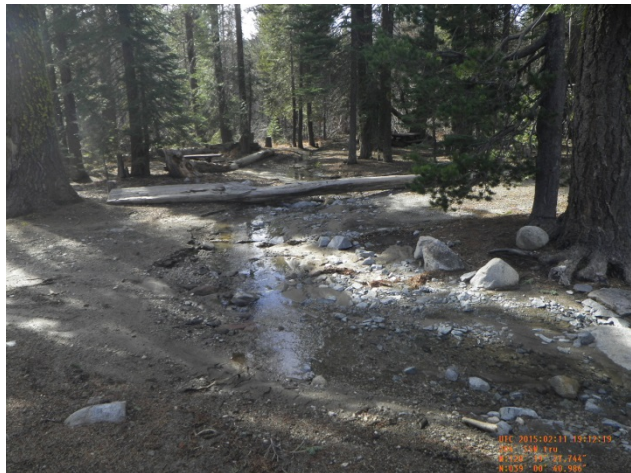
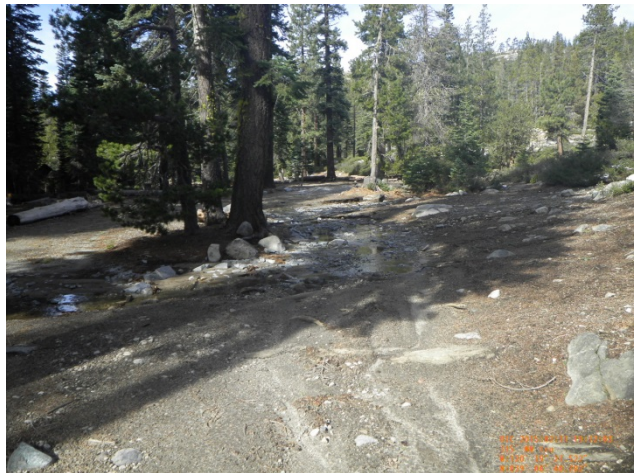
Wentworth Springs Campground
RT Station 33+65

Water Depths: 0.2', 0.2', 0.3'

Notes: The Rock Ditch Crossing (RDX) was exposed with minimal runoff observed.

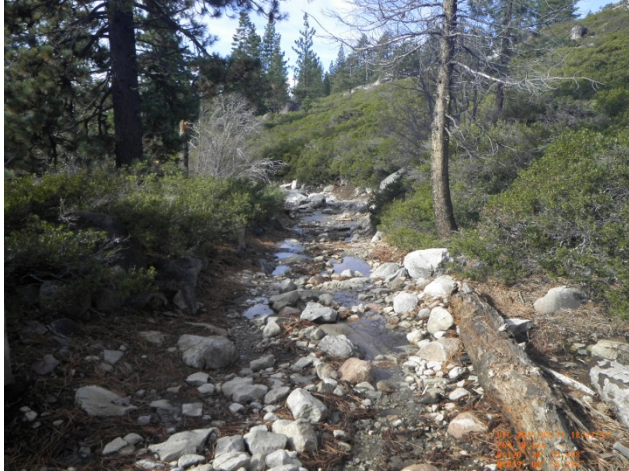
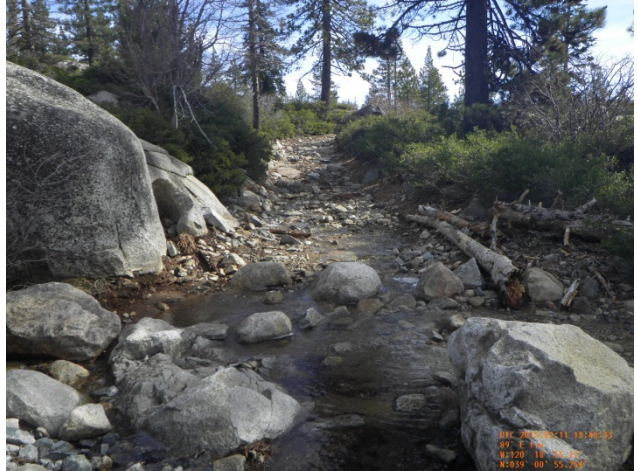
Post Pile
RT Station 75+00

Water Depths: 0.3', 0.5', 0.5'

Notes: The Rock Ditch Crossing (RDX) was observed and was functioning as designed. Runoff was observed flowing down the hardened surface of the Trail.

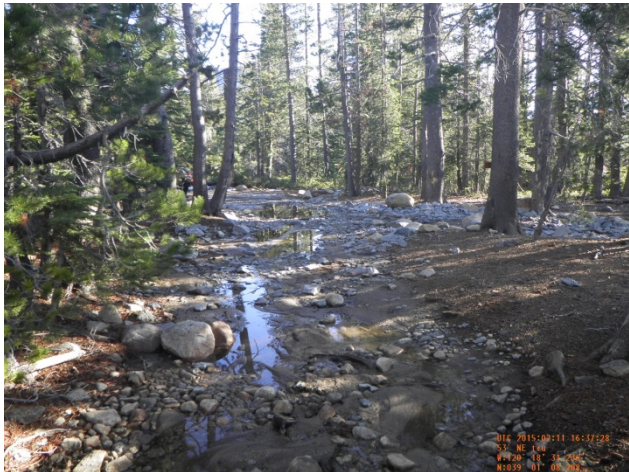
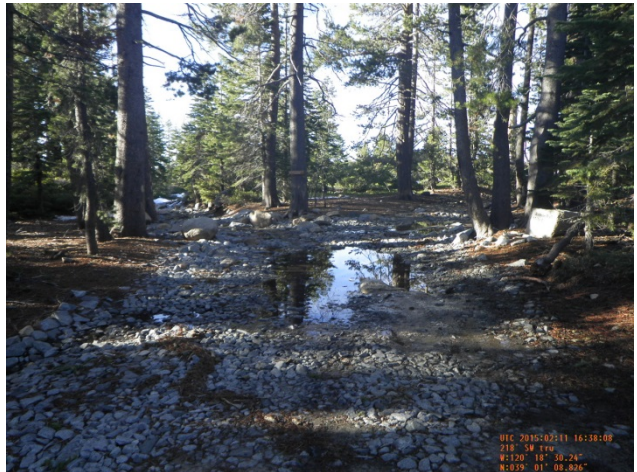
Ellis Creek Intertie
RT Station 99+86

Water Depths: 0.1', 0.2', 0.2'

Notes: The Rock Lined Channel (RLC) was exposed with minimal runoff observed in the RLC. The Rock Energy Dissipator (RED) was visible and with water in it. The water was observed to be flowing into the RED as designed.

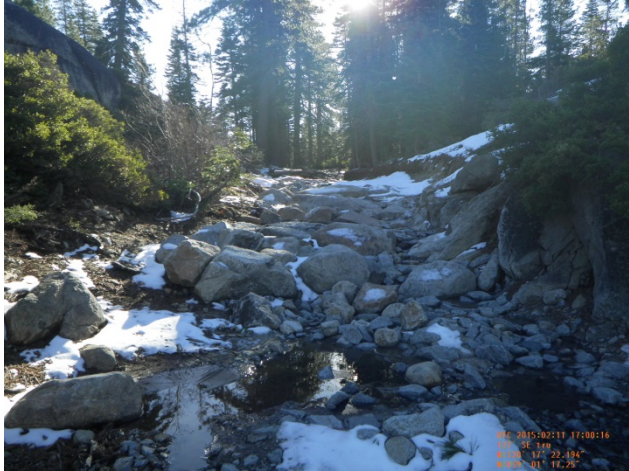
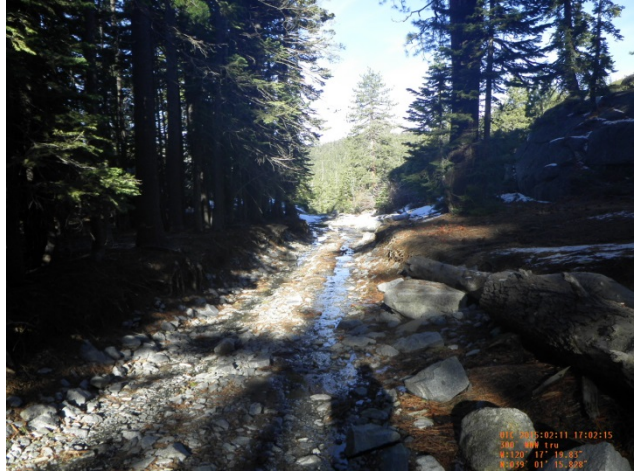
Walker Hill
RT Station 170+80

Water Depths: 0.2', 0.3', 0.3'

Notes: The Rock Slope Protection (RSP) was not fully exposed on one side of the Trail. There was runoff observed flowing down the hardened surface of the Trail.

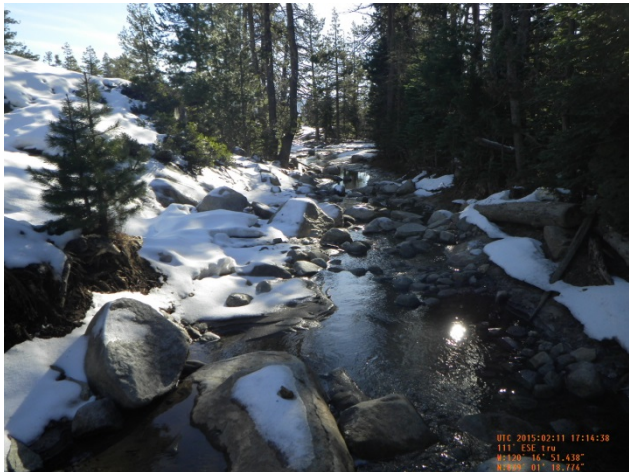
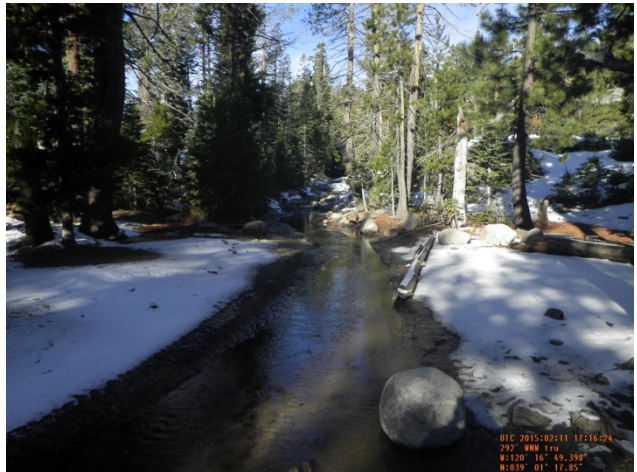
Soup Bowl
RT Station 198+40

Water Depth: 0.4', 0.4', 0.6'

Notes: The Rock Ditch Crossing (RDX) was exposed with runoff flowing through it.
