Rubicon Trail Site Assessment

March 21, 2014

**Rubicon Trail
El Dorado County Site Assessment
March 21, 2014**

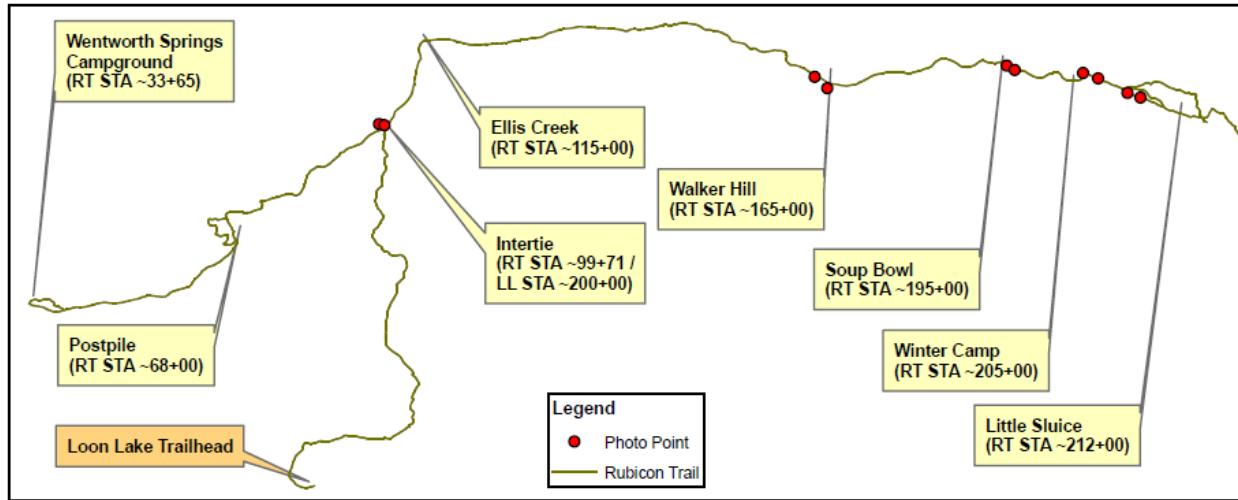
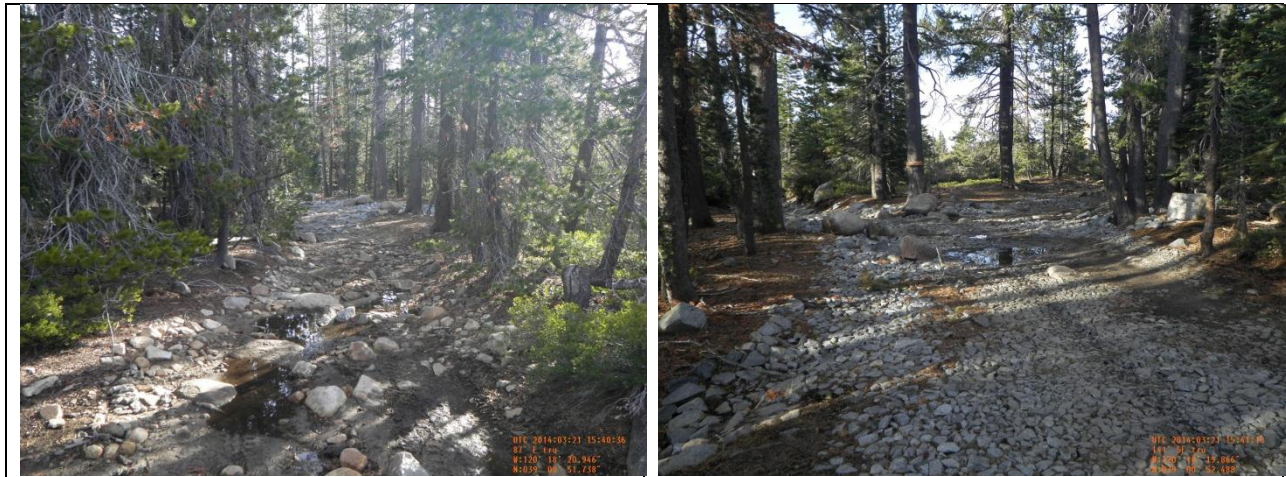
Ellis Creek Intertie
RT Station 99+86.95

Water Depths: 0, 0, 0
(Average: 0)

Notes: The Rock Lined Channel (RLC) was exposed along with the Rock Energy Dissipator (RED). There was no snow run off at this time.

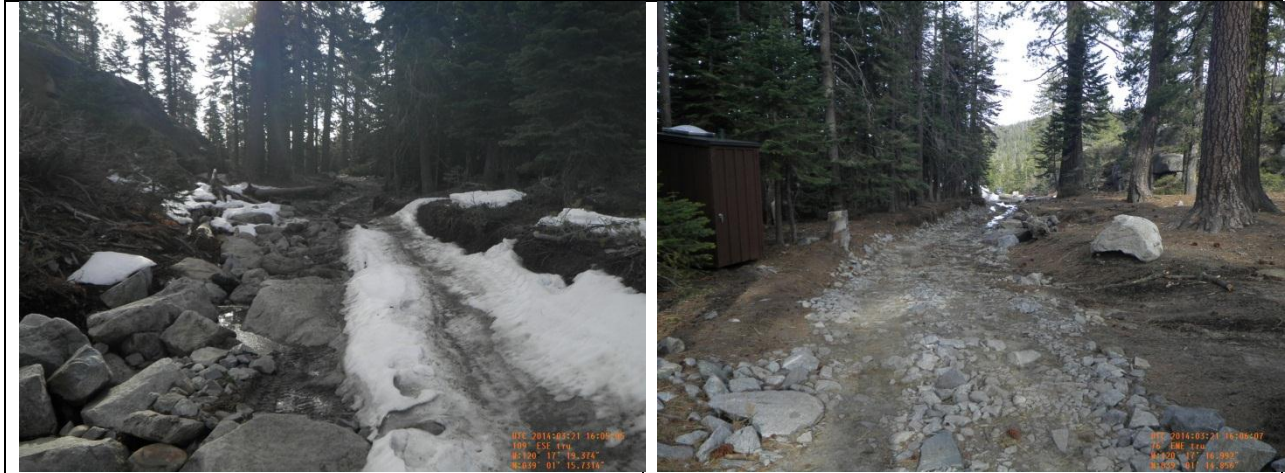
Walker Hill
RT Station 170+80

Water Depths: .05, .05, .05
(Average: .05)

Notes: The Rock Slope Protection (RSP) was not fully exposed on both sides of the Trail. There was minimal snow melt run-off flowing down the hardened surface of the Trail, which discharges into a Rock Energy Dissipator.

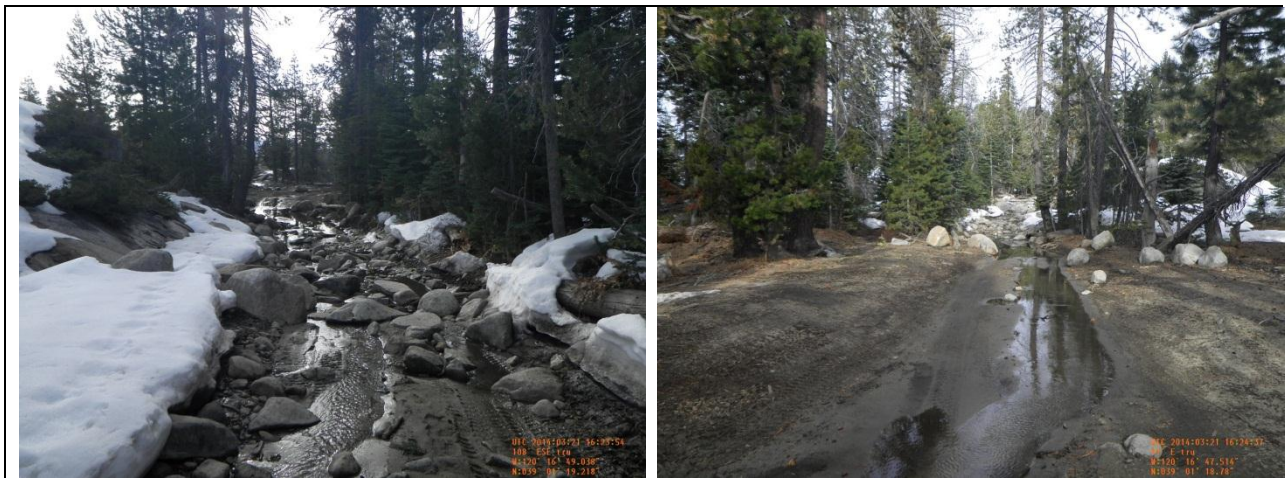
Soup Bowl
RT Station 198+40.84

Water Depth: .1, .2, .2
(Average: .17)

Notes: The Rock Ditch Crossing (RDX) was exposed through the snow with snow melt run-off flowing through it.

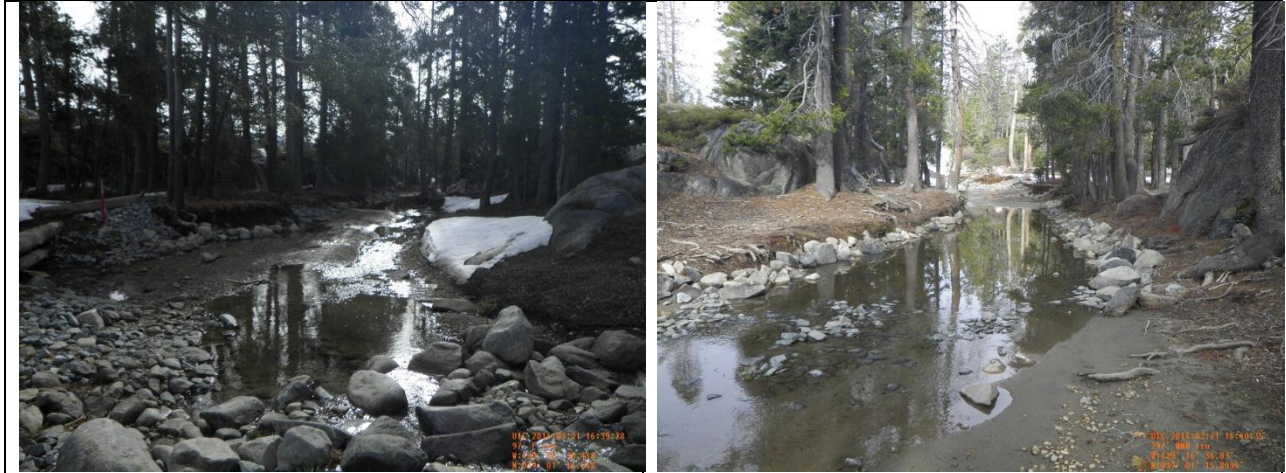
Winter Camp
RT Station 209+58.39

Water Depth: .4, .6, .8
(Average: .6)

The Rock Fill (RF) was fully exposed and the run off was flowing over the RF. There was one out of the three measurements that was greater than 8" however the length did not exceed 10'. Per Condition 2 of the Protocol closure of the trail is not warranted at this time.

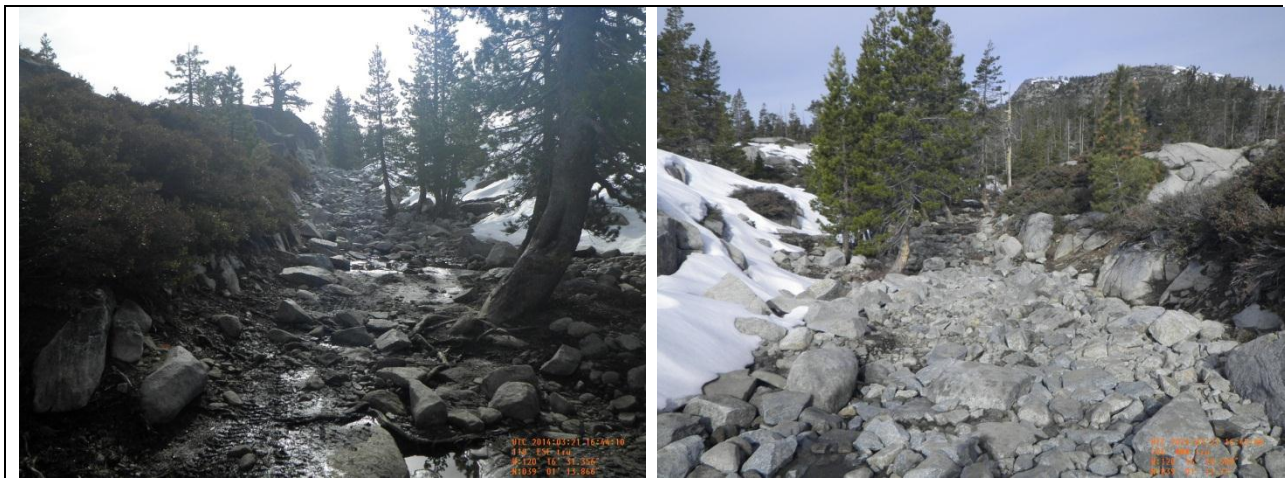
Little Sluice
RT 213+50.32

Water Depth: .05, .05, .05
(Average: .05)

The Rock Fill (RF) was mostly exposed through the snow. Where visible, the run off was flowing over the RF.
